# TEST REPORT

**Report No.** : SGS-R13-0686-EN  
**Applicant** : SAMSUNG TECHWIN Co., Ltd.  
**Address** : SAMSUNG TECHWIN R&D Center, #6 319 beongil,  
Pangyo-ro, Bundang-gu, Seongnam-si, Gyeonggi-do  
**Product** : NETWORK CAMERA  
**Model** : SNV-6012M  
**Environment** : Temp. (25 ± 3) °C, Humidity (42 ± 5) % R.H.  
**Test Date** : June 12, 2013 ~ June 13, 2013  
**Standard** : EN 50155: 2007 Electronic equipment used on rolling  
stock (Section 12.2.11)  
EN 61373: 2010 Rolling stock equipment - shock and  
vibration tests (Category 1 class A)  
**Test Result** : Refer to the attached document  
**Use of report** : Validation

## Summary of Test Results

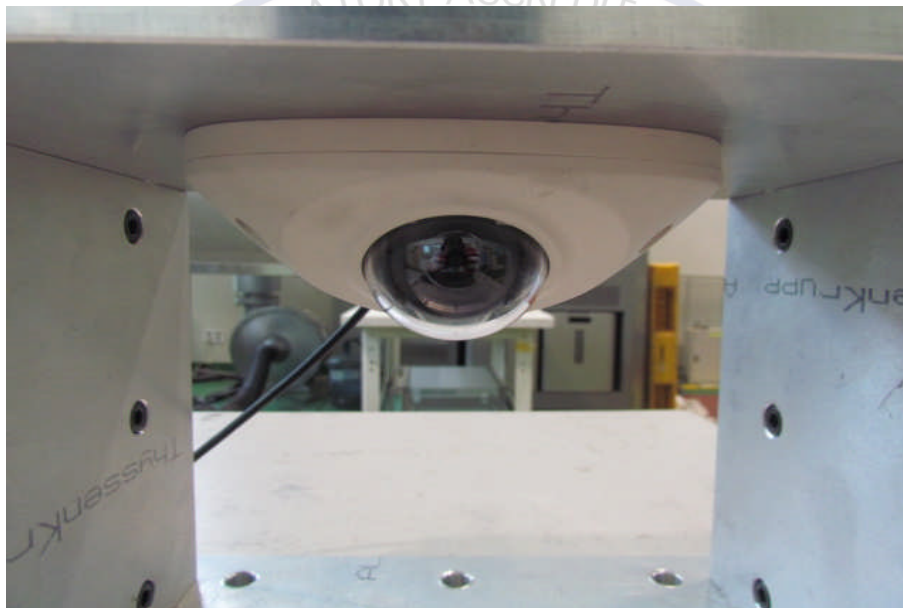
### 2.2 Photograph

Applicant : SAMSUNG TECHWIN Co., Ltd.  
Manufacturer : SAMSUNG TECHWIN Co., Ltd.  
Product : NETWORK CAMERA  
Model : SNV-6012M  
Serial No. : N/A  
Control Voltage : DC (48 ~ 52) V

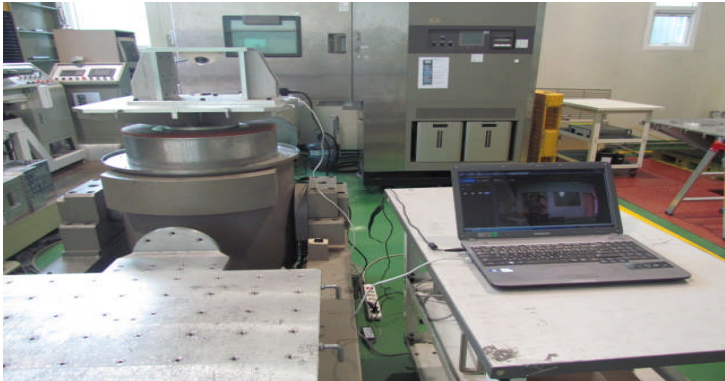
| Test axis | Test photograph |
|---|---|
| Vertical<br>(Z) | |

- 1) Perform a visual inspection and an operational check for the specimen.
- 2) Fix the specimen on the vibration table.
- 3) Operate the vibration tester.
- 4) Repeat from steps 1) to step 3) for each required axis.
- 5) Perform a final visual inspection and an operational check for the specimen.

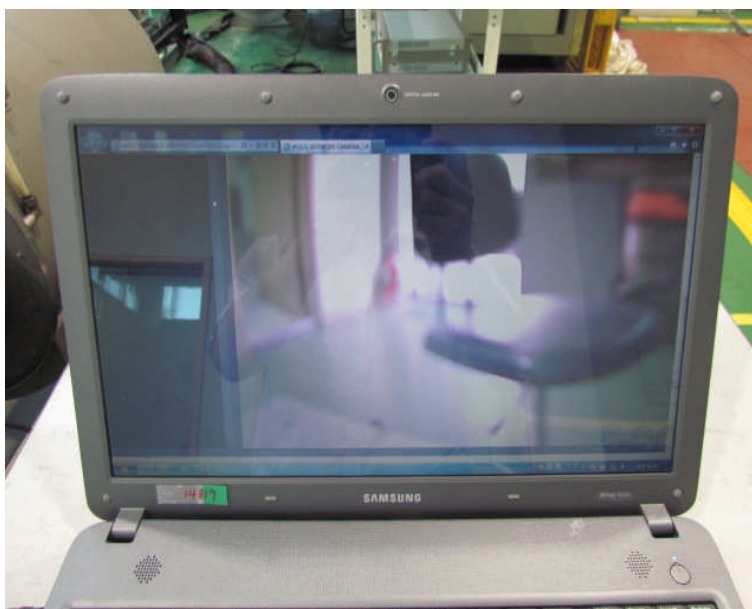
※ Appendix 1. Performance check

| Check List | Test Result |
|---|---|
| 2. Performance check<br>-. display output check | Refer to ※ Appendix 1 |

-. Display output check

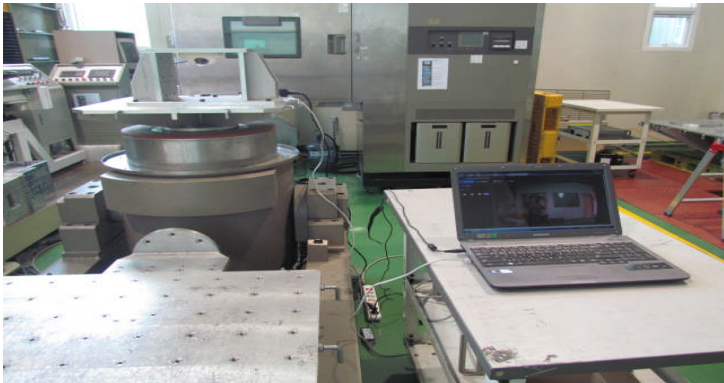
| Test axis | Test photograph |
|---|---|
| Vertical<br>(Z) | |

- 1) Perform a visual inspection and an operational check for the specimen.
- 2) Fix the specimen on the vibration table.
- 3) Operate the vibration tester.
- 4) Repeat from steps 1) to step 3) for each required axis.
- 5) Perform a final visual inspection and an operational check for the specimen.

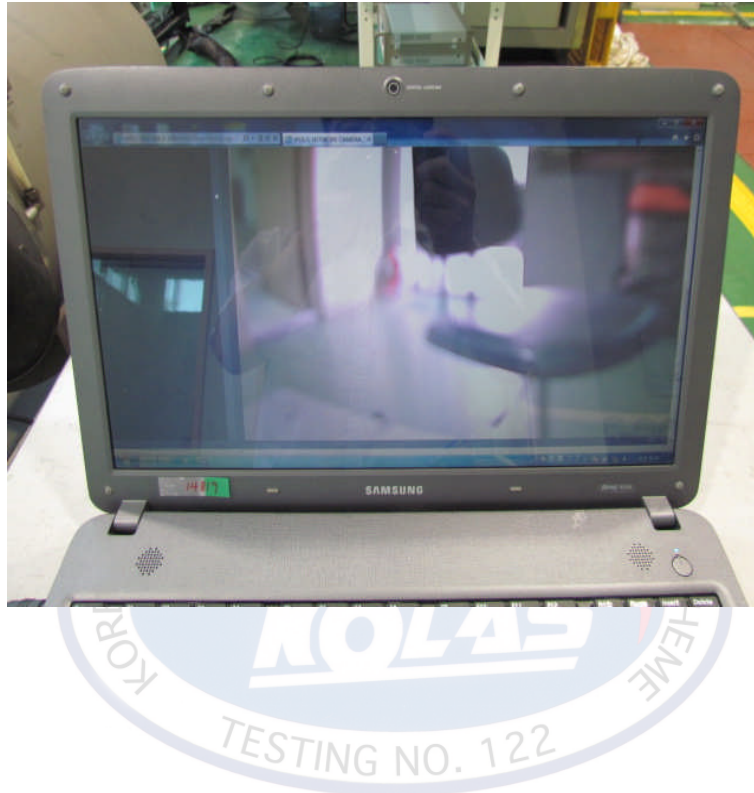
※ Appendix 1. Performance check

| Check List | Test Result |
|---|---|
| 2. Performance check<br>-. Display output check | Refer to ※ Appendix 1 |

-. Display output check

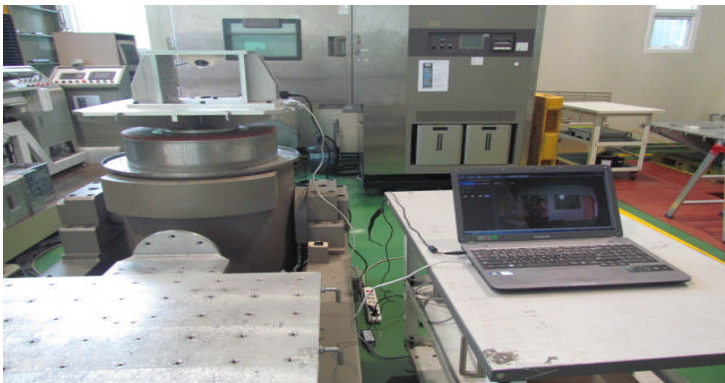
| Test axis | Test photograph |
|---|---|
| Vertical<br>(Z) | |

- 1) Perform a visual inspection and an operational check for the specimen.
- 2) Fix the specimen on the vibration table.
- 3) Operate the vibration tester.
- 4) Repeat from steps 1) to step 3) for each required axis.
- 5) Perform a final visual inspection and an operational check for the specimen.

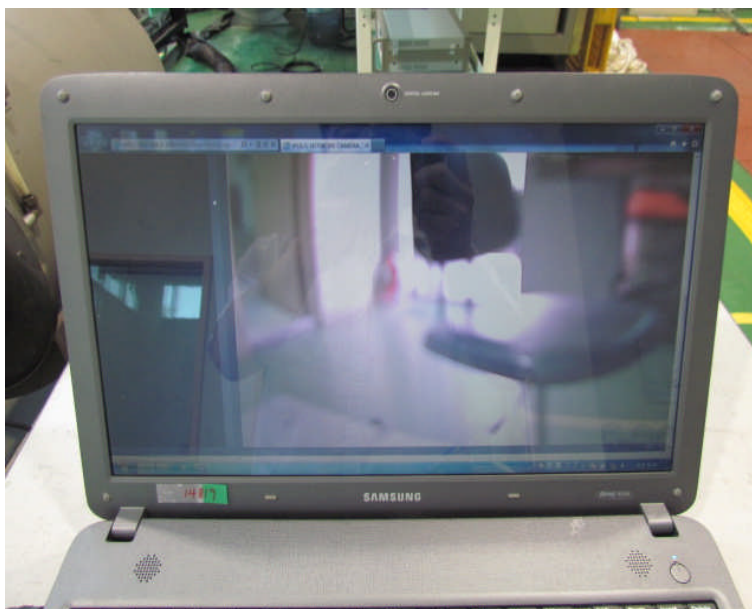
※ Appendix 1. Performance check

| Check List | Test Result |
|---|---|
| 2. Performance check<br>-. Display output check | Refer to ※ Appendix 1 |

-. Display output check
