# TEST REPORT

REPORT No.:  
CTK-2026-00880  
Page (1) / (12) pages

NETWORK CAMERA / SPS-A8016

IEC 62262:2002+AMD1:2021

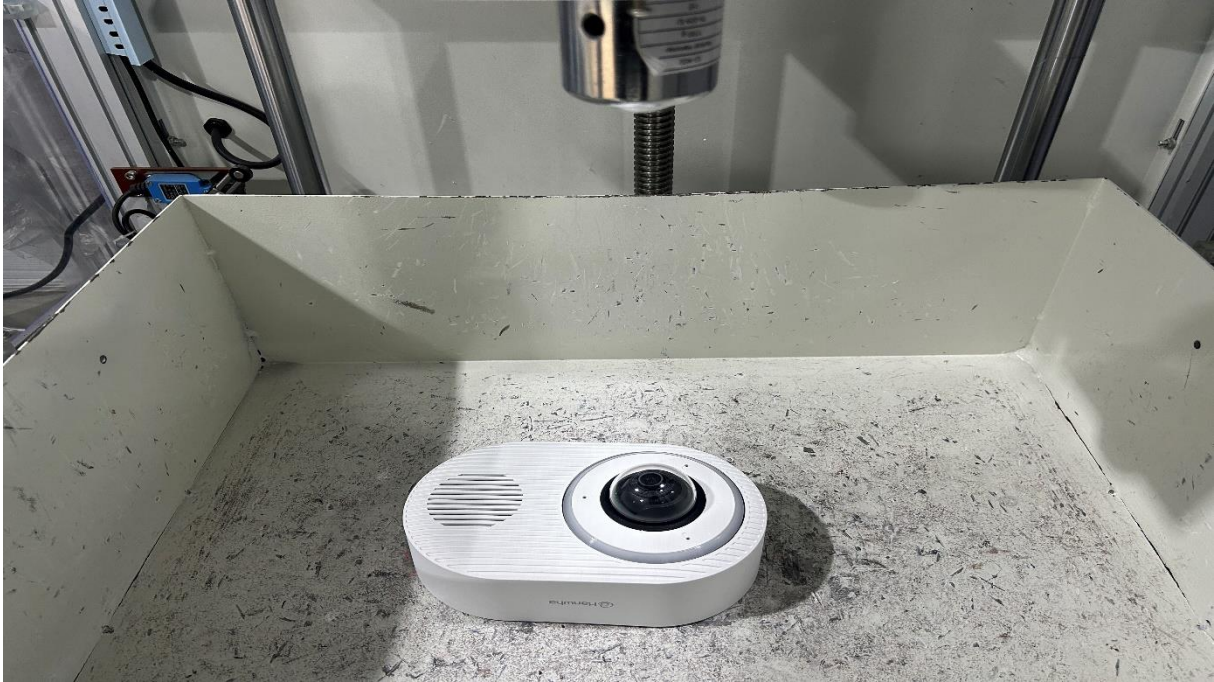
#### 3.3.1 Evidence of test setting

Impact times: five times for each of the exposed surface. (Do not impact more than 3 times in the same spot)

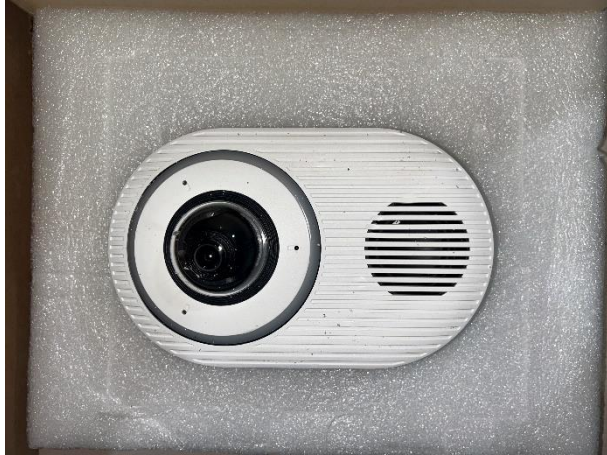
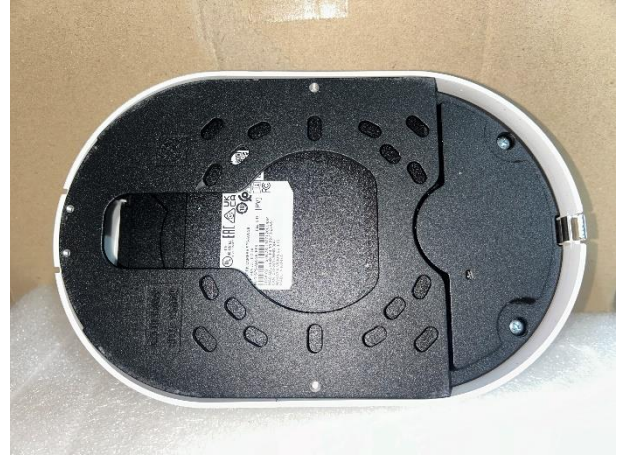
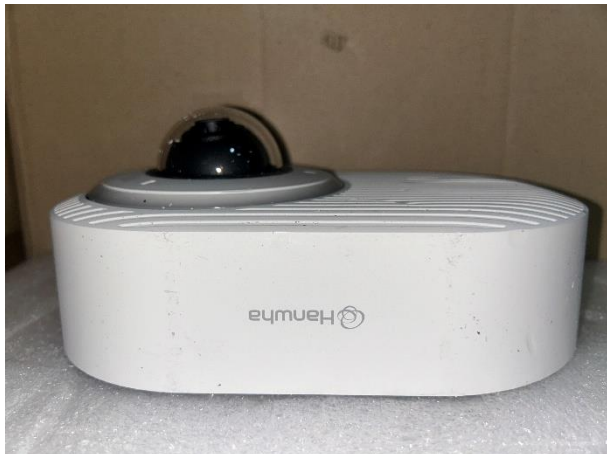
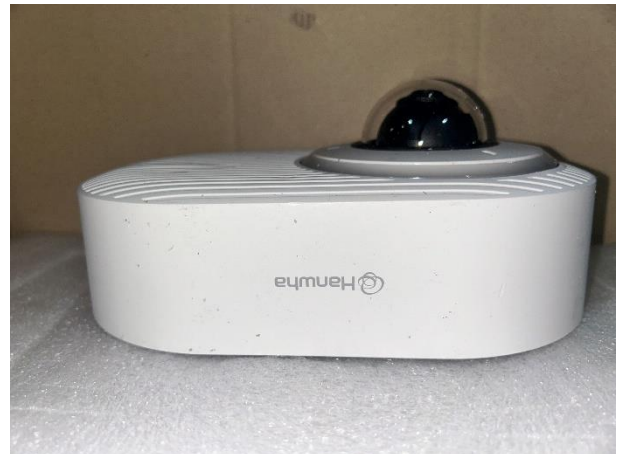
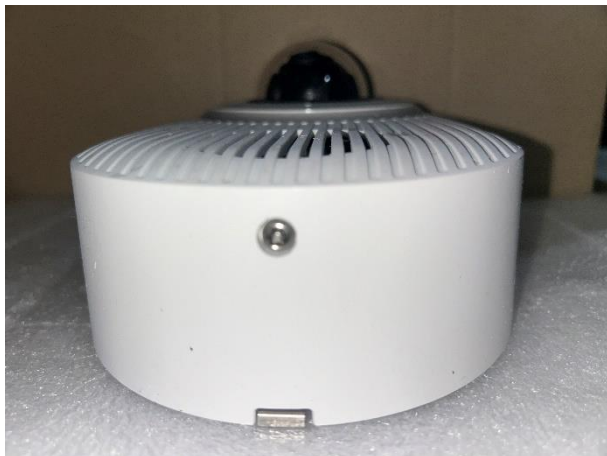
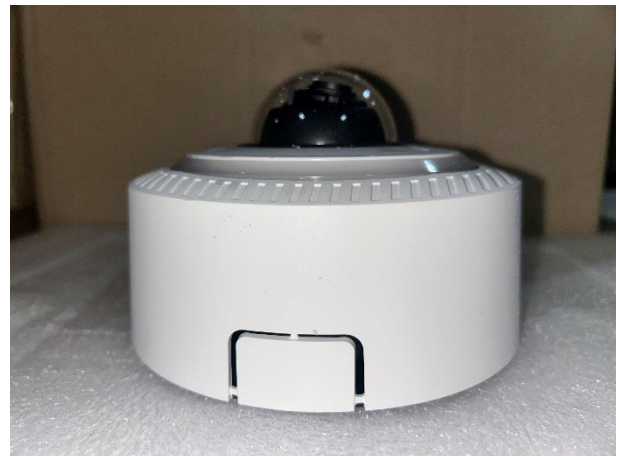
### 3.5.2 Post-test product images

| Evaluation Criteria | Test Results | Remark |
|---|---|---|
| Visual Inspection | Some scratches were generated on the outside of the product. | - |

※ Refer to the product photos after the completion of testing in section 3.5.2
