# 시 험 성 적 서

발 행 번 호 : SGS-R13-1066-KR

제품명 : Mobile NVR

모델명 : SRM-872

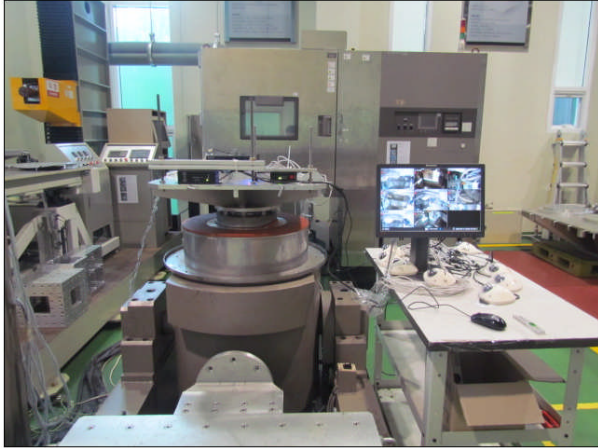
| 비고 | 시험 사진 |
|---|---|
| 상하<br>(Z축) | |

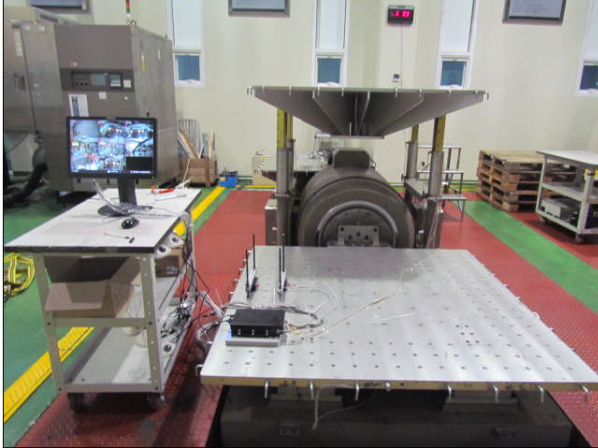
| 비고 | 시험 사진 |
|---|---|
| 전후<br>(Y축) | |

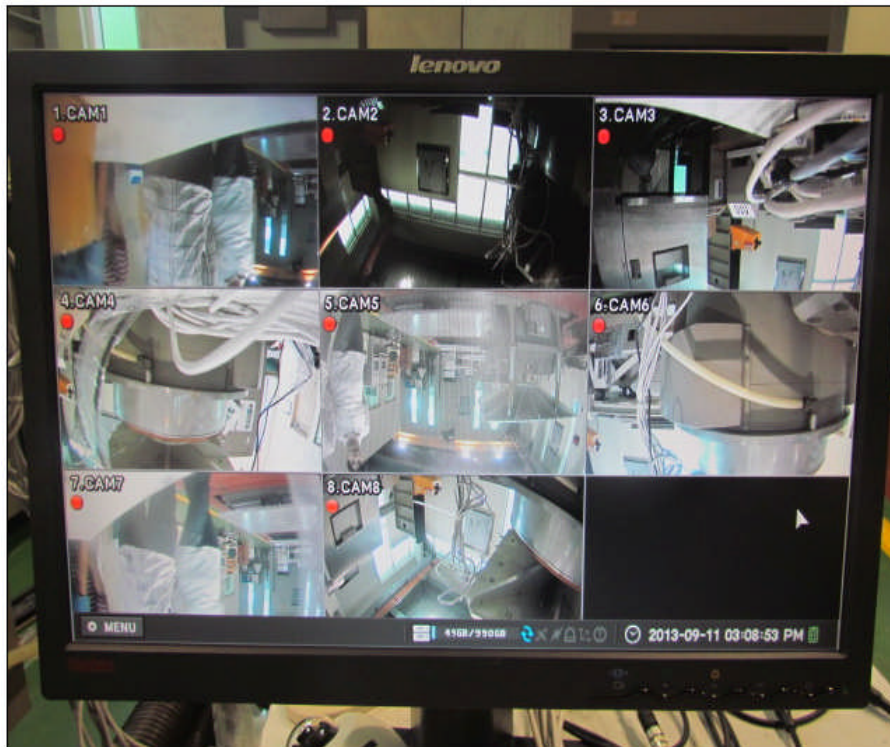
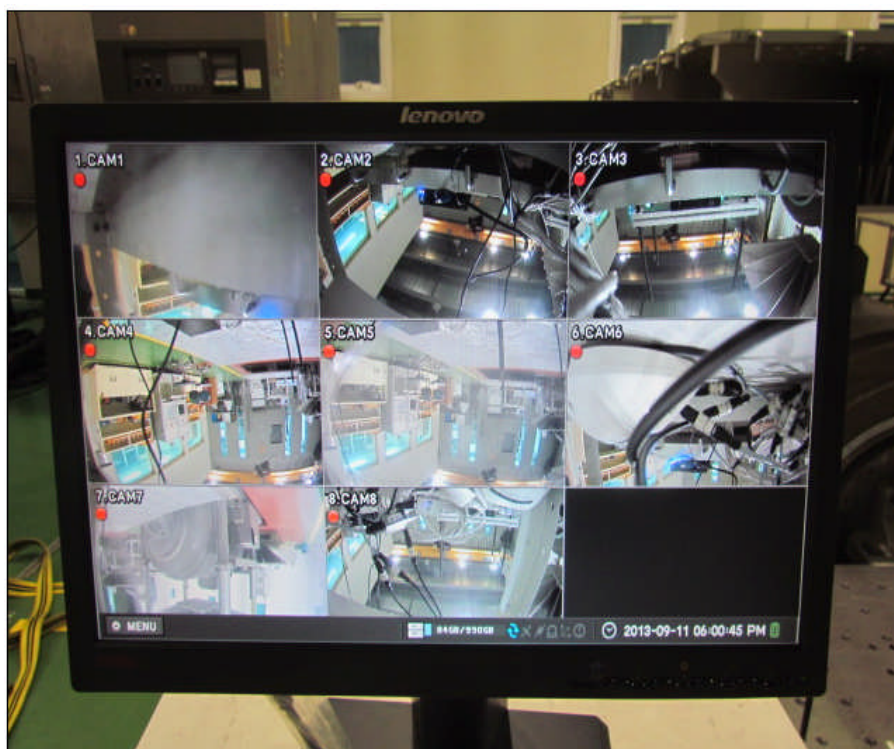
※ 별첨 1. 기능 동작 확인

| 점검항목 | 시험결과 |
|---|---|
| 2. 기능 동작 확인<br>- 영상 출력 확인 | ※ 별첨 1. 참조 |

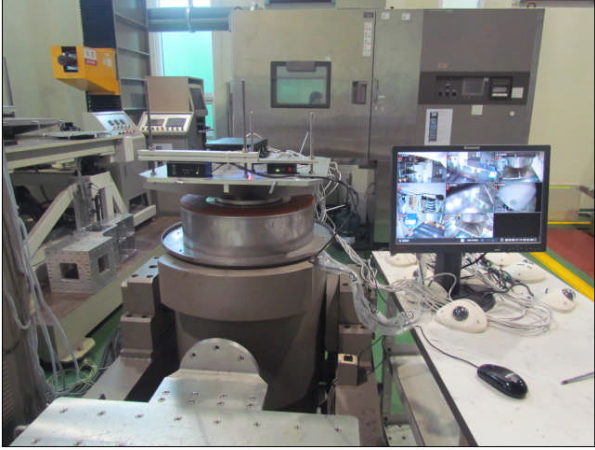
| 비고 | 시험 사진 |
|---|---|
| 상하<br>(Z축) | |

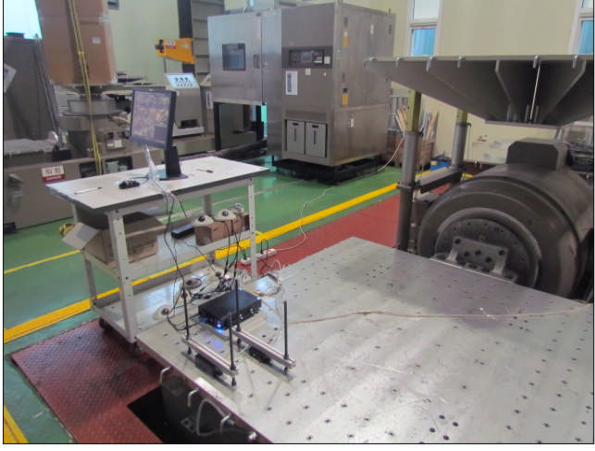
| 비고 | 시험 사진 |
|---|---|
| 전후<br>(Y축) | |

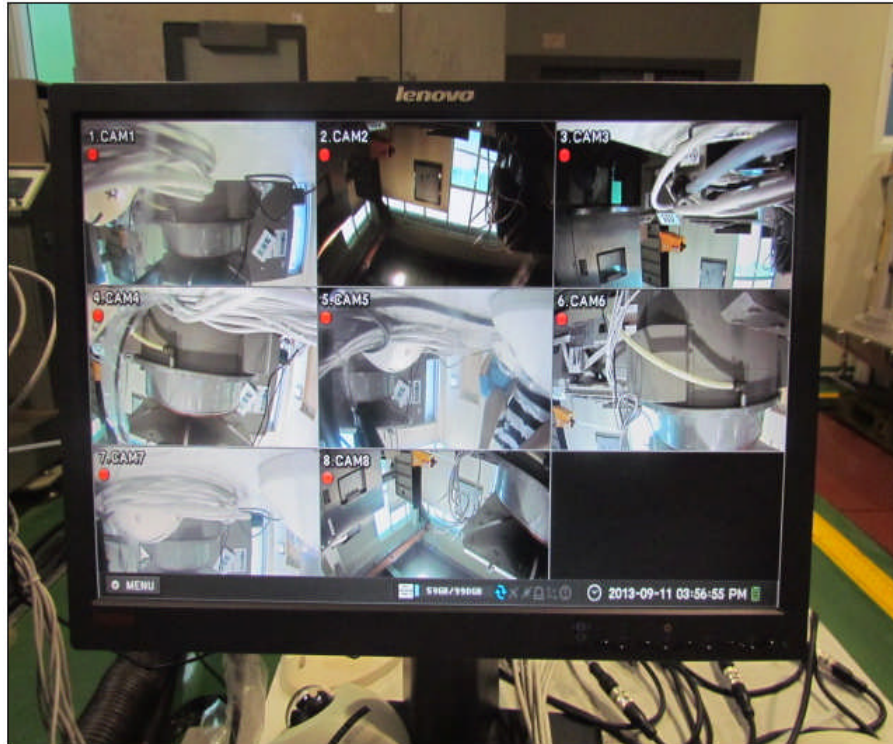
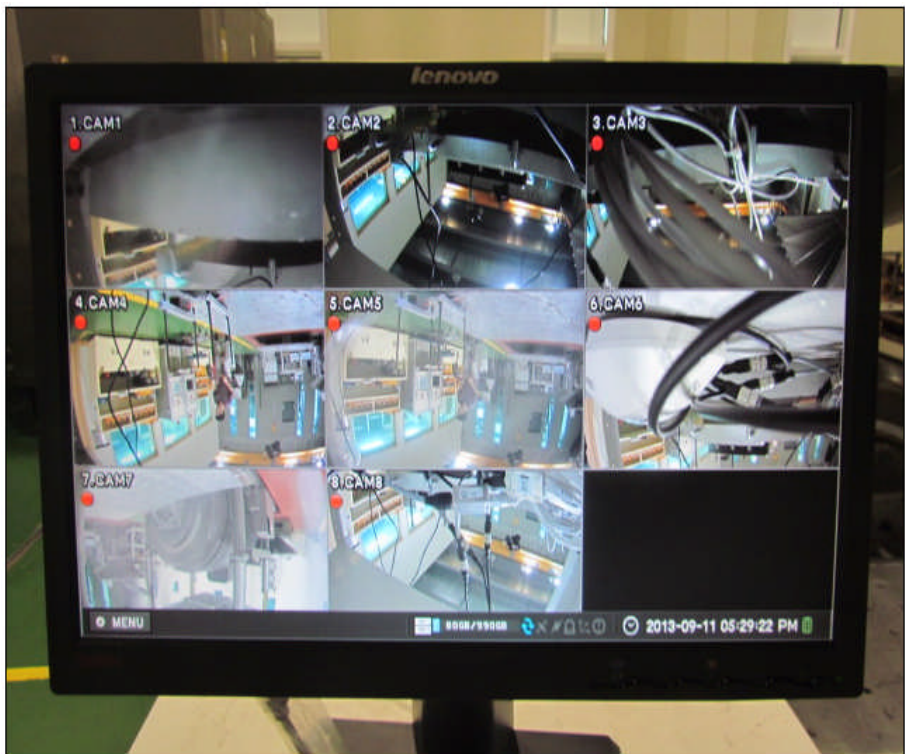
※ 별첨 1. 기능 동작 확인

| 점검항목 | 시험결과 |
|---|---|
| 2. 기능 동작 확인<br>-영상 출력 확인 | ※ 별첨 1. 참조 |
