# TEST REPORT

REPORT No.:  
CTK-2025-03141  
Page (1) / (17) pages

Network Thermal Camera / TNM-C4940TD

### 3. Degrees of protection provided by enclosures for electrical equipment against external mechanical impacts (IK code)

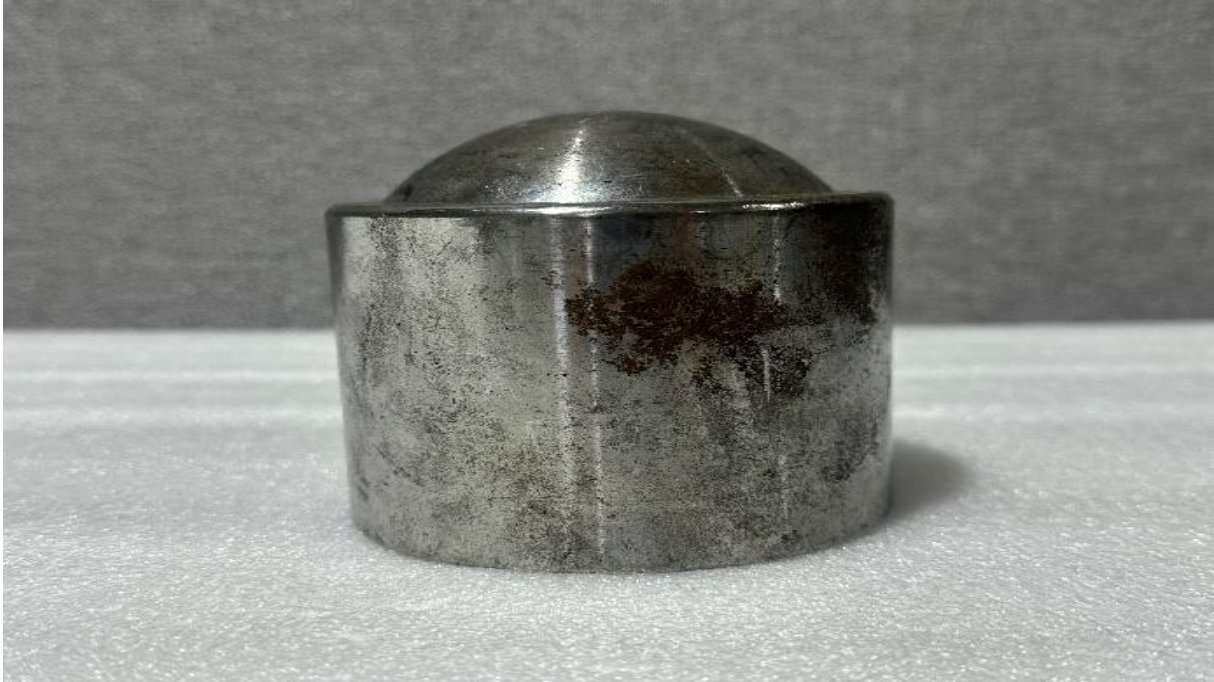
Vertical Hammer

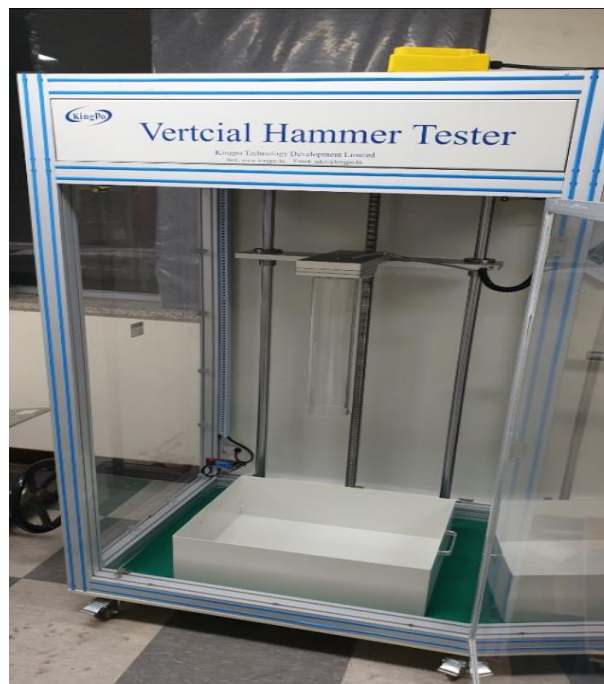
Vertical Hammer Tester

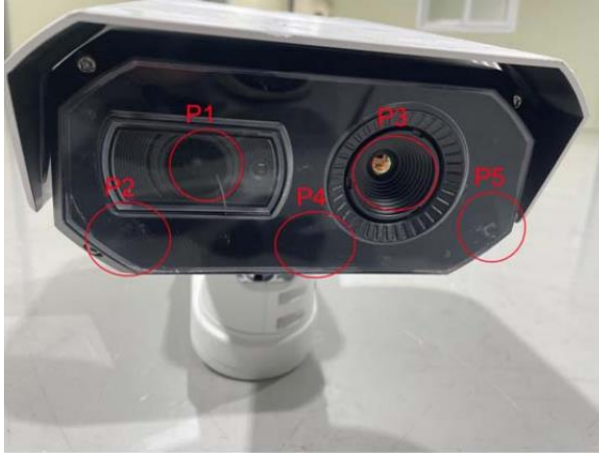
Check the hit area the test\_1

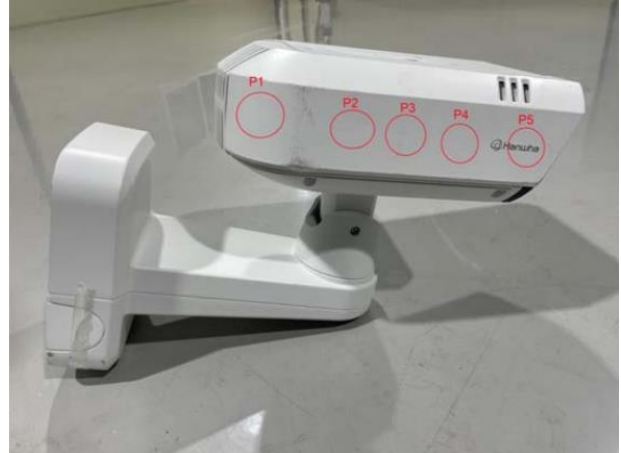
Check the hit area the test\_2

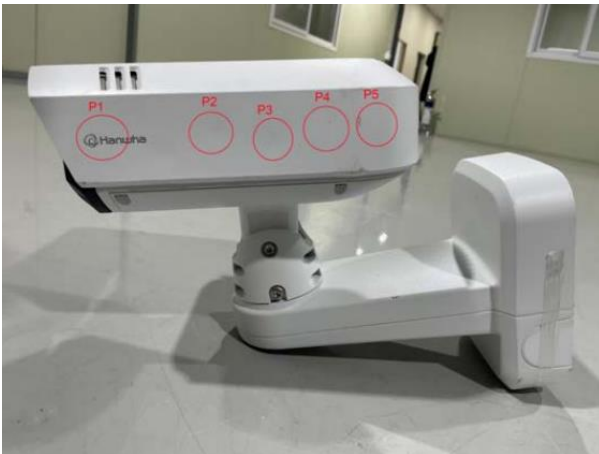
Check the hit area the test\_3

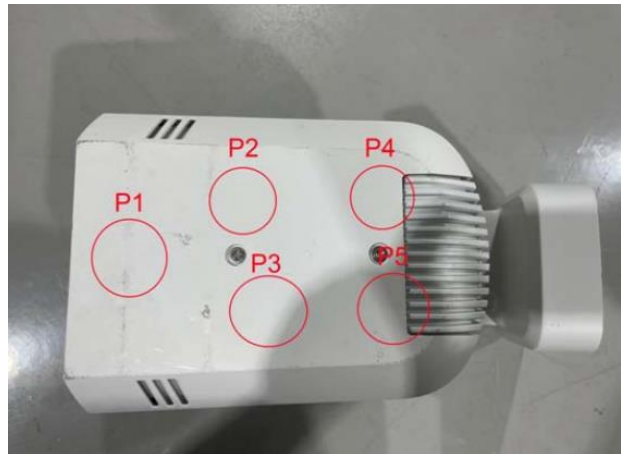
Check the hit area the test\_4

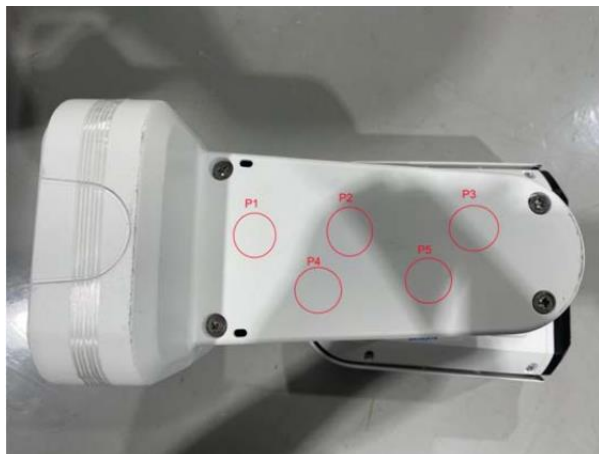
Check the hit area the test\_5

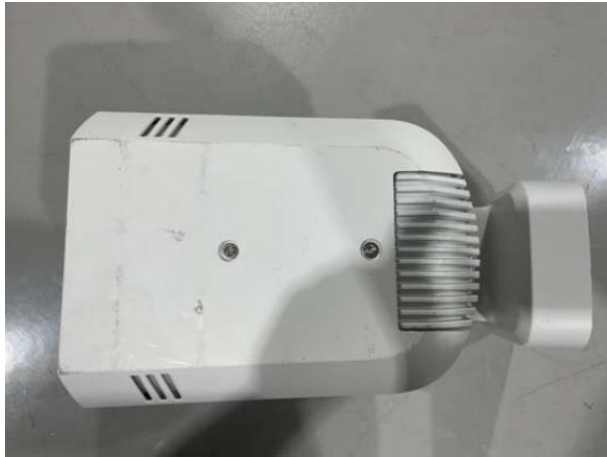
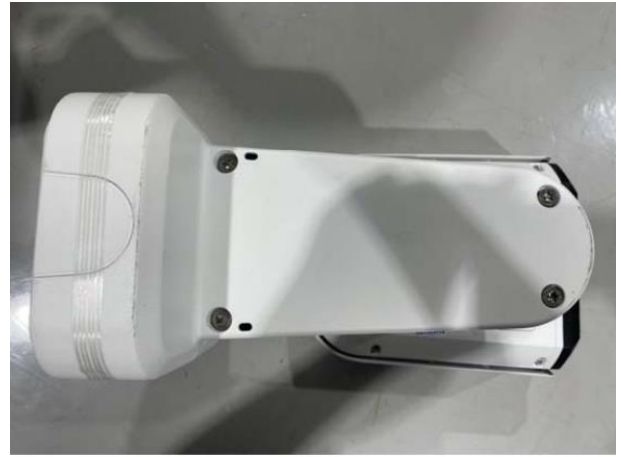
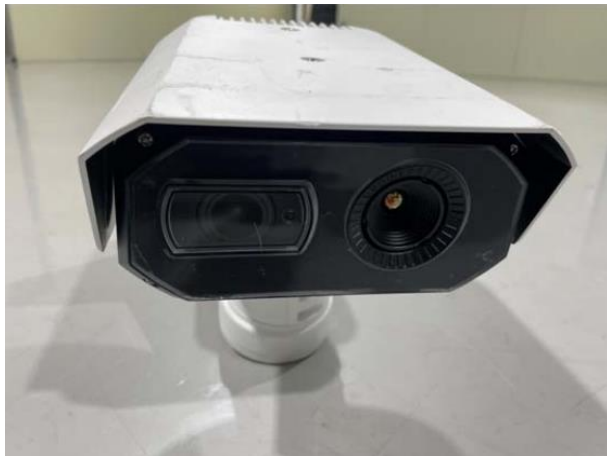
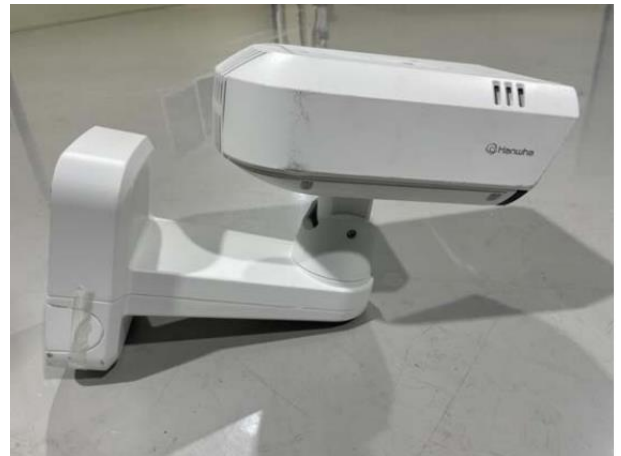
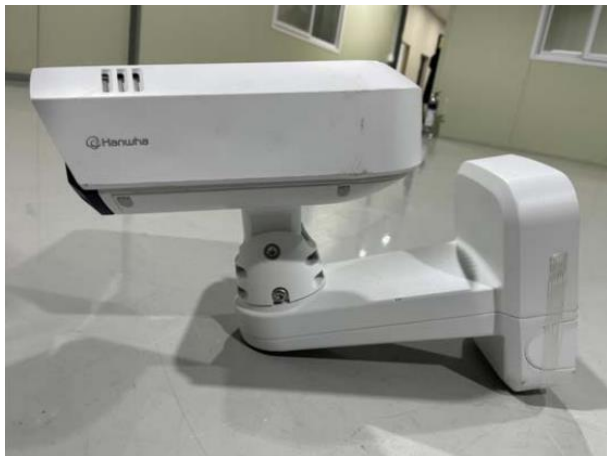
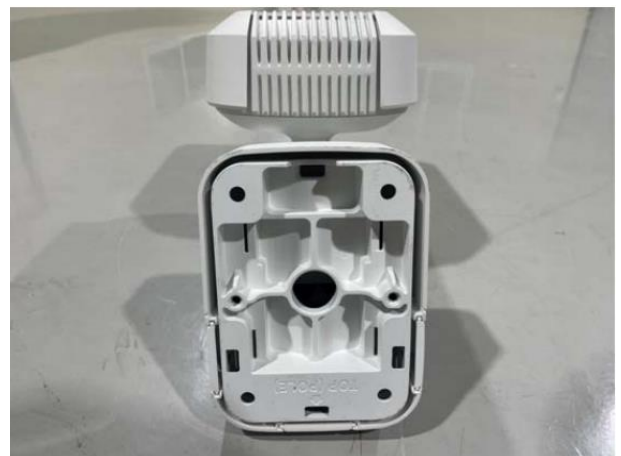
### 3.5.2 Post-test product images

| Evaluation Criteria | Test Results | Remark |
|---|---|---|
| Visual Inspection | Some scratches were generated on the outside of the product. | - |

※ Refer to the product photos after the completion of testing in section 3.5.2

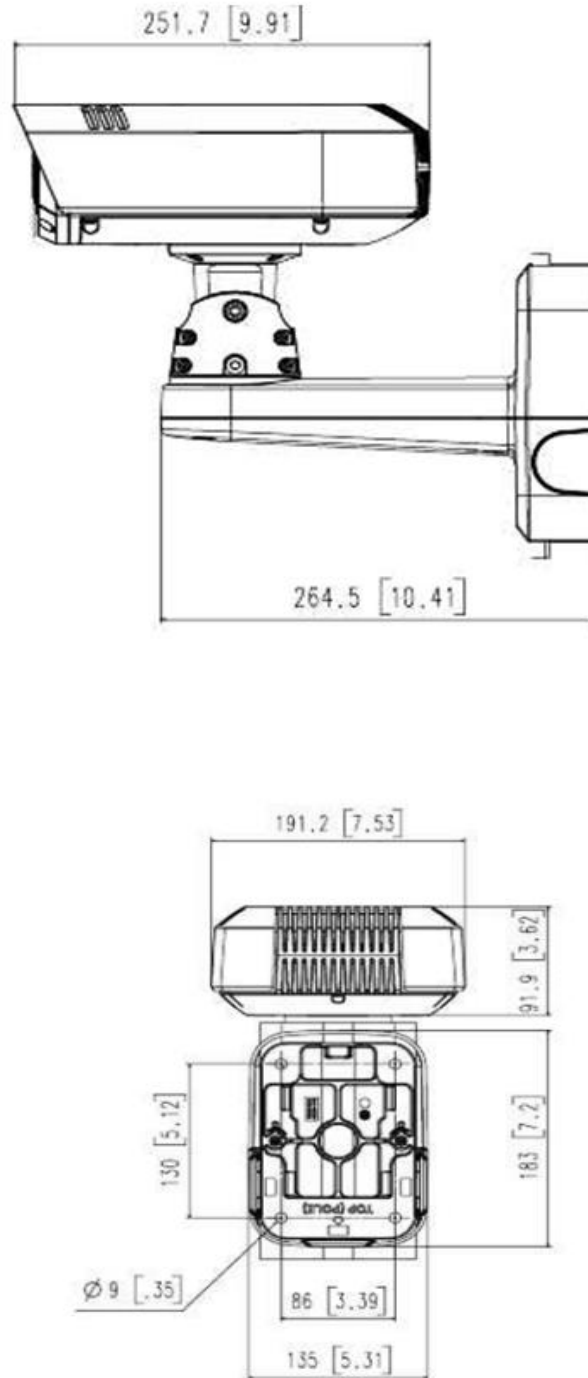
#### 3.6.1 Enclosure Dimensions (Unit: mm)

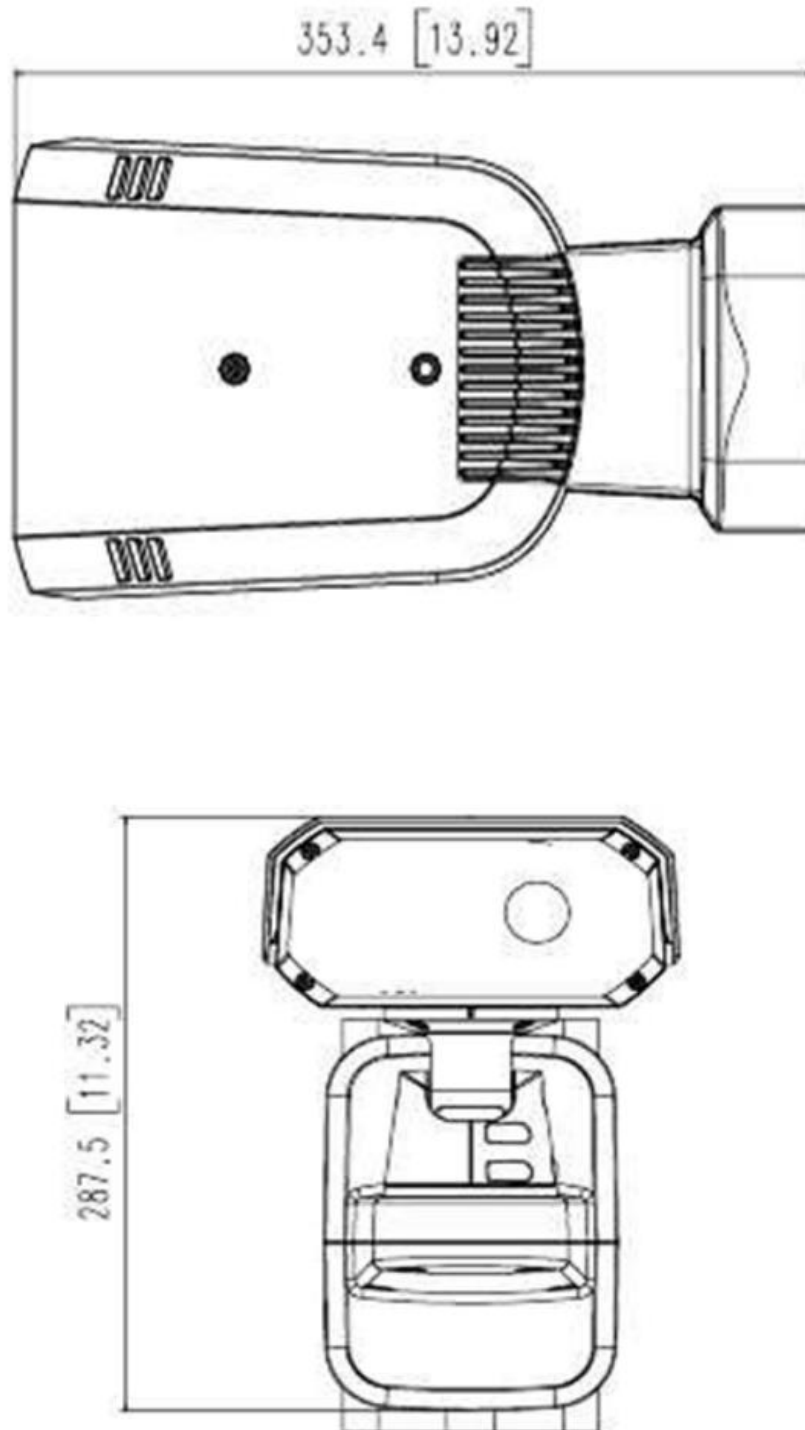
### 3.6.2 Enclosure Dimensions (Unit: mm)

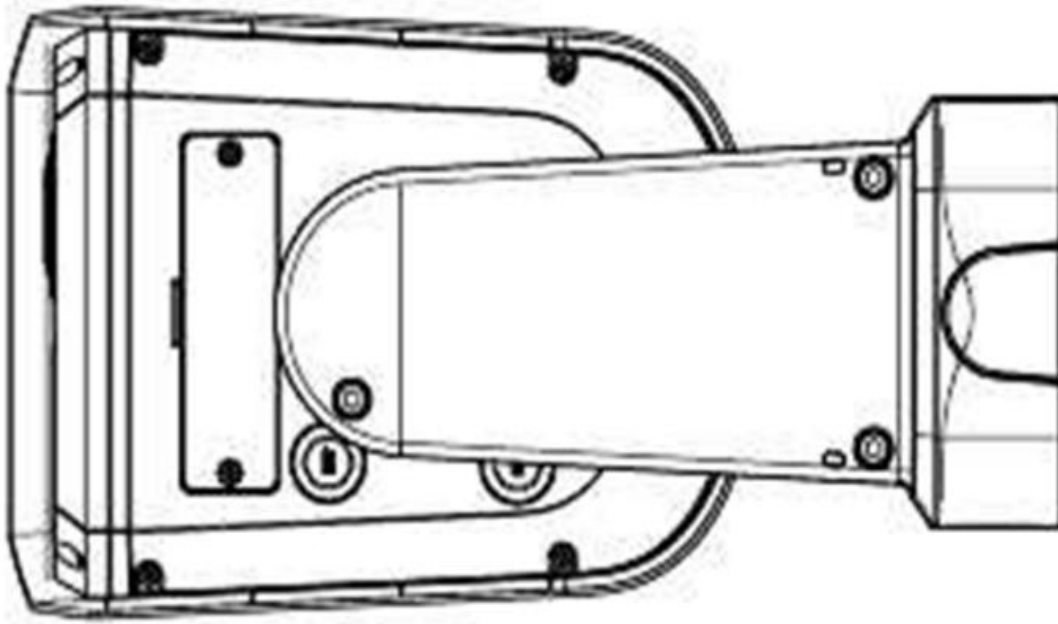
### 3.6.3 Enclosure Dimensions (Unit: mm)
