# TEST REPORT

REPORT No.:  
CTK-2025-03143  
Page (1) / (12) pages

NETWORK THERMAL CAMERA / TNP-C4940TD

NEMA TS 2-2013 2.2.7.3 Test C ~ 2.2.7.8 Test H,

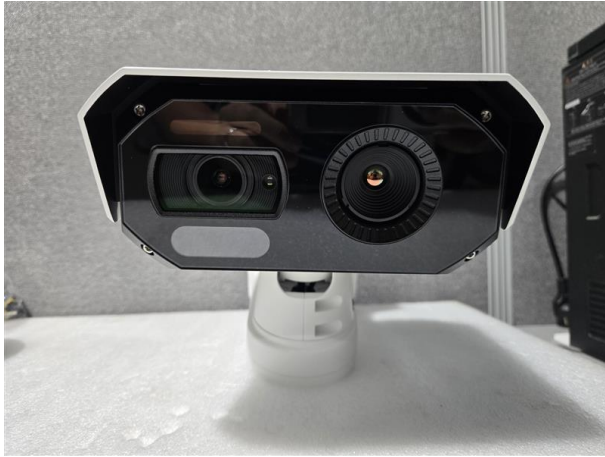
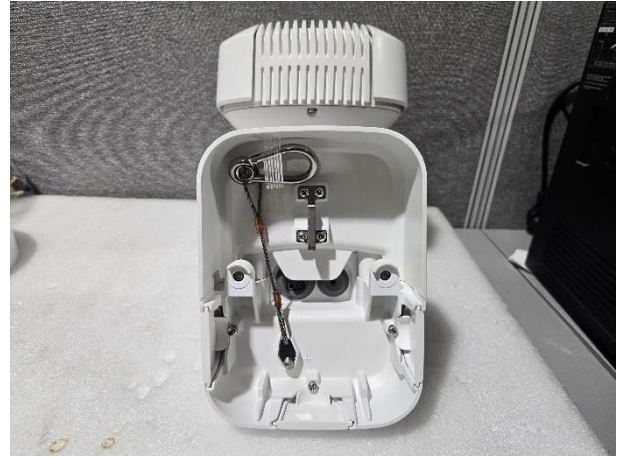
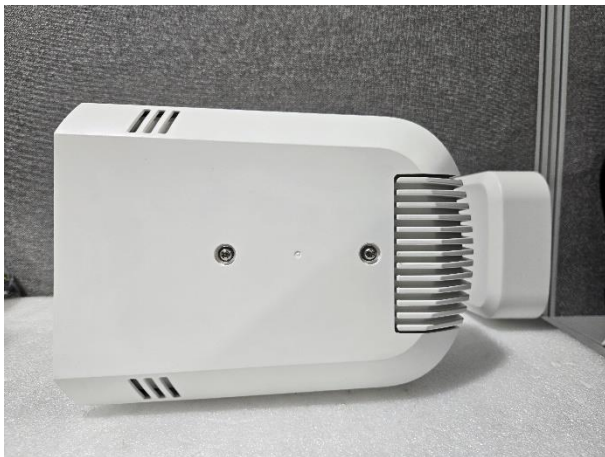
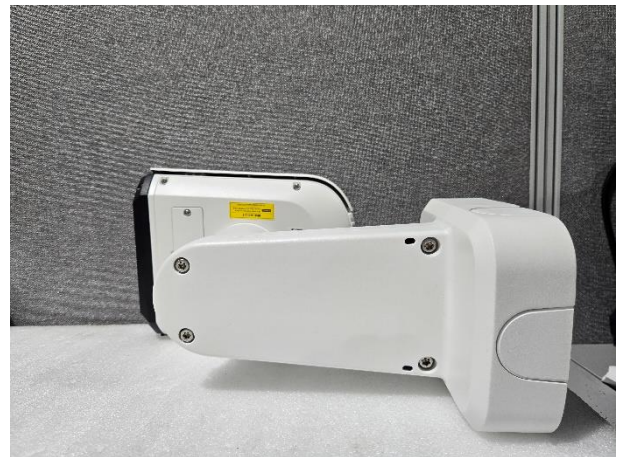
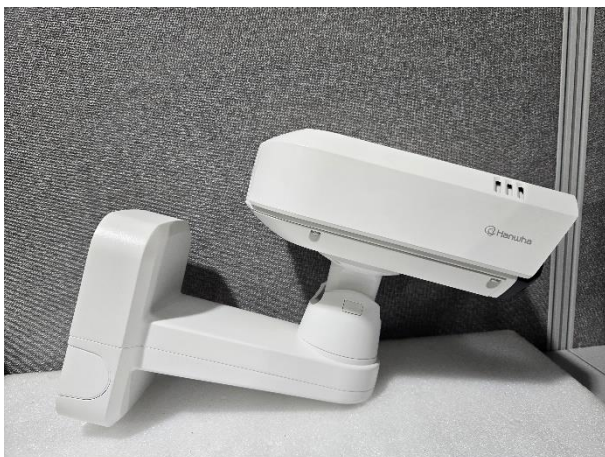
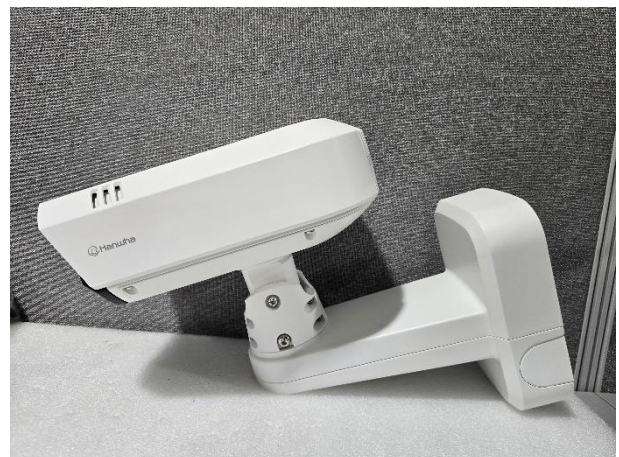
### 2.4.1 Test sample

Top

Bottom

Front

Rear

Left side

Right side

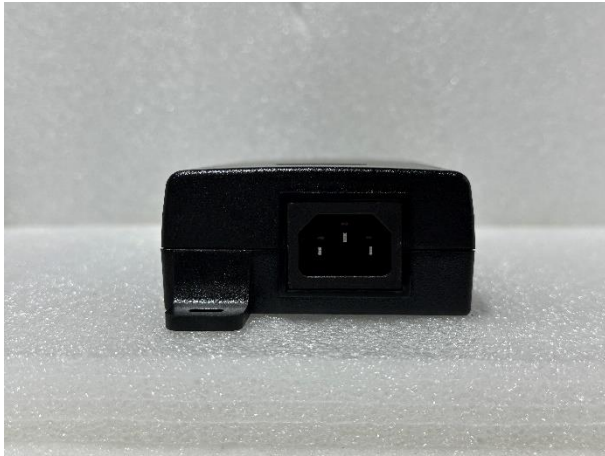
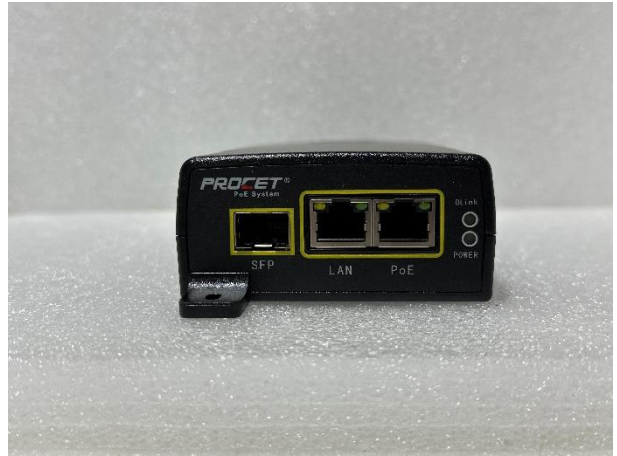
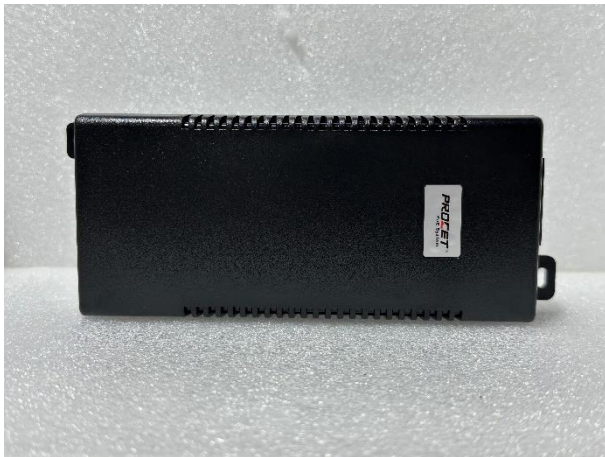
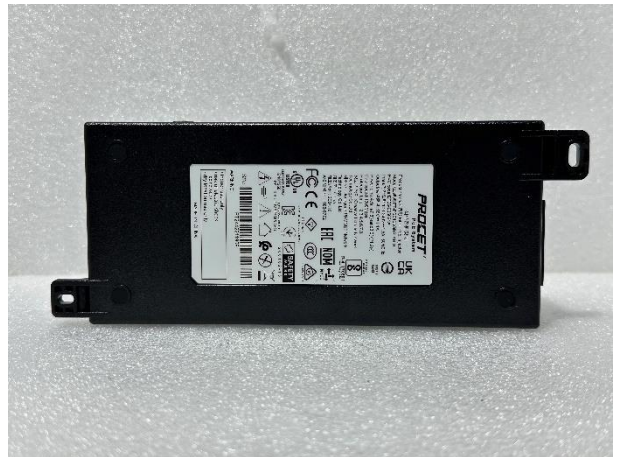
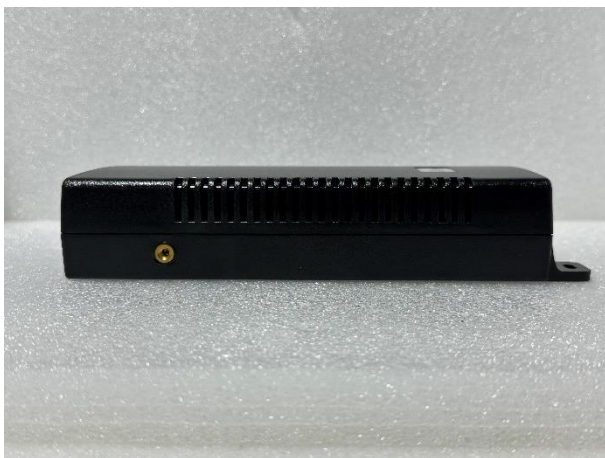
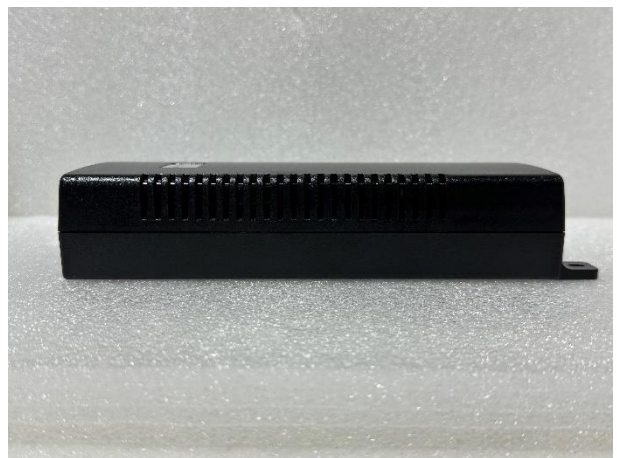
## 2.4.2 Test sample

Top

Bottom

Front

Rear

Left side

Right side

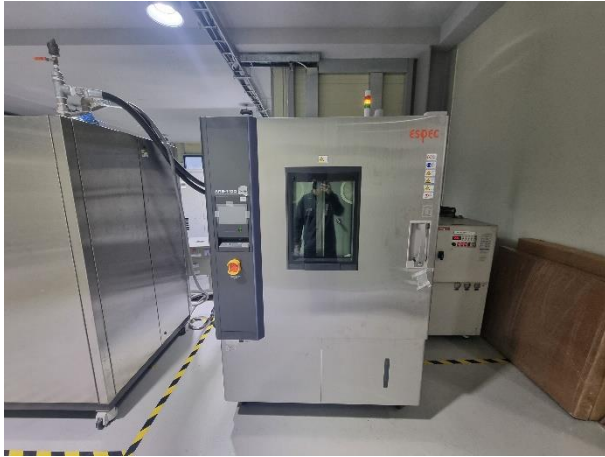
### 2.5.1 Test equipment

Temperature & Humidity Chamber

| Testing equipment | Model Name | Manufacturer | Manufacturing Number | Calibration Date |
|---|---|---|---|---|
| Temperature & Humidity Chamber | ARS-1100-AE | ESPEC | 1110024015 | Oct 07, 2025 |
