# TEST REPORT

CTK-2025-01616

Network Thermal Camera / TNO-C3080T

EN 60068-2-1, EN 60068-2-2, EN 60068-2-14, EN 60068-2-6, EN 60068-2-27, EN 60068-2-78, IEC 60068-2-1, IEC 60068-2-2, IEC 60068-2-14, IEC 60068-2-6, IEC 60068-2-27, IEC 60068-2-78

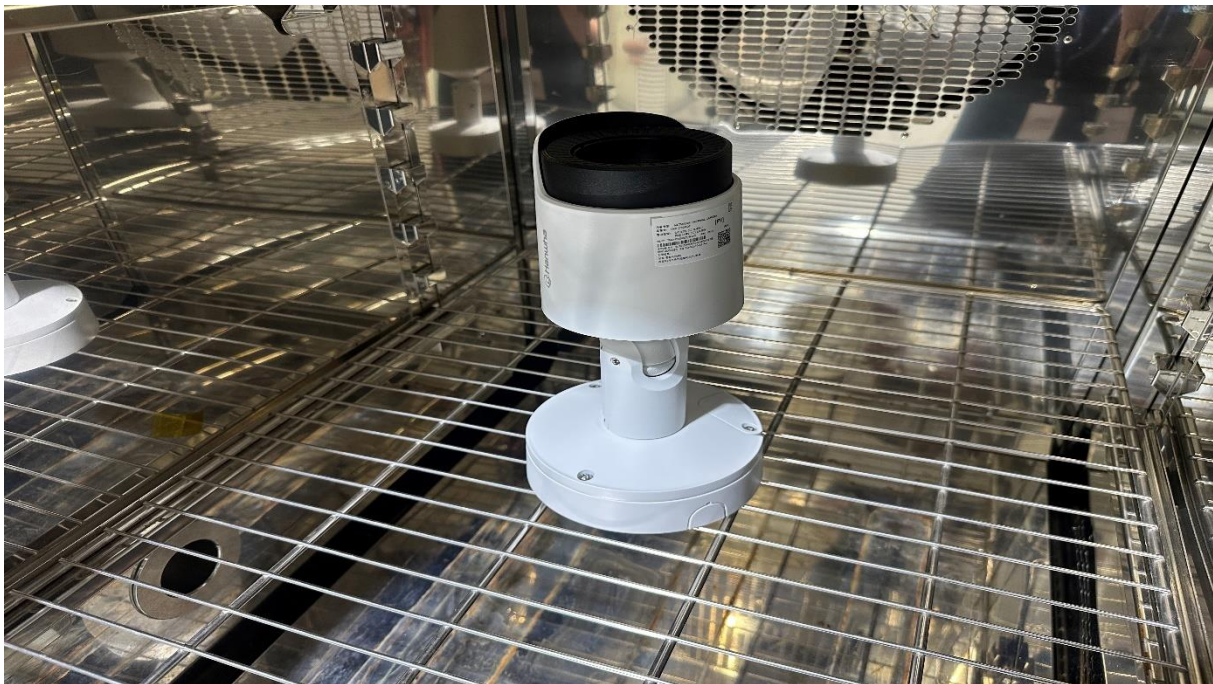
#### 3.3.1 Evidence of test setting

3.2.1 Sample status: Non-operation

3.2.2 Test temperature: -33 °C

3.2.3 Test time: 16 h

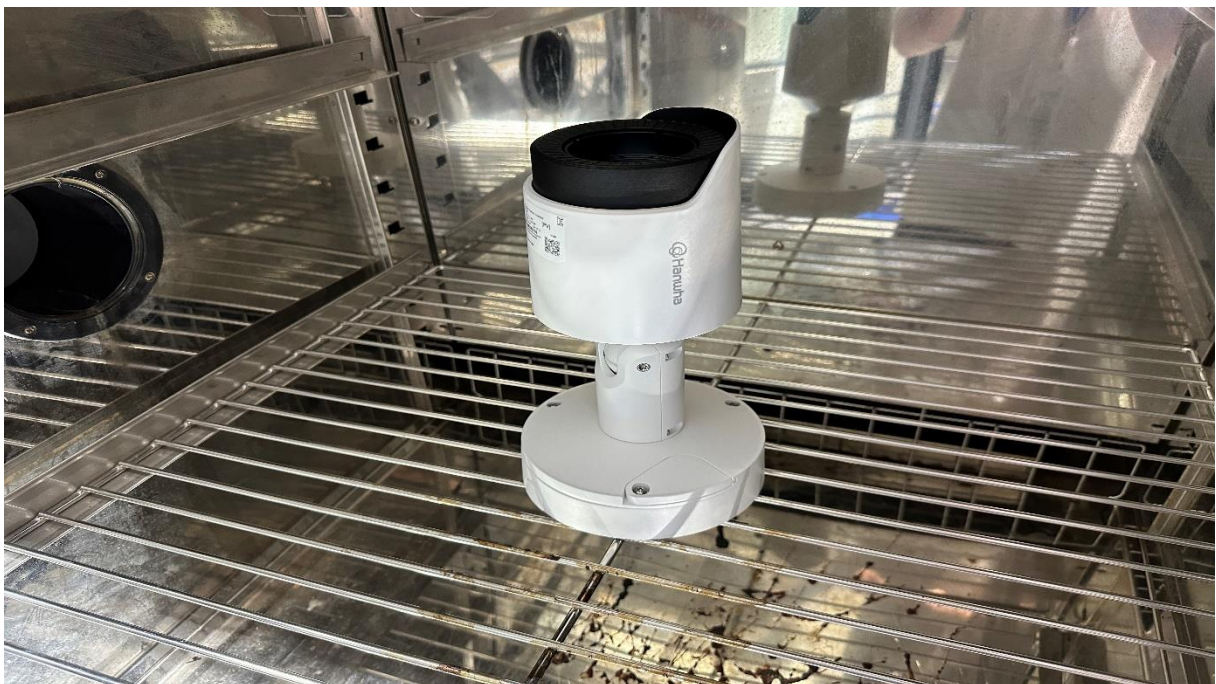
#### 4.3.1 Evidence of test setting

4.2.1 Sample status: Non-operation

4.2.2 Test temperature: 60 °C

4.2.3 Test time: 96 h

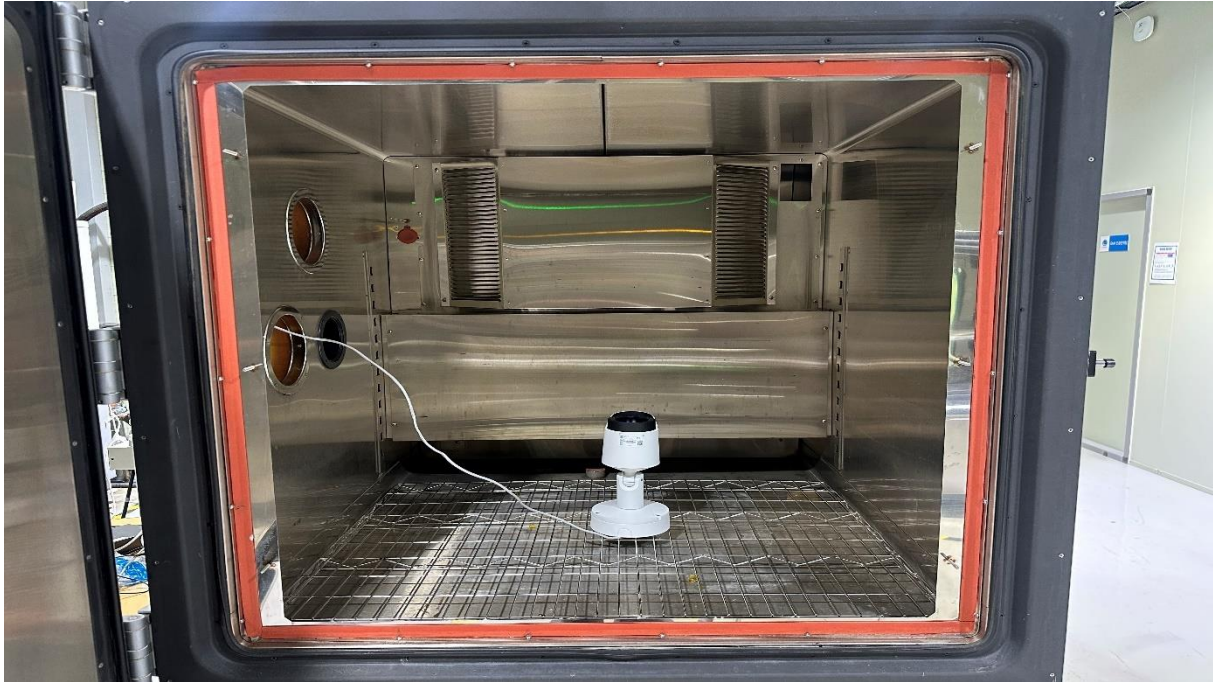
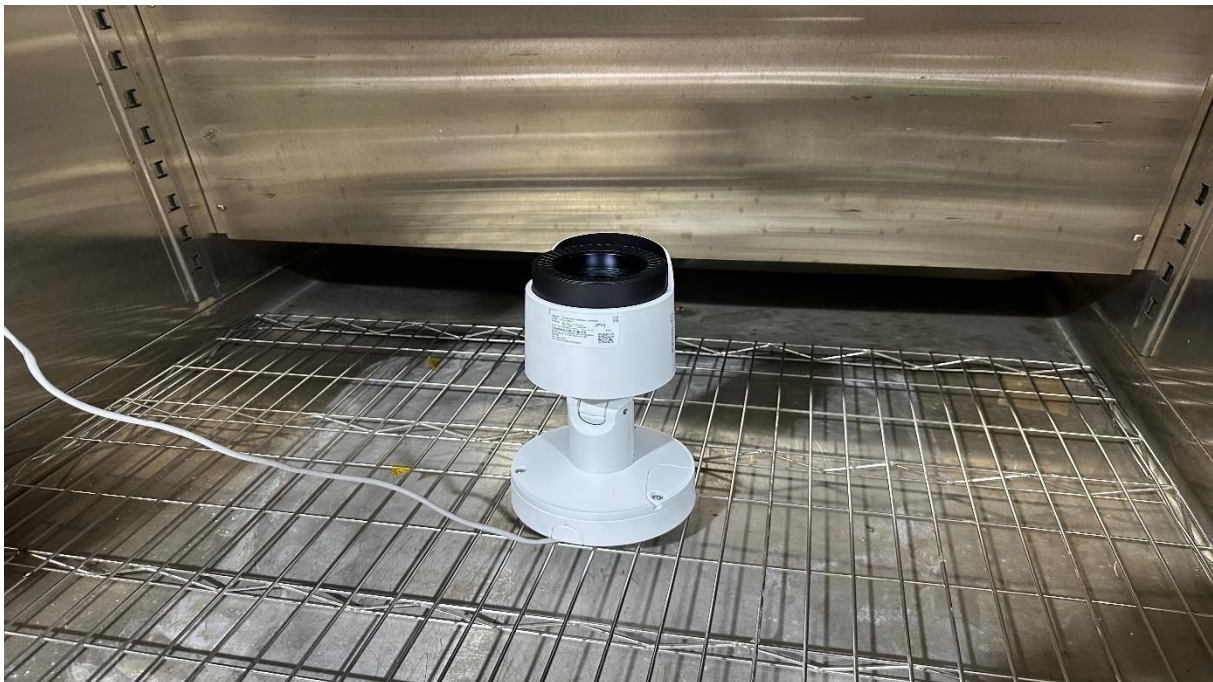
#### 5.3.1 Evidence of test setting

5.2.1 Sample status: operation

5.2.2 Test temperature: -40 °C, 60 °C

5.2.3 Test time: 24 h

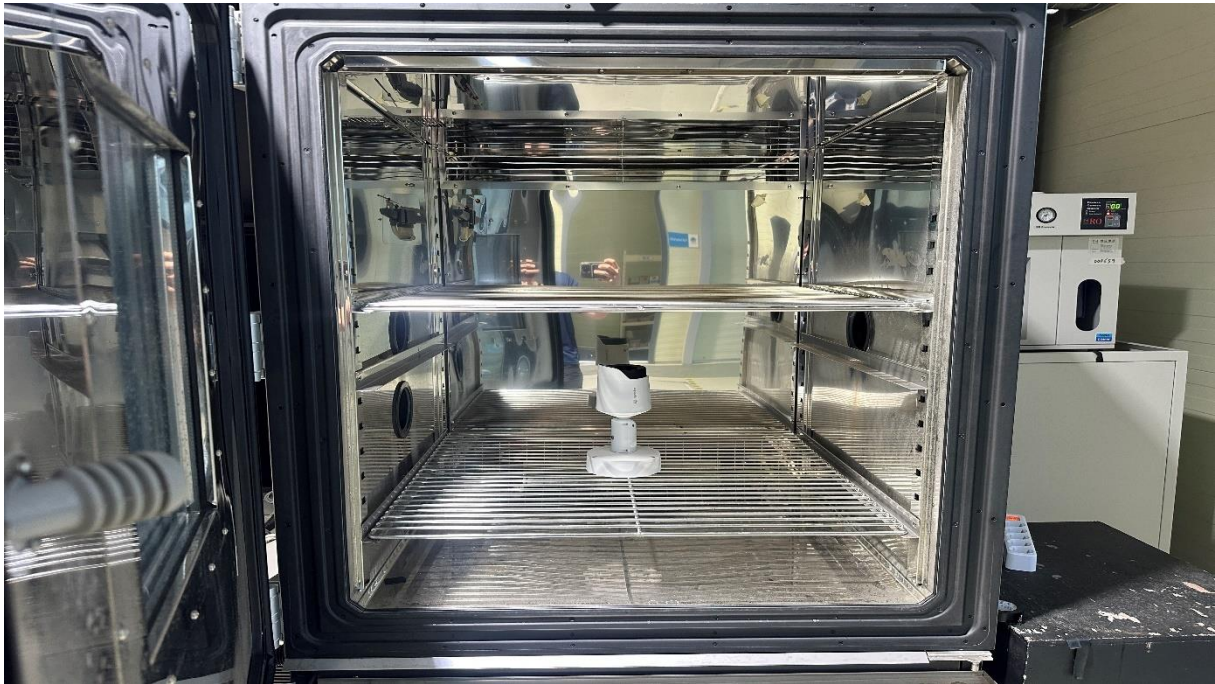
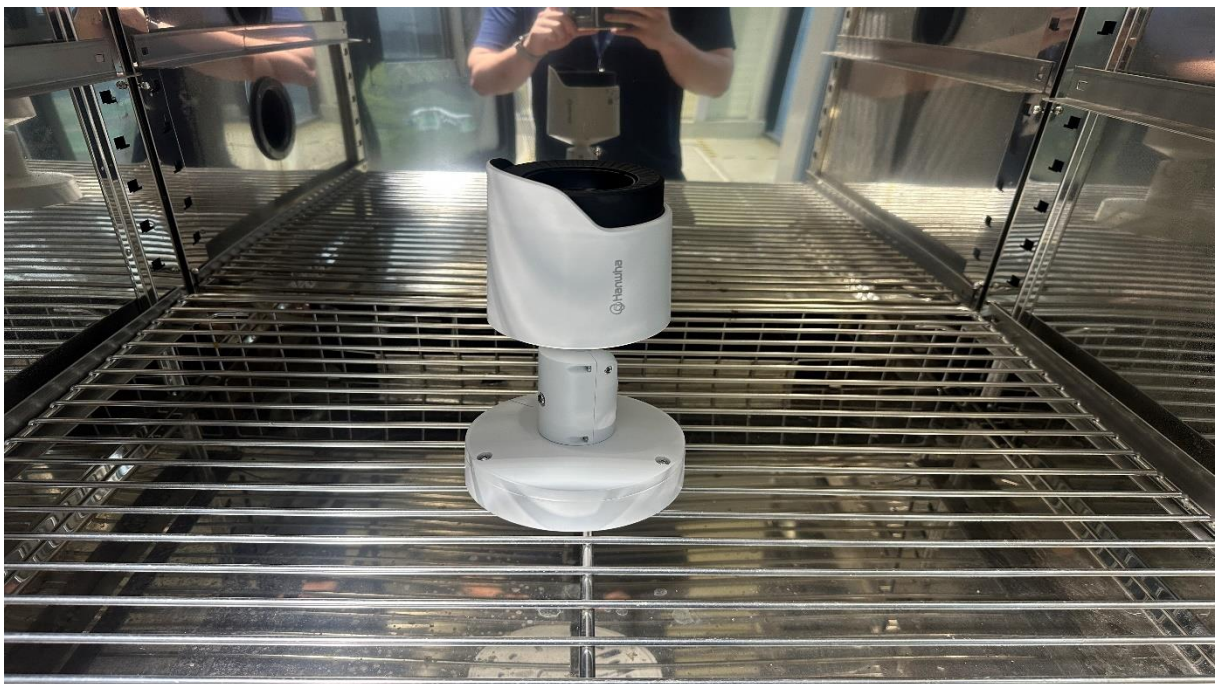
#### 8.3.1 Evidence of test setting

8.2.1 Sample status: operation

8.2.2 Test temperature:  $40 \pm 2$  °C

8.2.3 Test Humidity:  $93 \pm 3$  % R.H.

8.2.4 Test time: 240 h
