# TEST REPORT

REPORT No.:  
CTK-2025-01617  
Page (1) / (26) pages

Network Thermal Camera / TNO-C3080T

NEMA TS 2-2013 2.2.7.3 Test C ~ 2.2.7.8 Test H,  
NEMA TS 2.2.8, NEMA TS 2.2.9

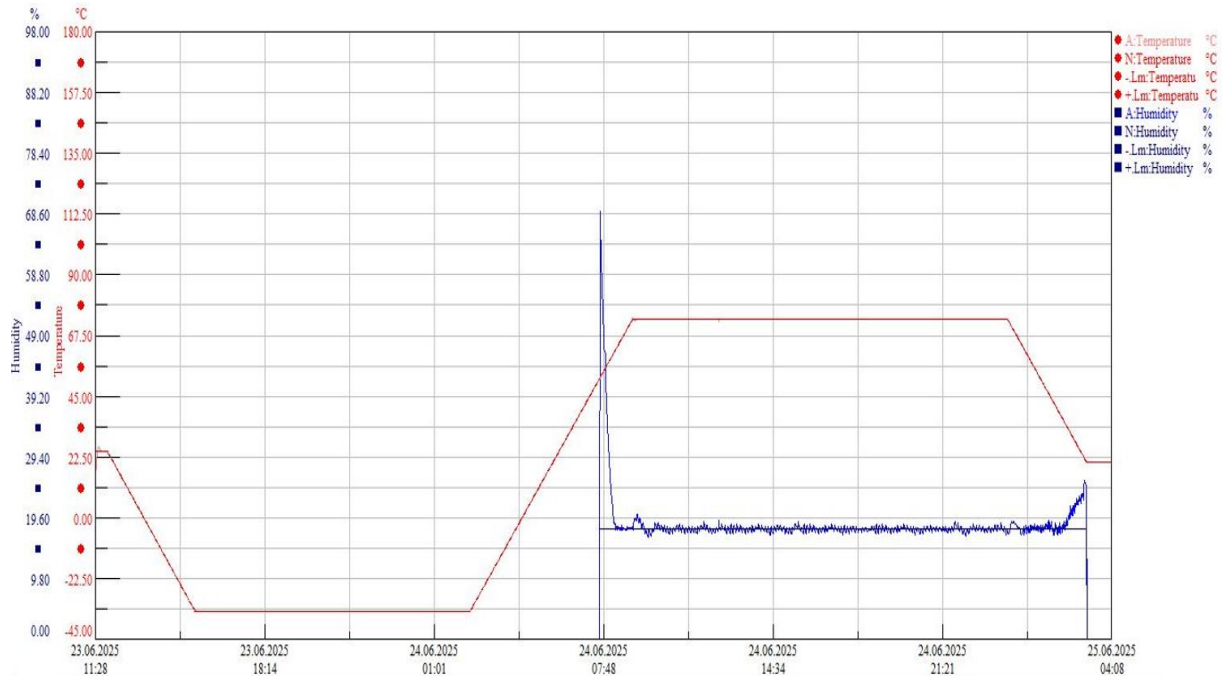
Temperature Data

#### 3.5.1 Power Service [NEMA TS 2-2013 2.2.7.2 Test B ~ 2.2.7.8 – 13. C]

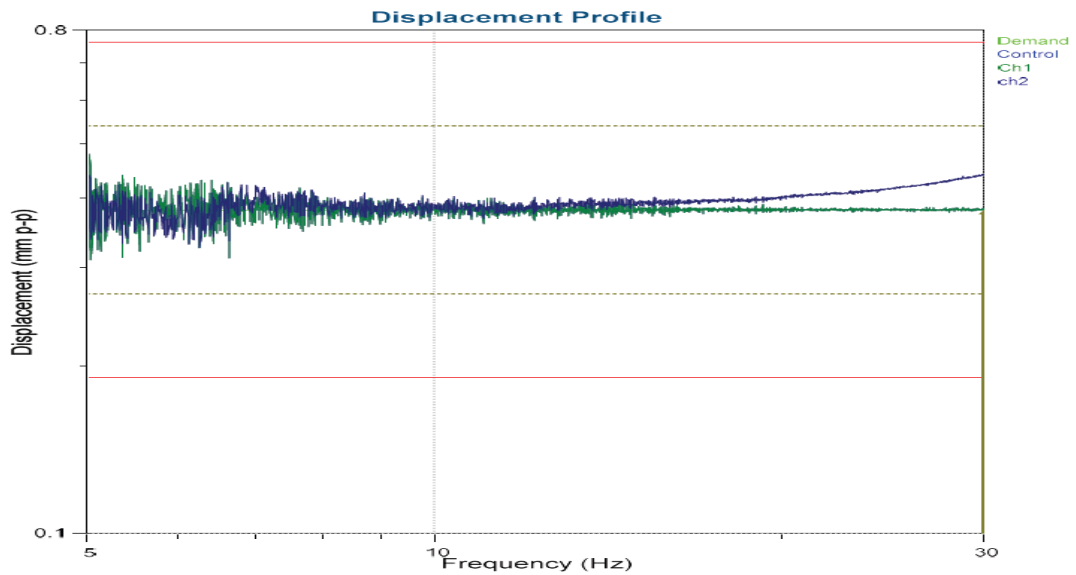
#### Resonant search Test ( X Axis )

5 08, 2025 09:53:52 Level 1) 100 % Output: 0.06755 Volts peak NEMA-TS 2.2.8.3  
Demand: 0.381 mm Level Time: 0:12:30 Frequency: 30 Hz  
Control: 0.3811 mm Total Time: 0:12:40 End of Sweep Test

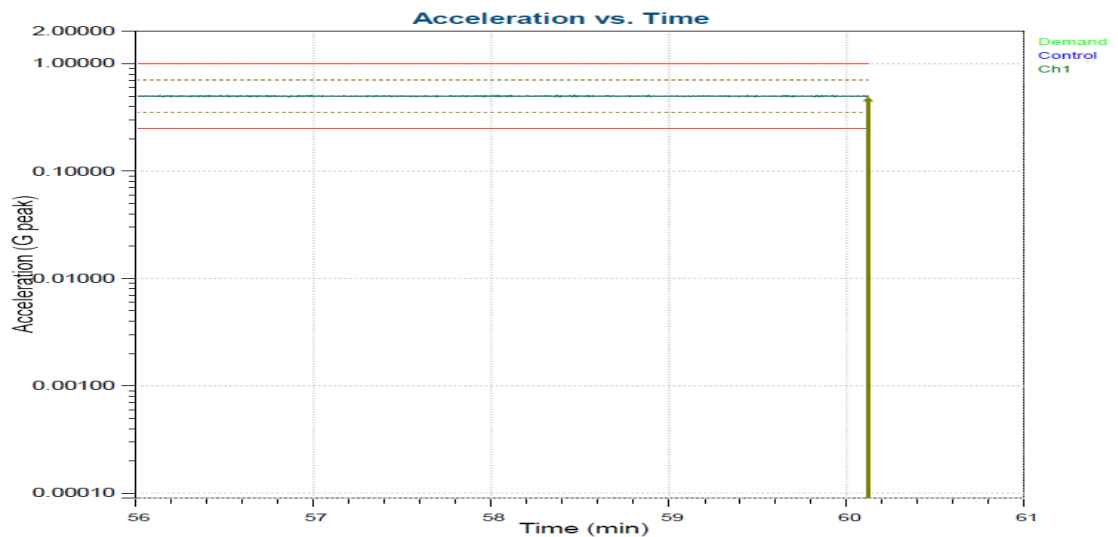
#### Endurance Test ( X Axis )

3 21, 2025 17:38:27 Level 1) 100 % Output: 0 Volts peak NEMA-TS 2.2.8.3.4  
Demand: 0.5 G Level Time: 1:00:00 Frequency: 30 Hz  
Control: 0.00066 G Total Time: 1:00:07 End of Timed Test

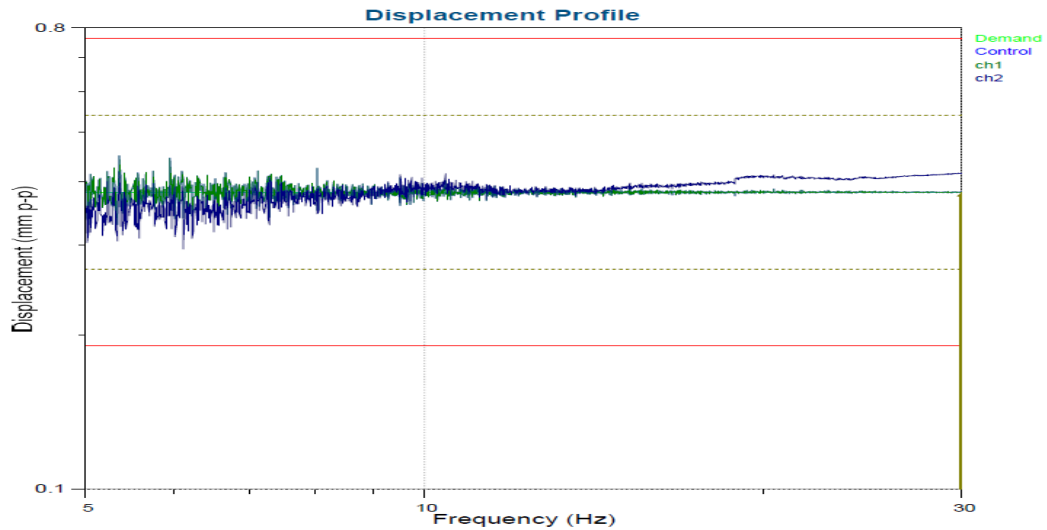
### Resonant search Test ( Z Axis )

5 08, 2025 14:53:2 Level 1) 100 % Output: 0 Volts peak NEMA TS-2 2.2.8 - search.  
Demand: 0.381 mm Level Time: 0:12:3 Frequency: 30 Hz  
Control: 0.0005673 mm Total Time: 0:12:3 End of Sweep Test

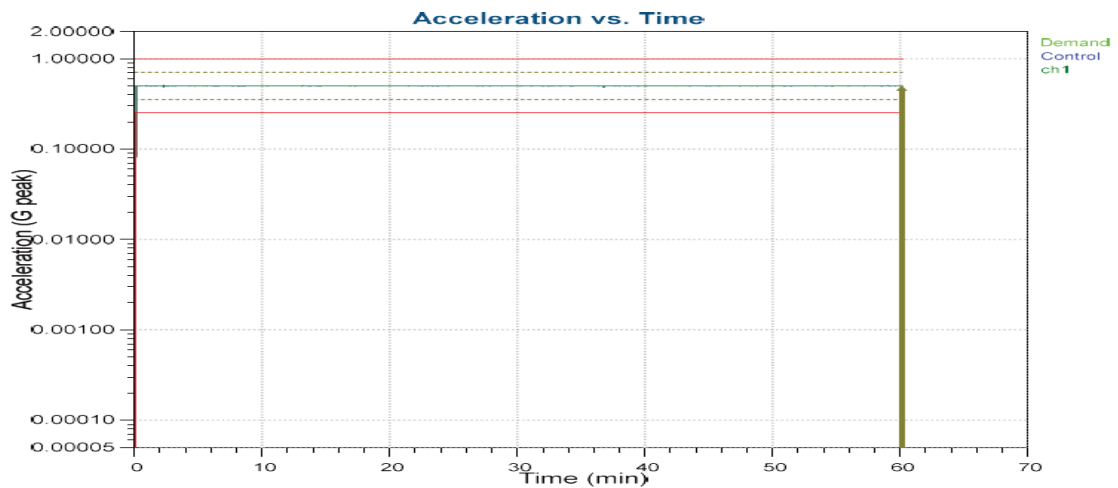
### Endurance Test ( Z Axis )

5 09, 2025 09:36:00 Level 1) 100 % Output: 0 Volts peak 한화비전 공진 L  
Demand: 0.5 G Level Time: 1:00:00 Frequency: 30 Hz  
Control: 0.0003912 G Total Time: 1:00:07 End of Timed Test

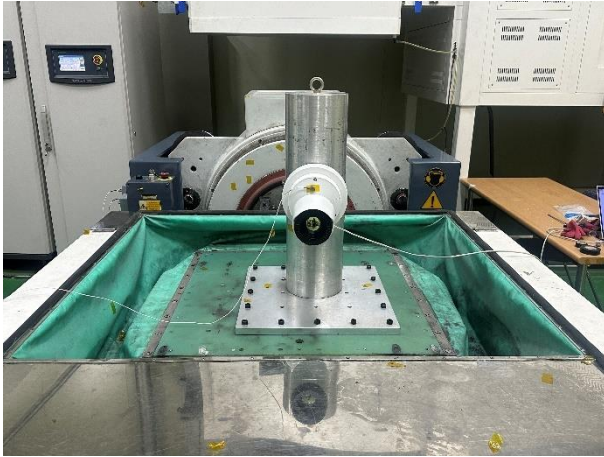
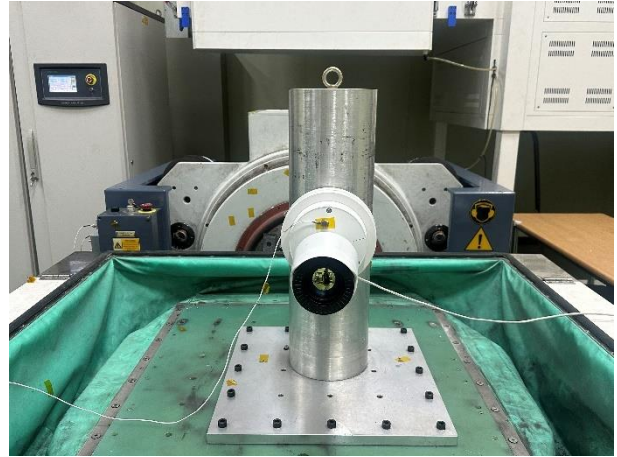
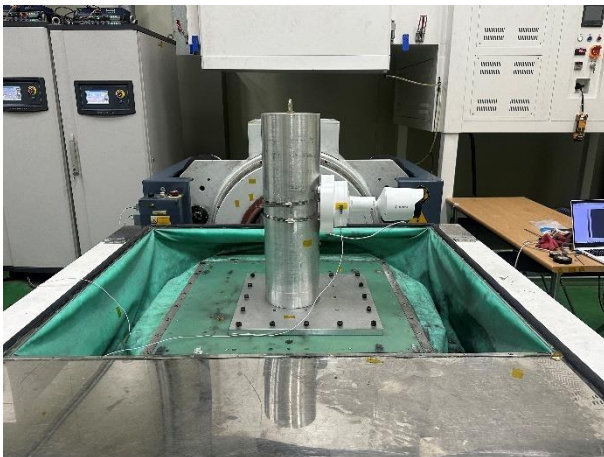
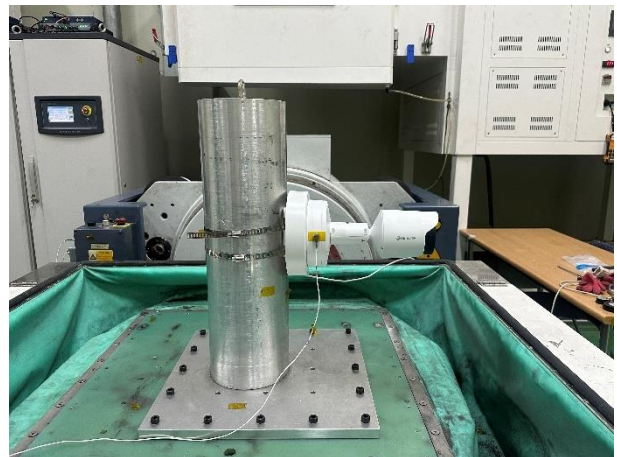
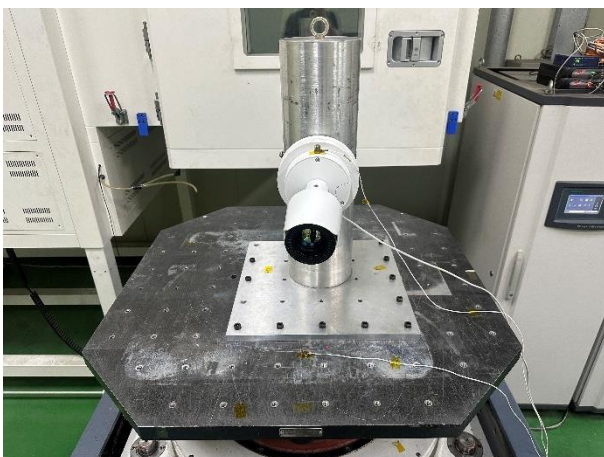
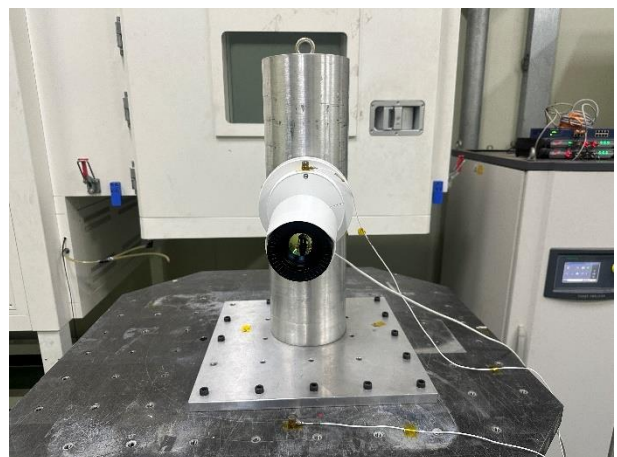
### 5.3.1 Evidence of test setting (NEMA TS 2-2013 2.2.9)

5.2.2 Applied waveform: Half sine

5.2.3 Acceleration(G): 10 G

5.2.4 Nominal duration (ms): 11

5.2.6 Number of impacts: 1 per direction (total 6)

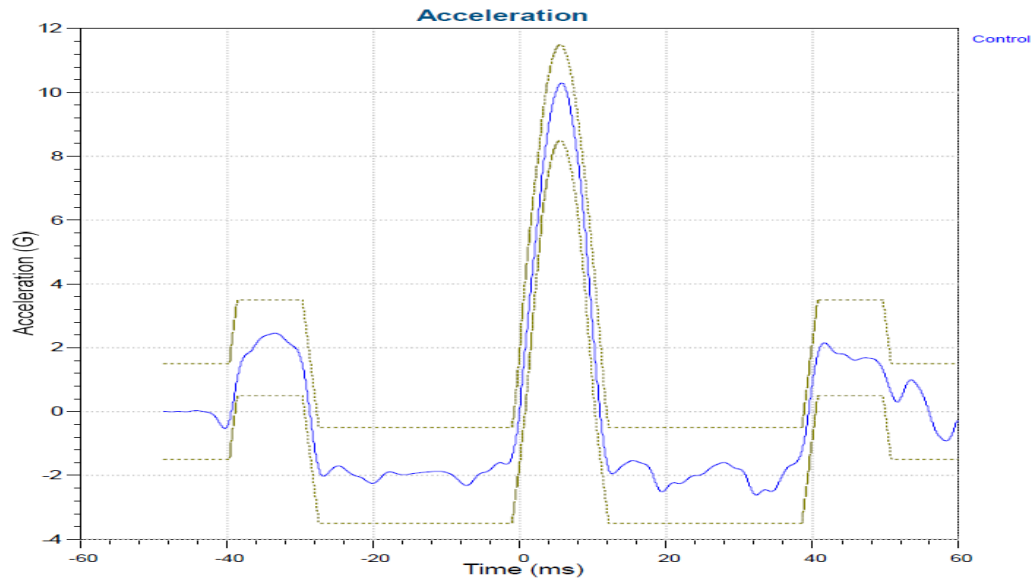
X+

5 08, 2025 10:57:21 Level 1) 100 % Output: 0.7058 Volts peak NEMA-TS 2.2.9

Demand: 10 G

Control: 10.3 G

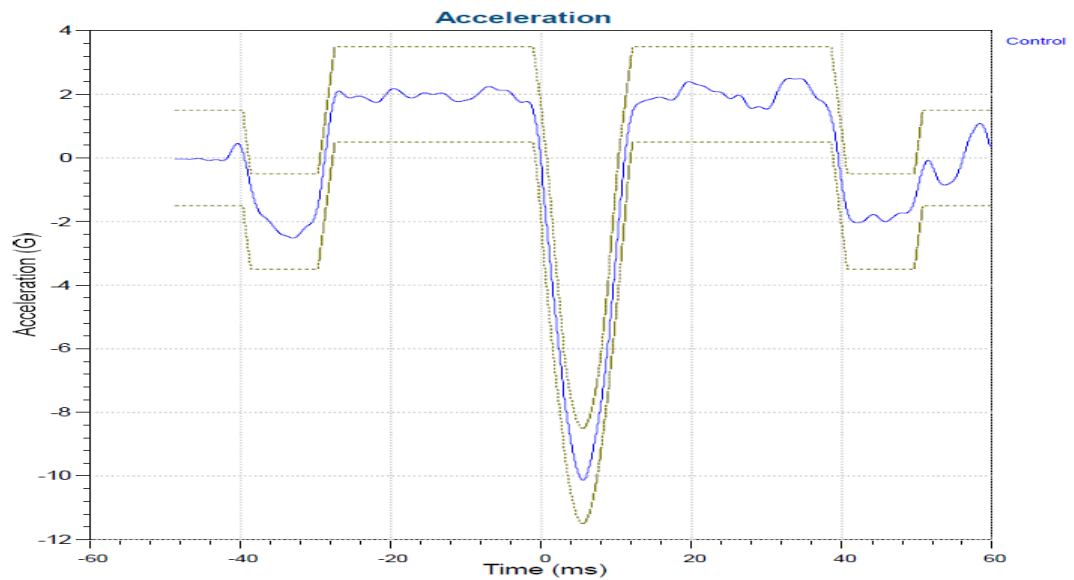
X-

5 08, 2025 10:57:33 Level 2) 100 % Output: 0.7105 Volts peak NEMA-TS 2.2.9

Demand: 10 G

Control: 10.13 G

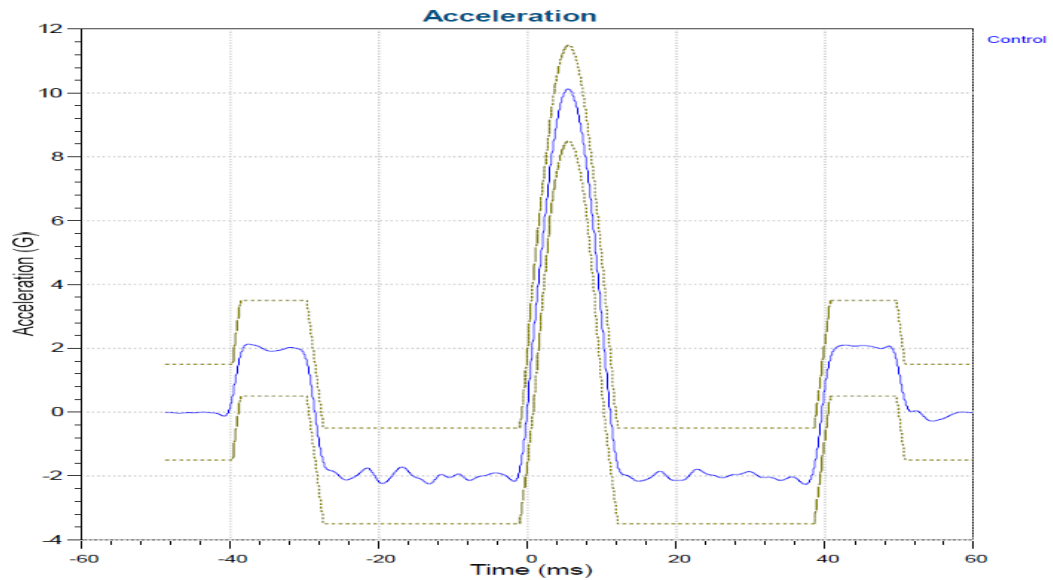
Z+

5 09, 2025 09:47:17 Level 1) 100 % Output: 0.6829 Volts peak NEMA-TS 2.2.9  
Demand: 10 G  
Control: 10.13 G Pulse: 1 of 1 Running

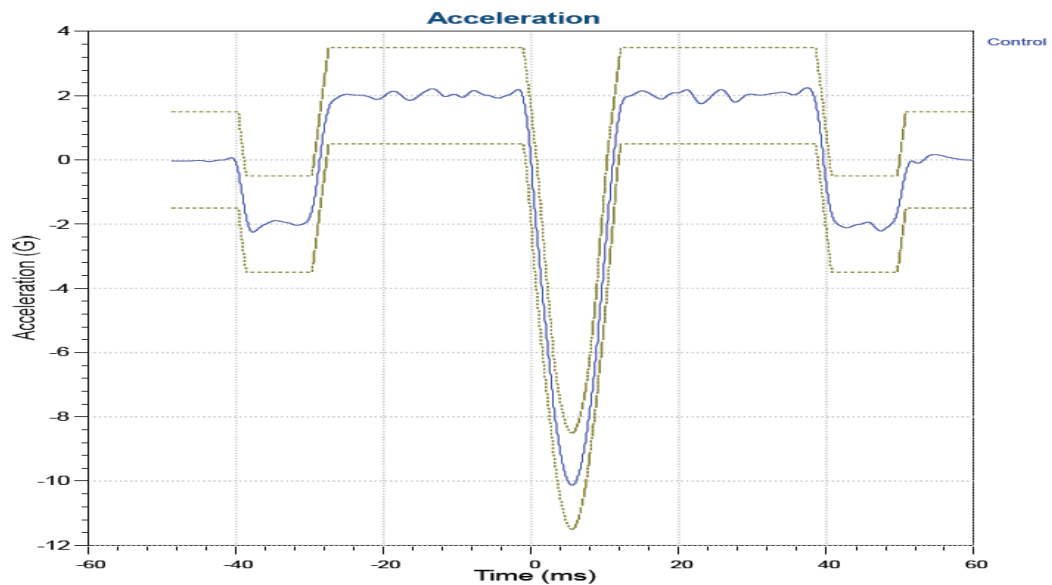
Z-

5 09, 2025 09:46:43 Level 2) 100 % Output: 0.6827 Volts peak NEMA-TS 2.2.9  
Demand: 10 G  
Control: 10.13 G Pulse: 1 of 1 End of Test
