# TEST REPORT

REPORT No.:  
CTK-2026-00349  
Page (1) / (12) pages

NETWORK THERMAL CAMERA / TNO-C4080T

IEC 62262:2002+AMD1:2021

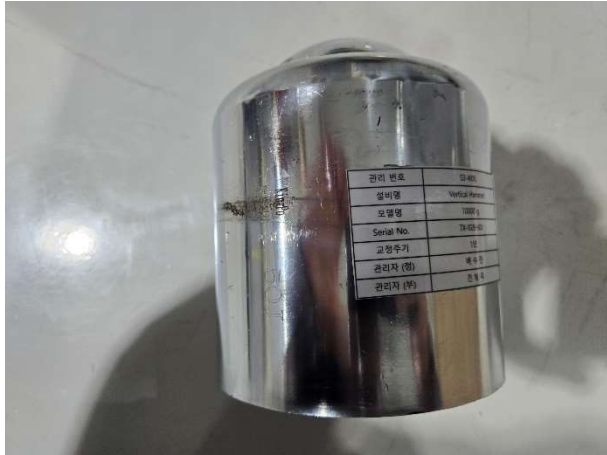
| Testing equipment | Model Name | Manufacturer | Manufacturing Number | Next Cal. Date |
|---|---|---|---|---|
| Vertical Hammer | 5000g | Kingpo | TX-029-20J | Jul. 08, 2026 |

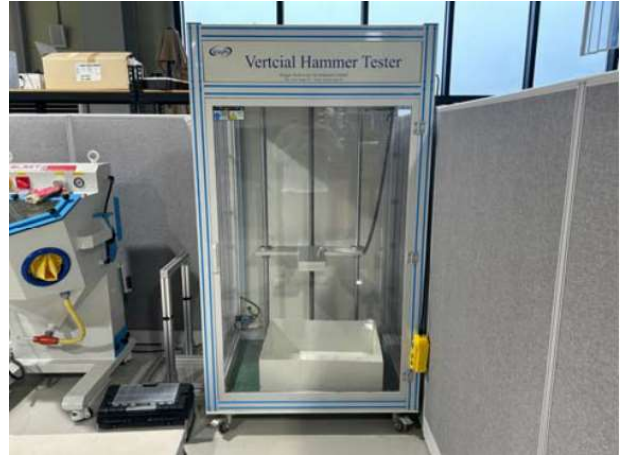
| Testing equipment | Model Name | Manufacturer | Manufacturing Number | Next Cal. Date |
|---|---|---|---|---|
| Vertical Hammer Tester | Vertical Hammer | Kingpo | 0190605A01002 | - |

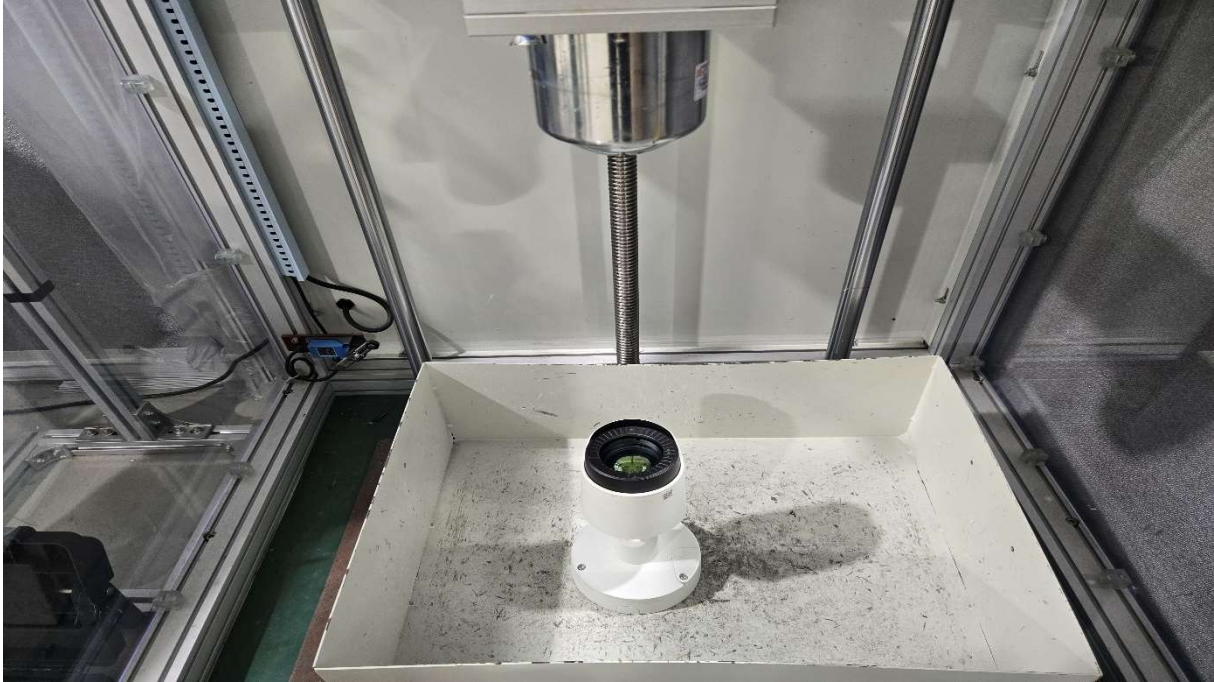
#### 3.3.1 Evidence of test setting (1)

| IK code | Impact Energy (J) | Equivalent mass (kg) | Drop height (mm ± 1%) | Application |
|---|---|---|---|---|
| 10 | 20.00 | 5.00 | 400 | <input checked="" type="checkbox"/> |

Impact times: five times for each of the exposed surface. (Do not impact more than 3 times in the same spot)

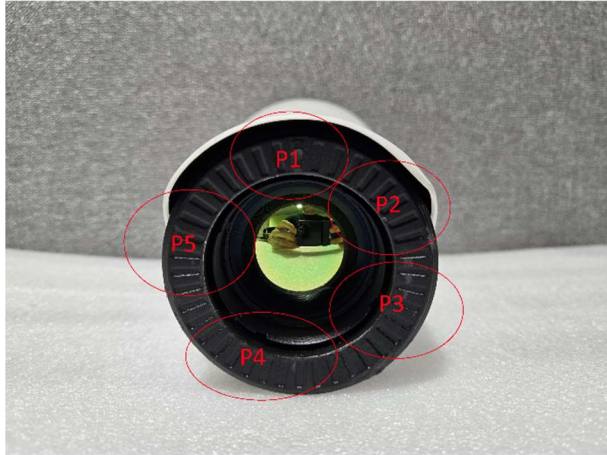
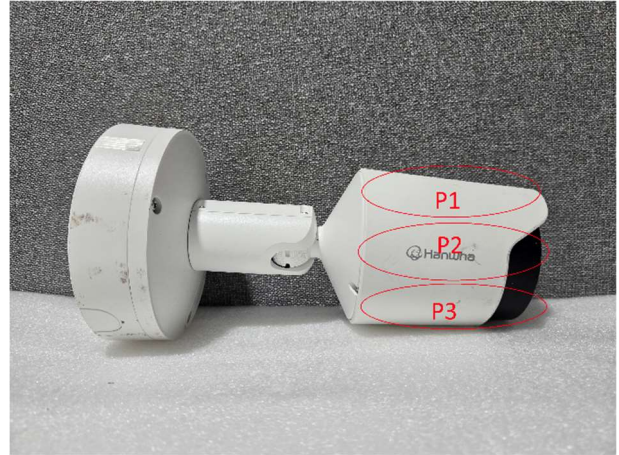
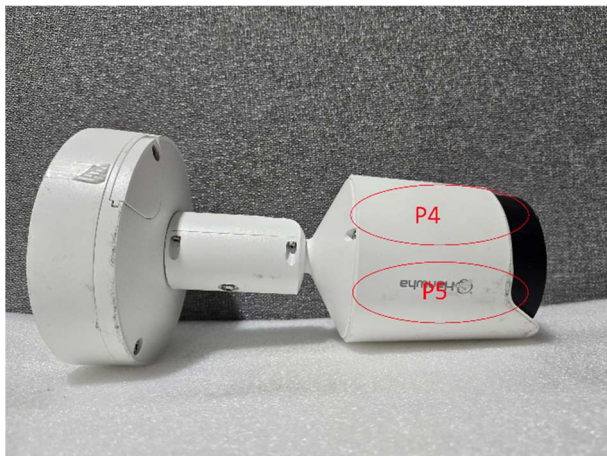
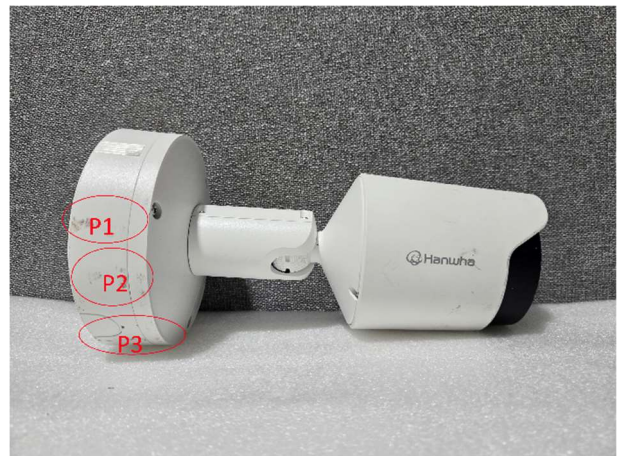
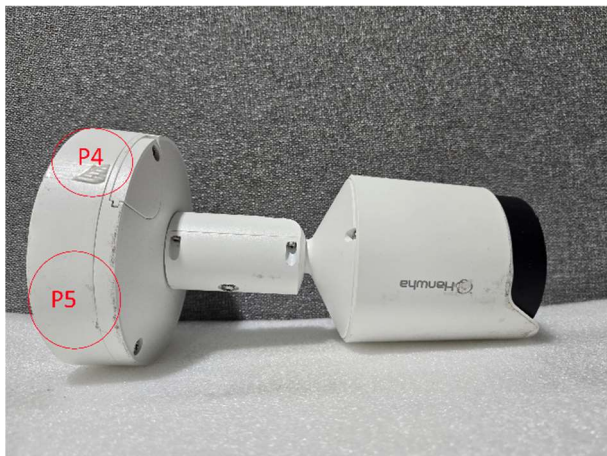
#### 3.5.1 Check the hit area during the test

Check the hit area the test\_1

Check the hit area the test\_2

Check the hit area the test\_3

Check the hit area the test\_4

Check the hit area the test\_5

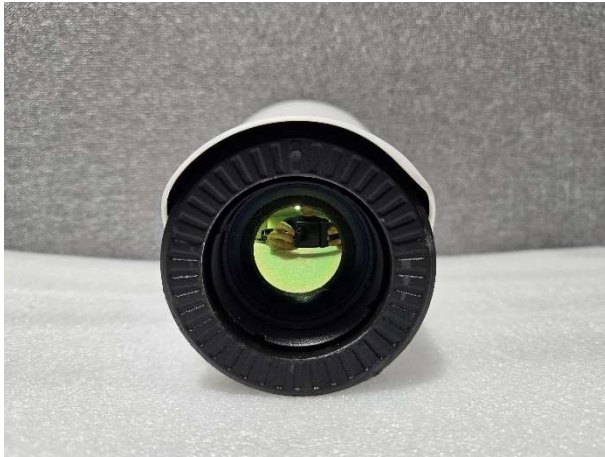
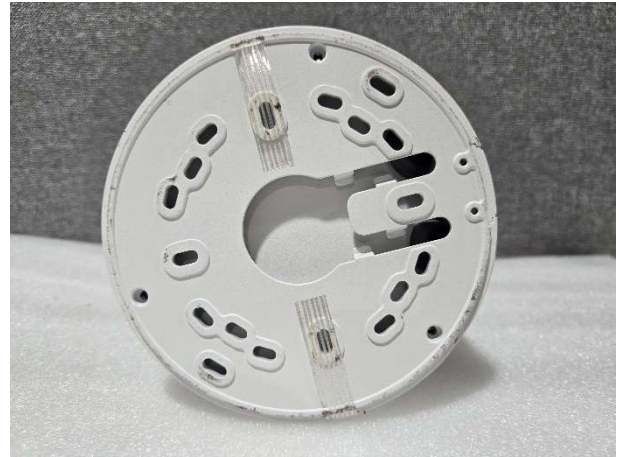
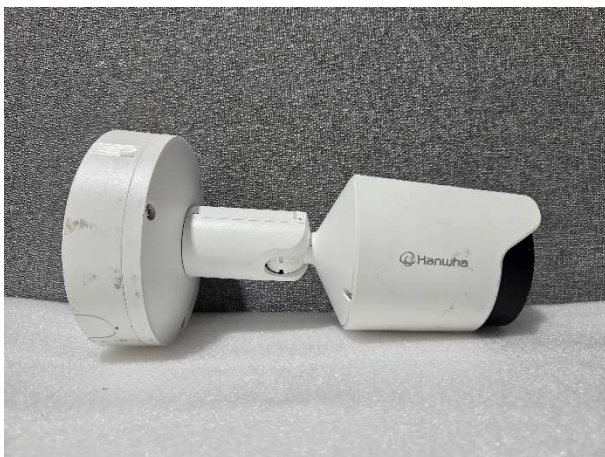
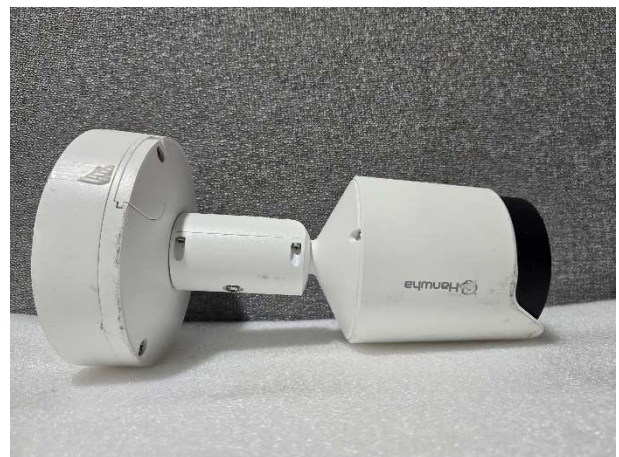
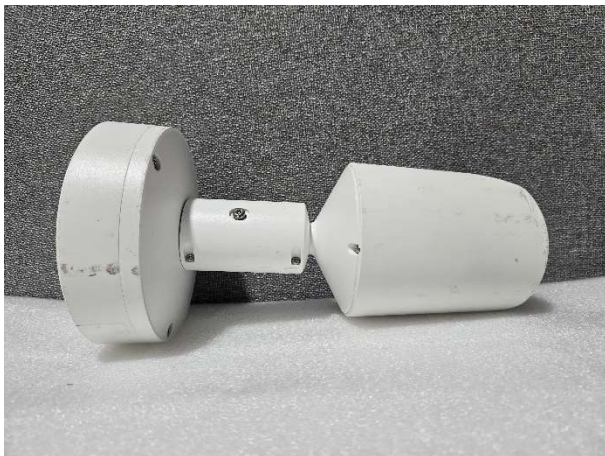
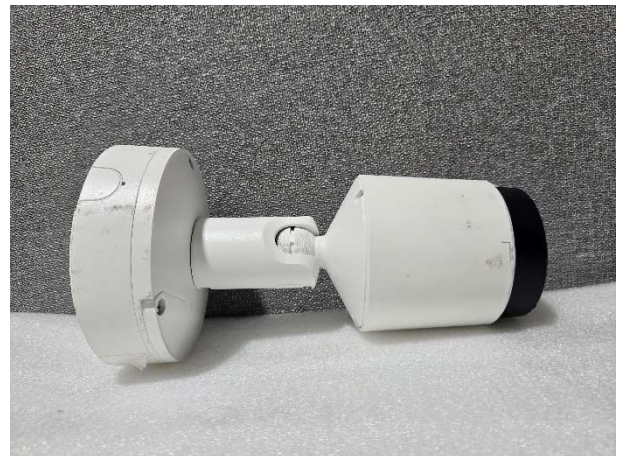
### 3.5.2 Post-test product images

| Evaluation Criteria | Test Results | Remark |
|---|---|---|
| Visual Inspection | Some scratches were generated on the outside of the product. | - |

※ Refer to the product photos after the completion of testing in section 3.5.2
