# TEST REPORT

| <b>CTK Co., Ltd.</b><br>5 Dongbu-ro 221beon-gil, Cheoin-gu,<br>Yongin-si, Gyeonggi-do, Republic of Korea<br>Tel: +82-31-339-9970<br>Fax: +82-31-624-9501 | REPORT No.:<br>CTK-K-2026-00284<br>Page (1) / (58) pages | |

NETWORK THERMAL CAMERA / TNO-C4080T

MIL-STD-810H

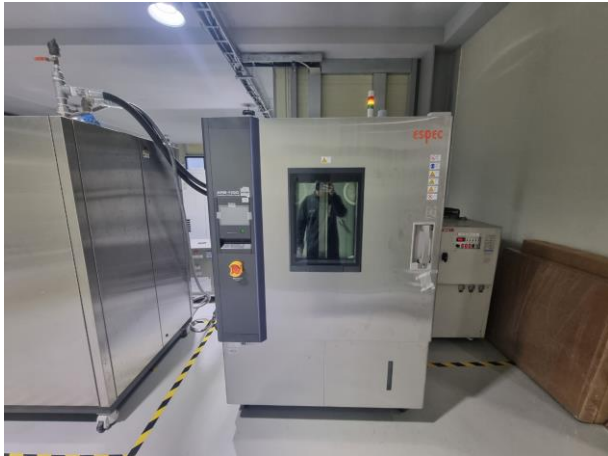
| Testing equipment | Model Name | Manufacturer | Manufacturing Number | Next Cal. Date |
|---|---|---|---|---|
| Temperature & Humidity Chamber | ARS-0390-AE | ESPEC | 4120200113 | Feb. 06, 2027 |

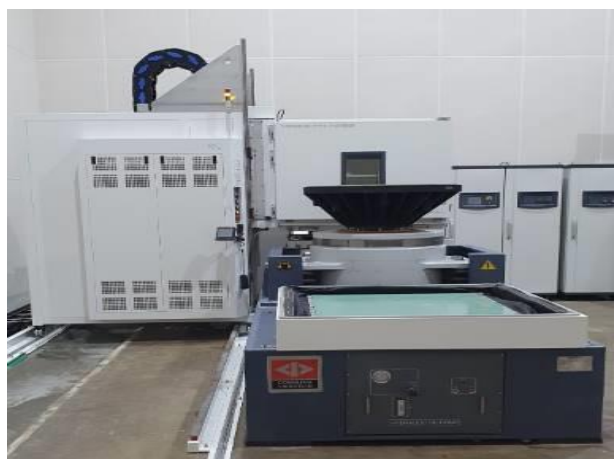
| Testing equipment | Model Name | Manufacturer | Manufacturing Number | Next Cal. Date |
|---|---|---|---|---|
| VIBRATION TESTING SYSTEM | LT1010 | FAMTECH | D2012335 | N/A |

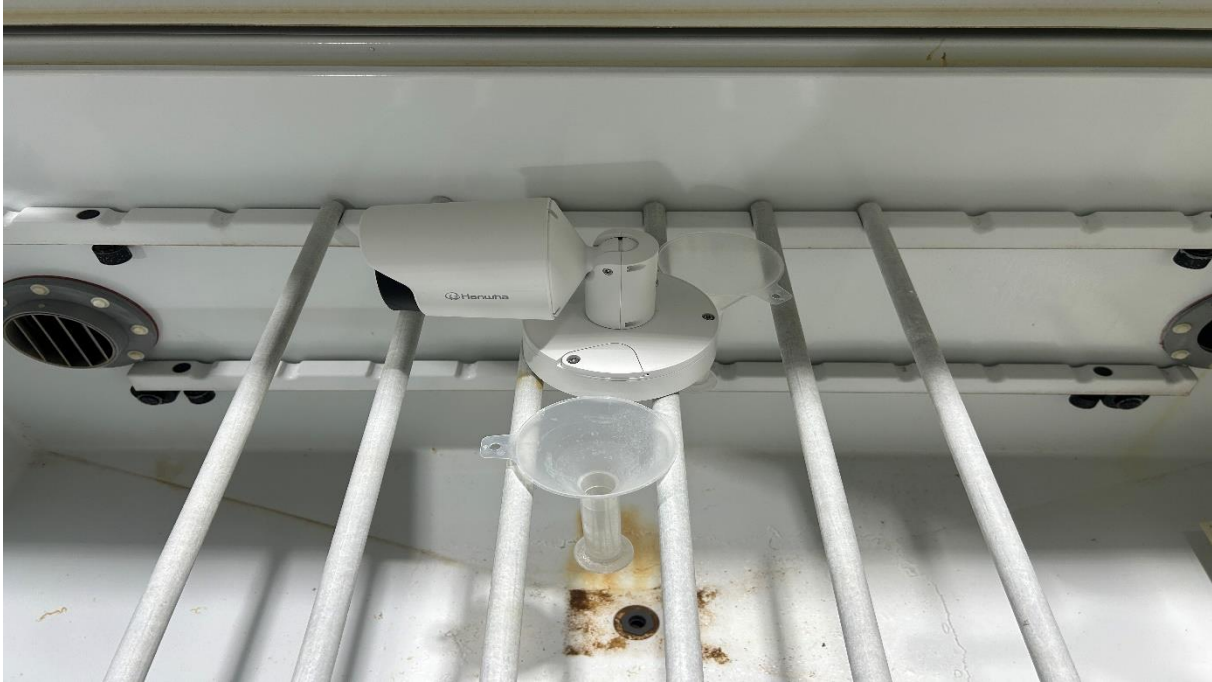
#### 5.3.1 Evidence of test setting

5.2.2 Salt concentration: NaCl 5 %, pH (6.85 ±0.35)

5.2.3 Temperature condition: 35 °C

5.2.5 Salt fog Exposure time: 48 h

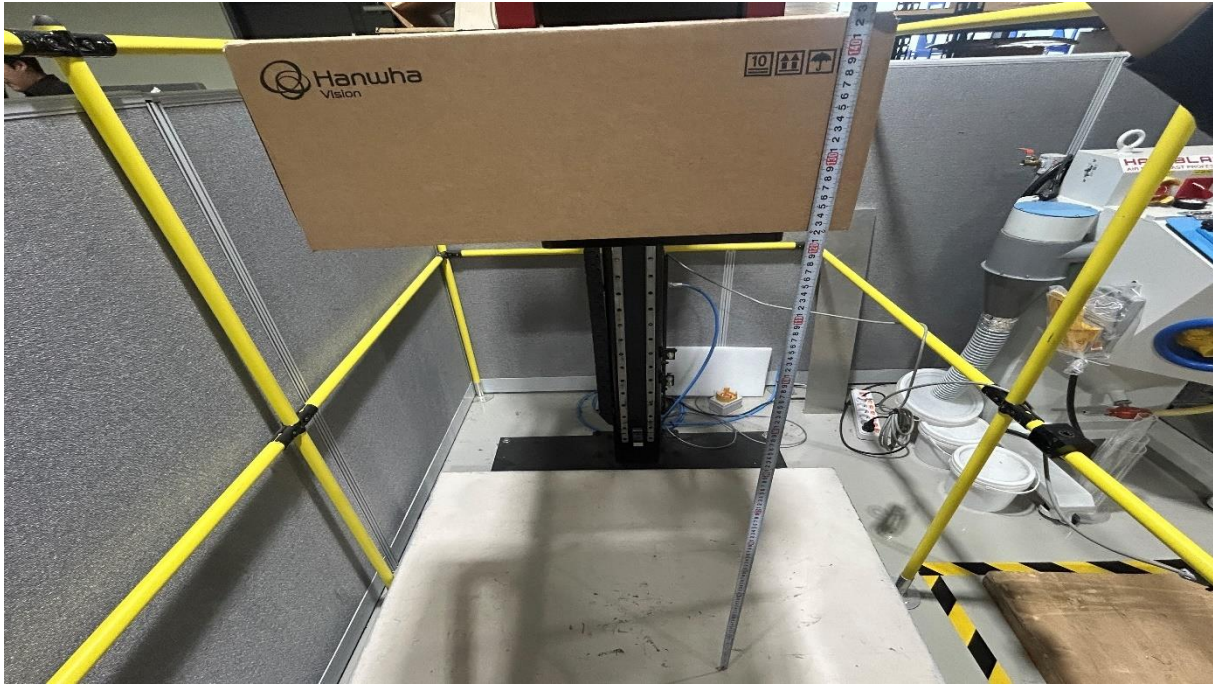
### 6.4.1 Evidence of test setting

6.2.2 Test methods: Logistic transit drop test

| Weight of test item & case (kg) | Largest Dimension (cm) | Height of drop (cm) | Number of Drops |
|---|---|---|---|
| Under 45.4<br>Man-packed or<br>man-portable | Under 91 | 122 | Drop on each face, edge and<br>conner, total of 26 drops |
