# TEST REPORT

REPORT No.:  
CTK-2026-01569  
Page (1) / (12) pages

Security Camera / TNO-C9083ER

IEC 62262:2002+AMD1:2021

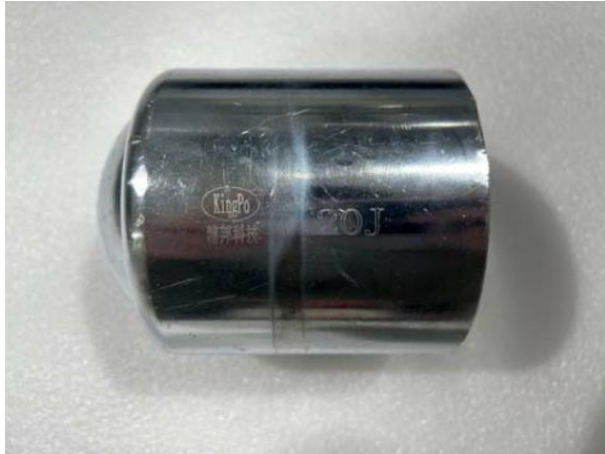
| Testing equipment | Model Name | Manufacturer | Manufacturing Number | Next Cal. Date |
|---|---|---|---|---|
| Vertical Hammer | 5 kg | Kingpo | TX-029-20J | Jul. 08, 2027 |

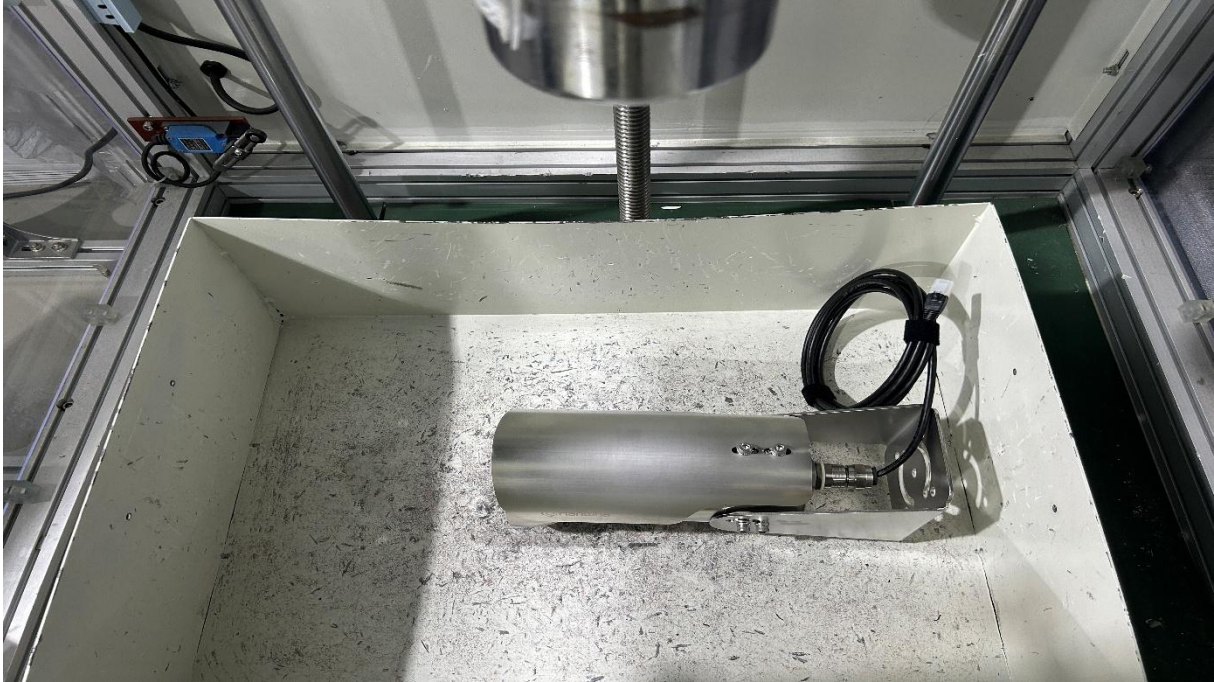
#### 3.3.1 Evidence of test setting

| IK code | Impact Energy (J) | Equivalent mass (kg) | Drop height (mm ± 1%) | Application |
|---|---|---|---|---|
| Impact times: 5 times for each of the exposed surface. (Do not impact more than 3 times in the same spot) | | | | |

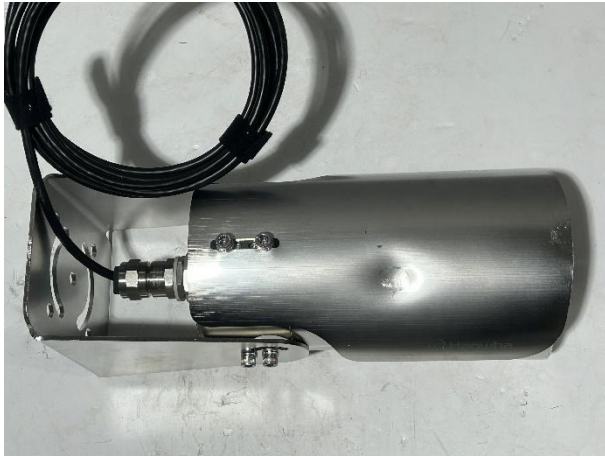
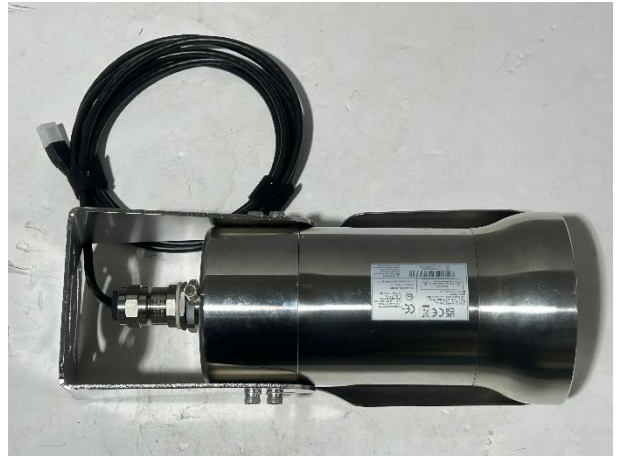
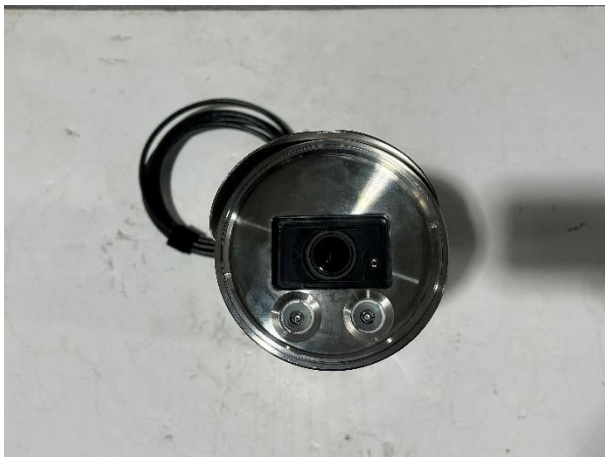
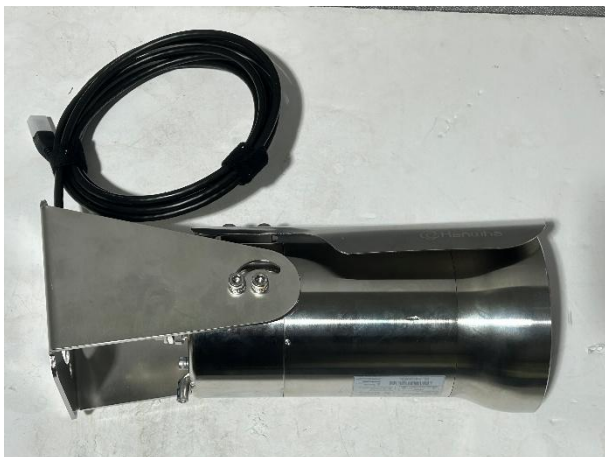
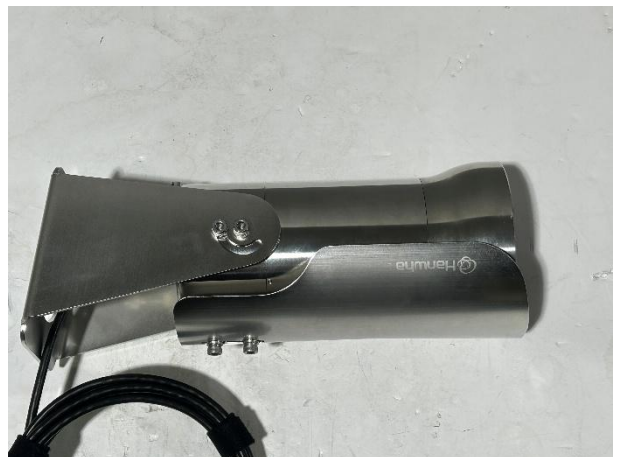
#### 3.6.1 Test sample

| Evaluation Criteria | Test Results | Remark |
|---|---|---|
| Visual Inspection | Some scratches were generated on the outside of the Sample. | Excluding frontal blows |

※ Refer to the sample images after the completion of testing in section 3.6.
