# TEST REPORT

REPORT No.:  
CTK-2025-02424  
Page (1) / (24) pages

NETWORK CAMERA / TNP-A6550RW

NEMA TS 2-2013 2.2.7.3 Test C ~ 2.2.7.8 Test H,  
NEMA TS 2.1.9, NEMA TS 2.1.10

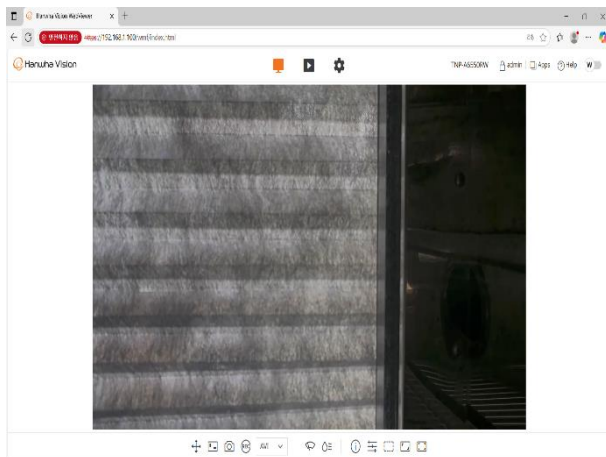
(21 ±6) °C 120 Vac

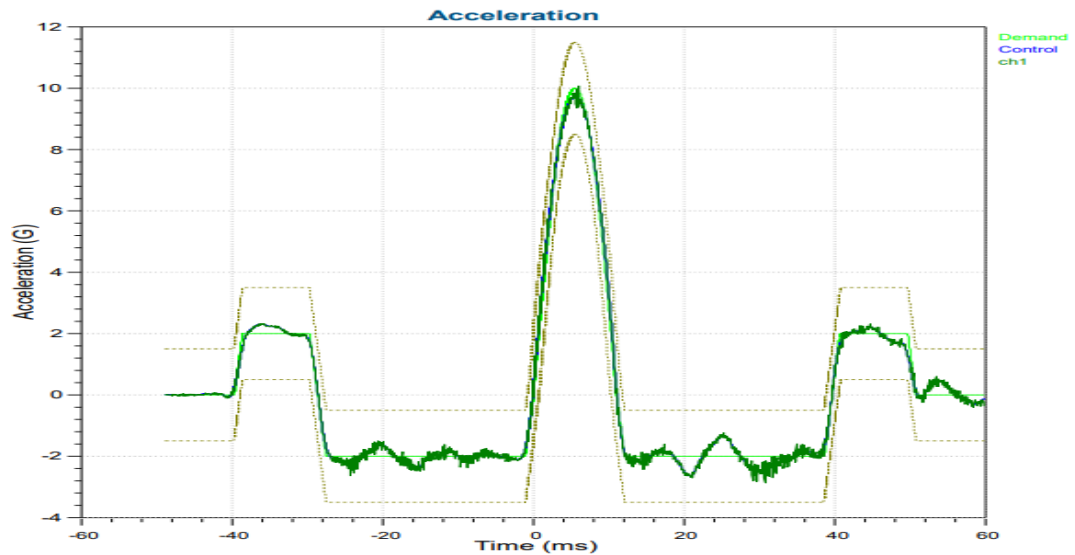
X+

8 19, 2025 09:02:52 Level 1) 100 % Output: 0.7462 Volts peak 한화비전 NEMA-TS 2.1.1

Demand: 10 G

Control: 9.737 G Pulse: 1 of 1 Running

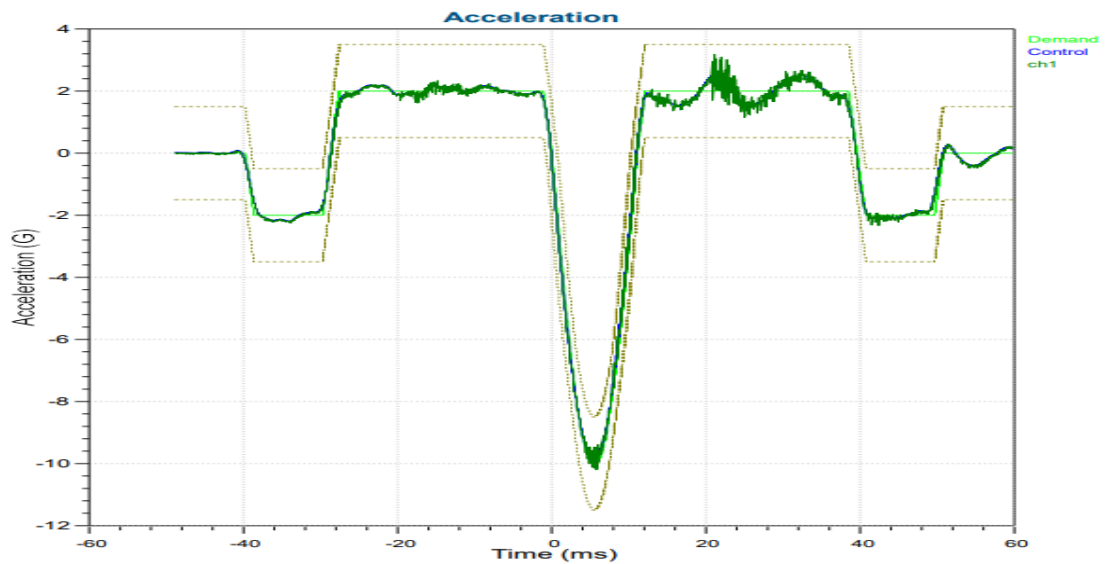
X-

8 19, 2025 09:02:57 Level 2) 100 % Output: 0.7426 Volts peak 한화비전 NEMA-TS 2.1.1

Demand: 10 G

Control: 9.812 G Pulse: 1 of 1 End of Test

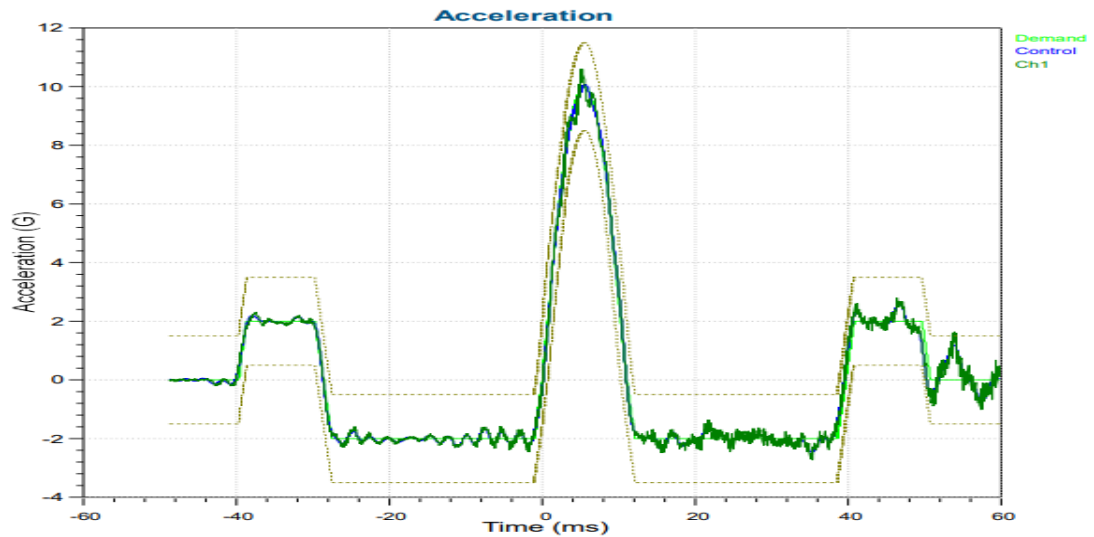
Z+

8 19, 2025 13:21:34 Level 1) 100 %

Output: 0.6916 Volts peak

Demand: 10 G

Control: 10.07 G

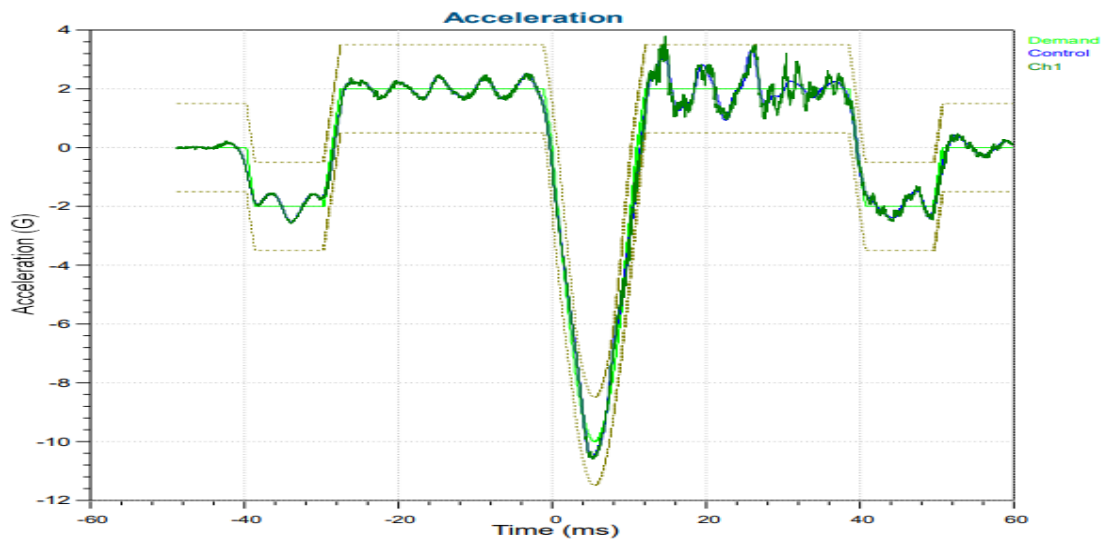
Z-

8 19, 2025 13:21:43 Level 2) 100 %

Output: 0.6676 Volts peak

Demand: 10 G

Control: 10.55 G
