# TEST REPORT

REPORT No.:  
CTK-2025-02424  
Page (1) / (25) pages

NETWORK CAMERA / TNP-A6550RW

NEMA TS 2-2013 2.2.7.3 Test C ~ 2.2.7.8 Test H,  
NEMA TS 2.1.9, NEMA TS 2.1.10

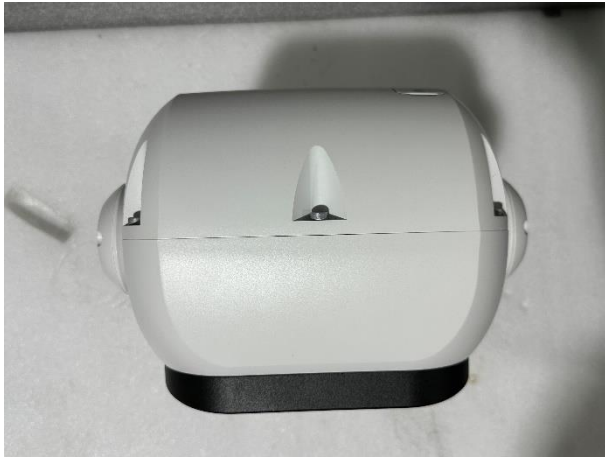
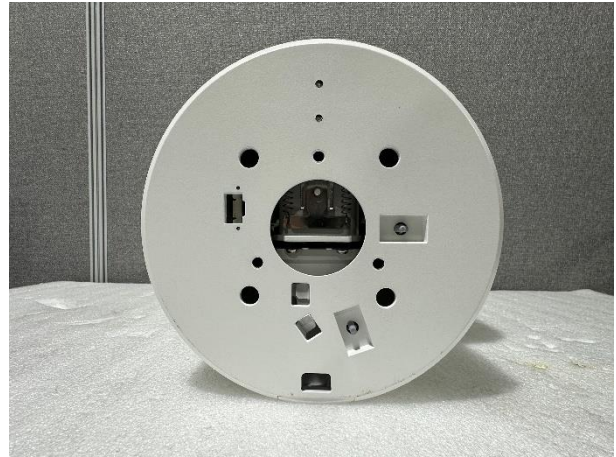
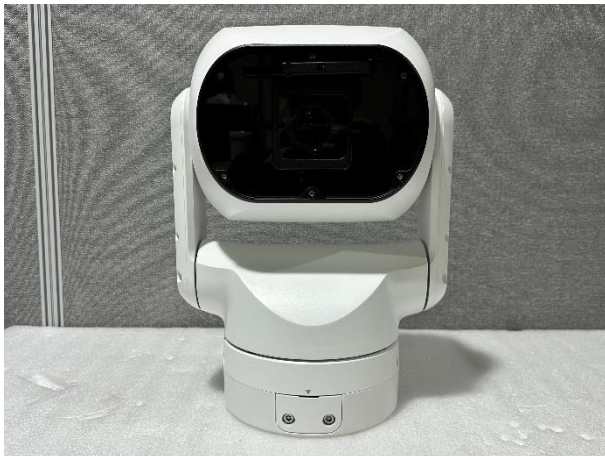
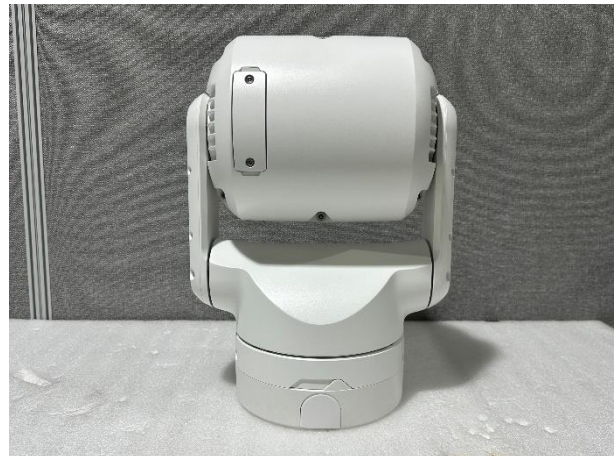
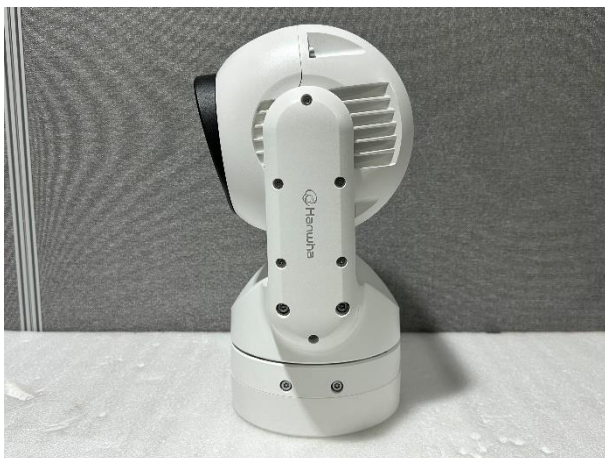
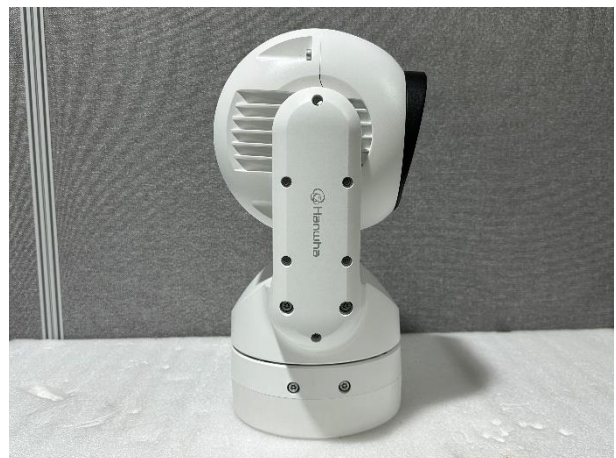
### 2.4.1 Test sample

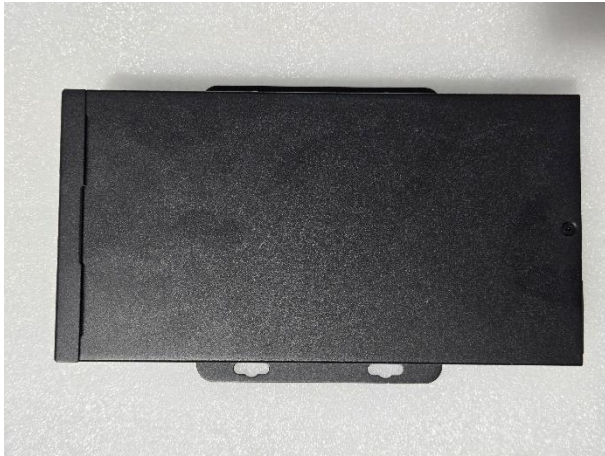
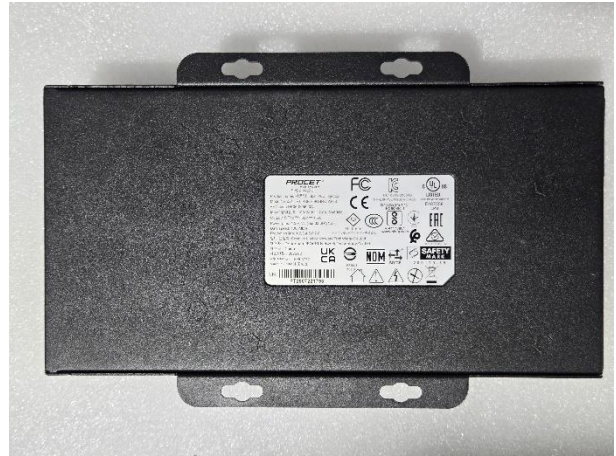
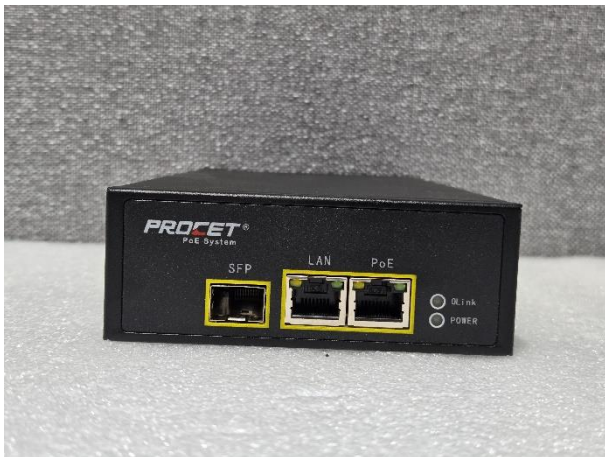
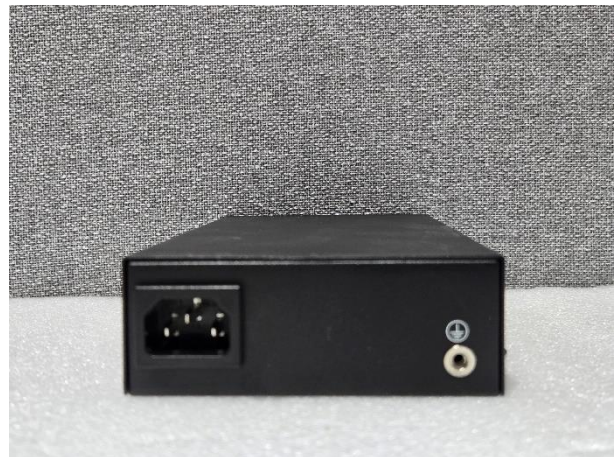
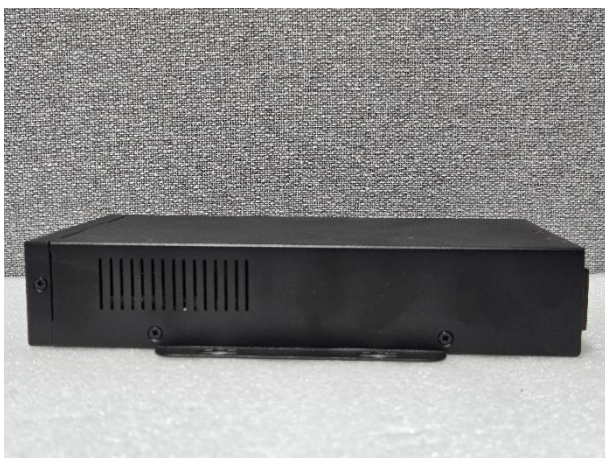
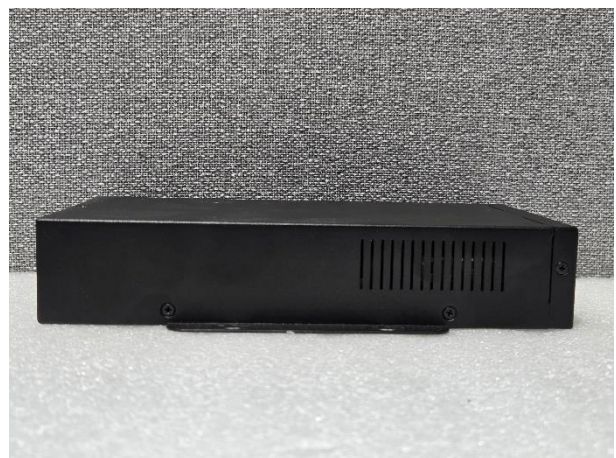
## 2.4.2 Test sample

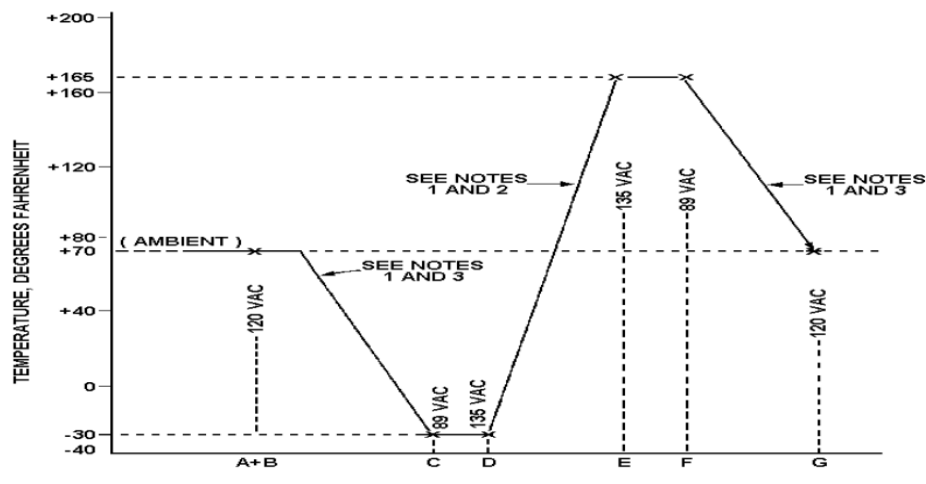
- 3.2.1 2.2.7.3 Test C: - 34 °C, 89 Vac, 10 h (Check interim operation after 5 h and operation check after 10h)
- 3.2.2 2.2.7.4 Test D: - 34 °C, 135 Vac, 1 h (Operating state)
- 3.2.3 2.2.7.5 Test E: 74 °C, 18 %, 135 Vac, 15 h (Operating state)
- 3.2.4 2.2.7.6 Test F: 74 °C, 18 %, 89 Vac (Operation check after 2.2.7.5 Test E)
- 3.2.5 2.2.7.7 Test G: (21 ±6) °C, 120 Vac (Operating state)
- 3.2.6 2.2.7.8 Test H: Check for mechanical damage
- 3.2.7 Test Methods

- Evaluations Criteria :
  - Check for mechanical damage before and after testing
- Test methods

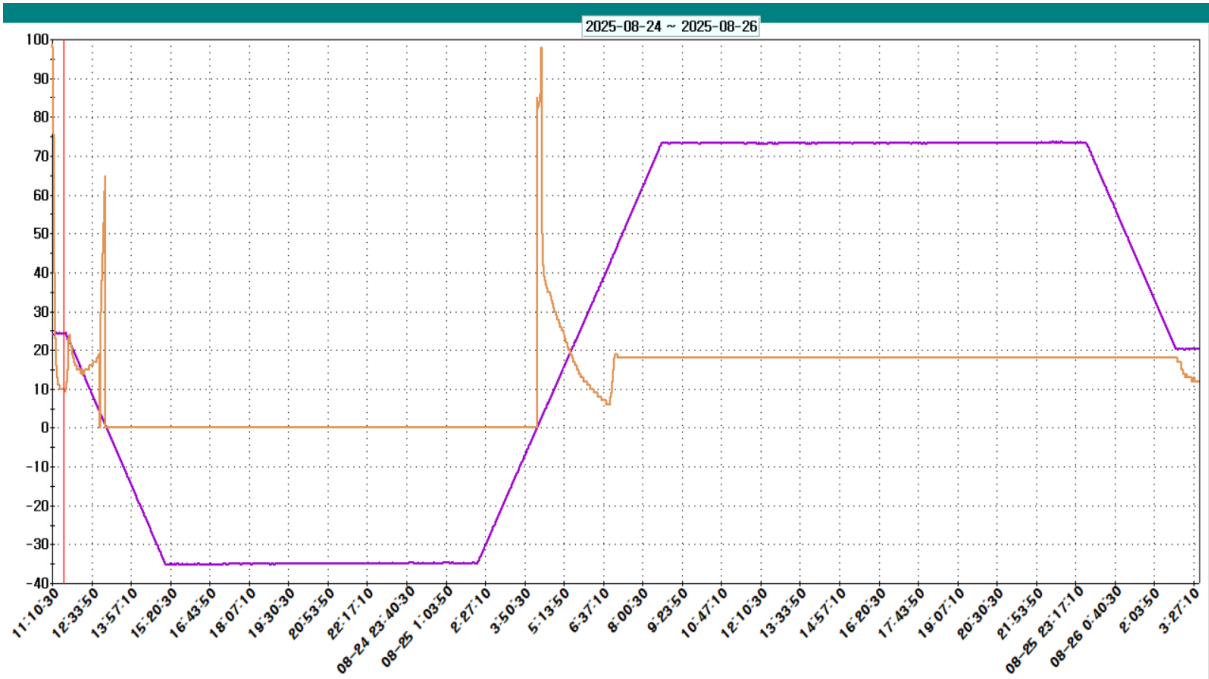
Temperature Data

#### 3.5.1 Test data and graph

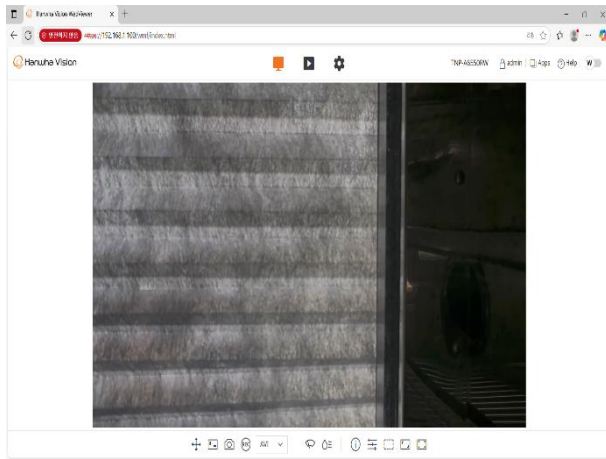
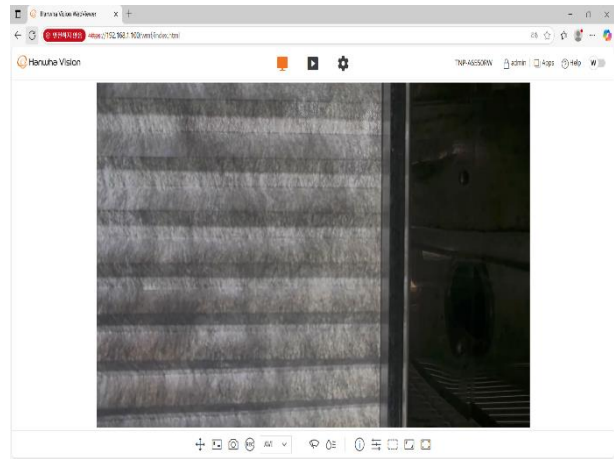
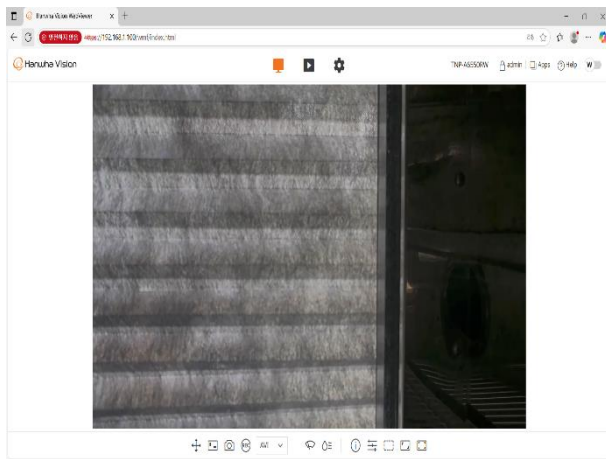
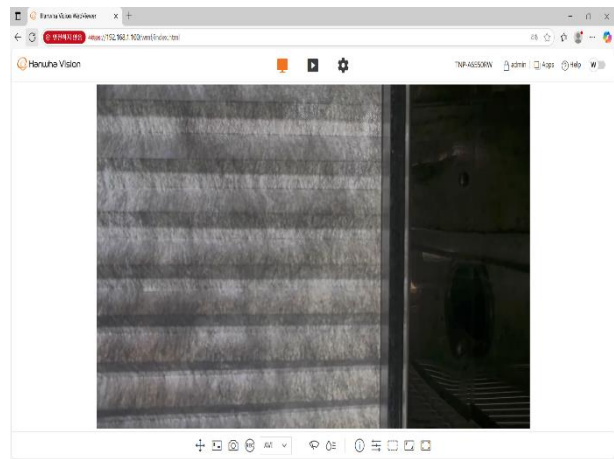
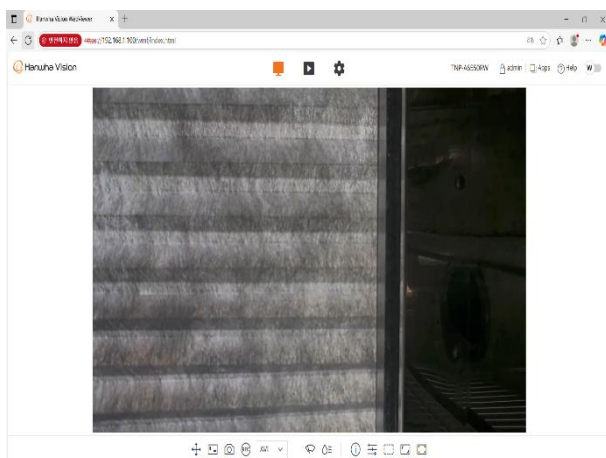
#### 3.6.1 Test sample operation and function

-34 °C 89 Vac

-34 °C 135 Vac

74 °C 135 Vac

74 °C 89 Vac

(21 ±6) °C 120 Vac

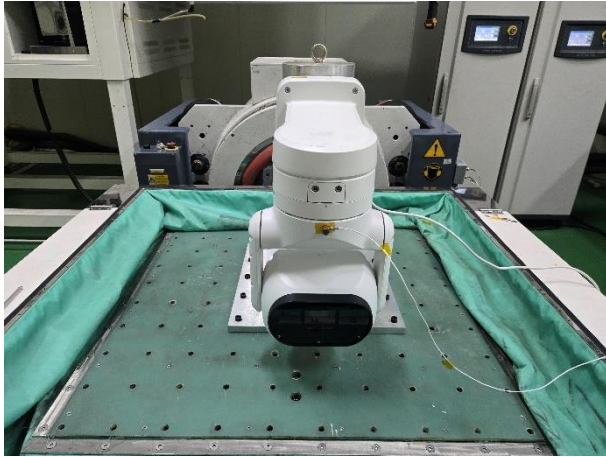
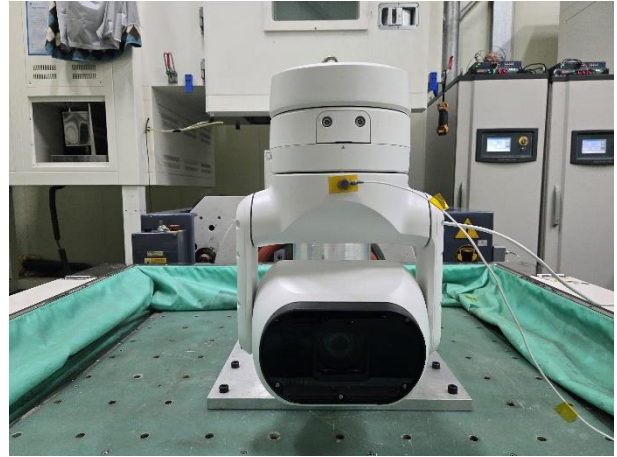
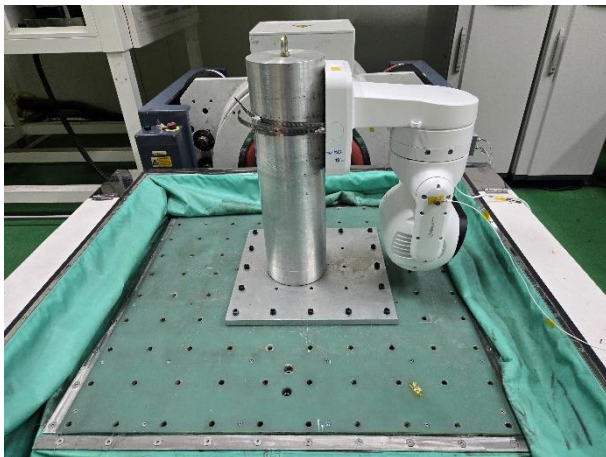
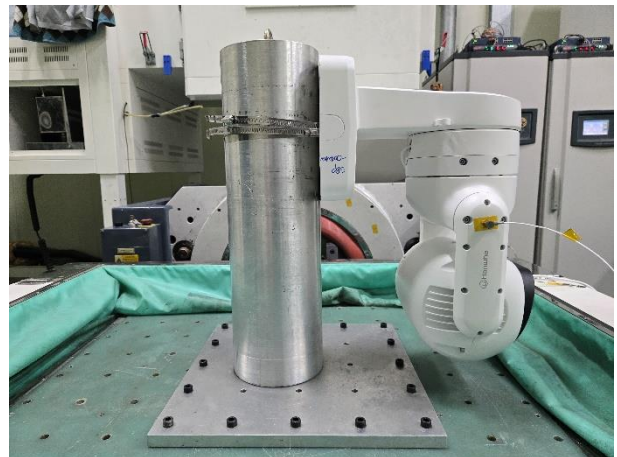
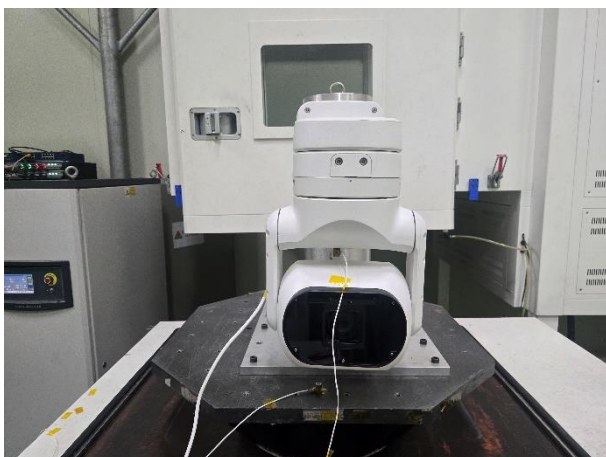
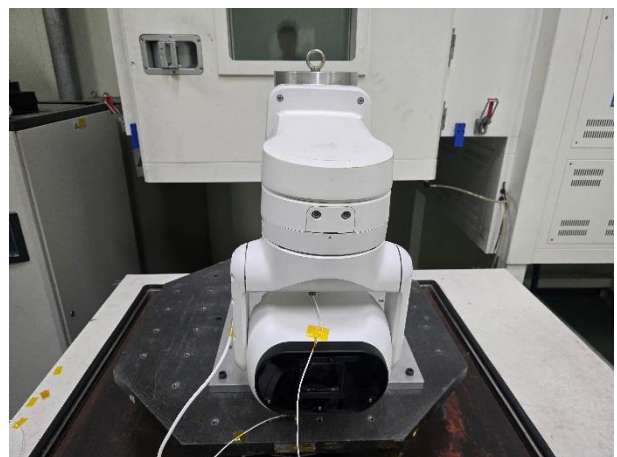
#### 4.3.1 Evidence of test setting (NEMA TS 2-2013 2.1.9)

- Sample status : unpackaged / operation
- Applied waveform : Sine
- Frequency(Hz) : 5 ~ 30
- Acceleration(G) : 0.5
- Applicable axis : X, Y, Z
- Test time(h) : All 3(Each axis 1)
- Evaluation items
  - Check for mechanical damage before and after testing
- Test methods
  - The major units of the CA shall maintain all programmed functions and physical integrity when subjected to a vibration of 5 to 30 Hz up to 0.5g's applied in each of three mutually perpendicular planes.

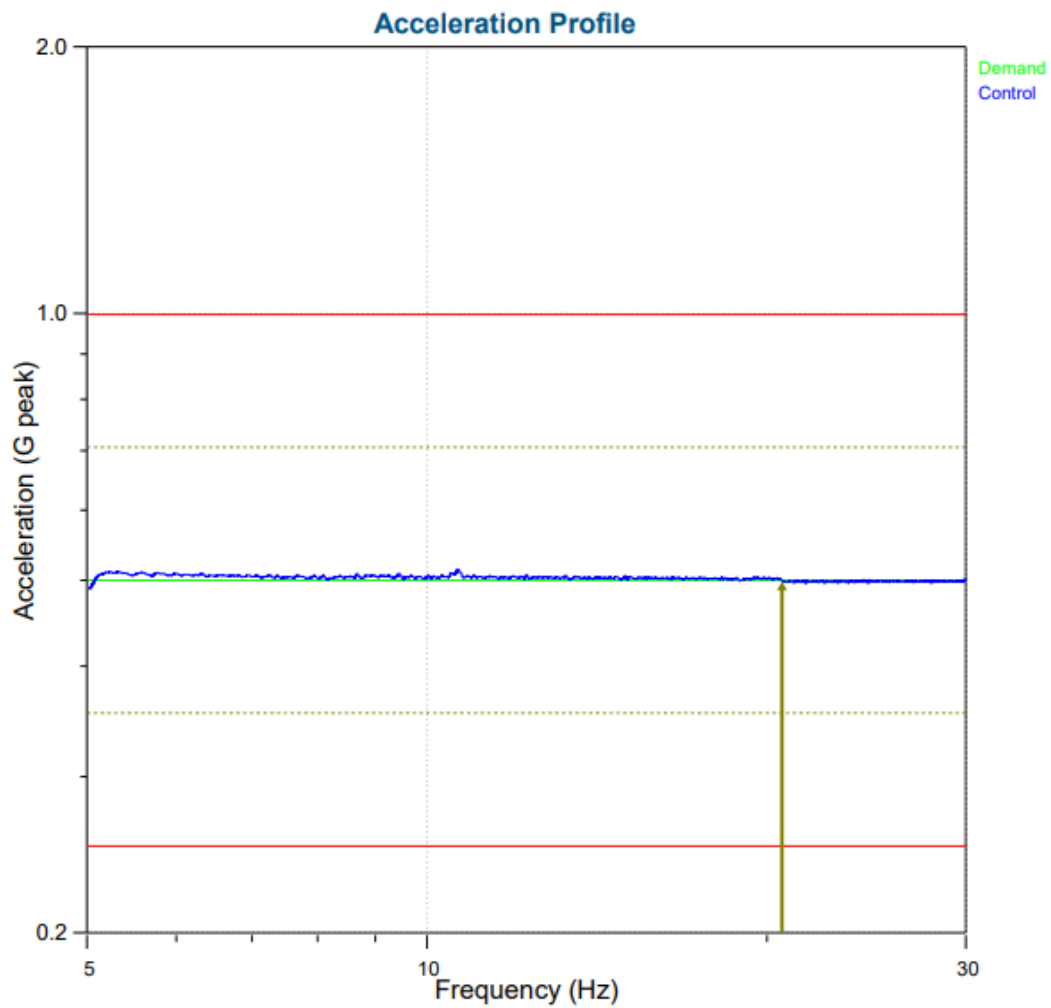
#### 4.5.1 Test Data X Axis

8 19, 2025 09:02:09    Level 1) 100 %    Output: 0 Volts peak    NEMA-TS 2.1.9 진동

Demand: 0.5 G    Level Time: 1:00:00    Frequency: 30Hz

Control: 0.001716 G    Total Time: 1:00:11    End of Timed Test

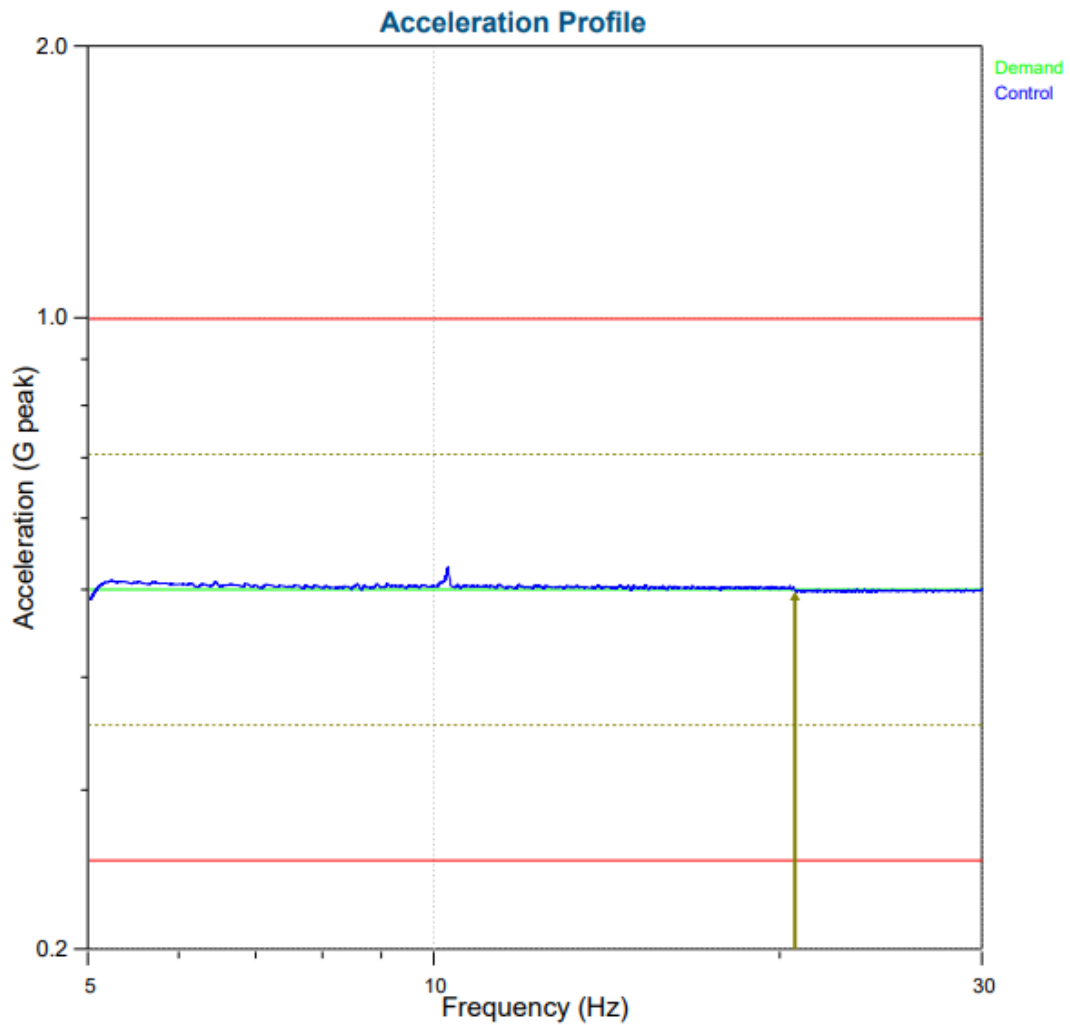
### 4.5.2 Test Data Y Axis

8 19, 2025 11:14:28    Level 1) 100 %    Output: 0 Volts peak    NEMA-TS 2.1.9 진동

Demand: 0.5 G    Level Time: 1:00:00    Frequency: 30Hz

Control: 0.0004021 G    Total Time: 1:00:11    End of Timed Test

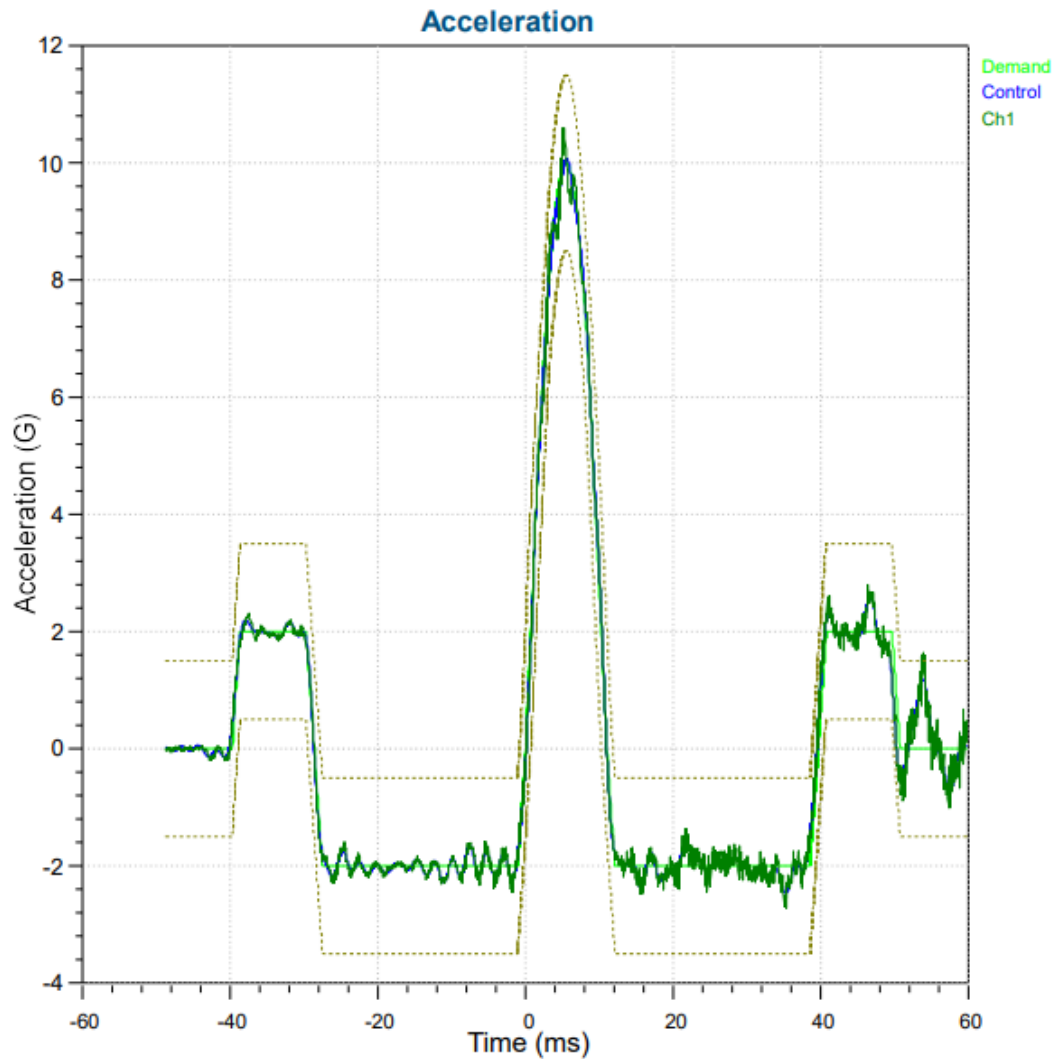
### 4.5.3 Test Data Z Axis

8 19, 2025 13:21:34 Level 1) 100 %

Output: 0.6916 Volts peak

NEMA-TS 2.1.10

Demand: 10 G

Control: 10.07 G

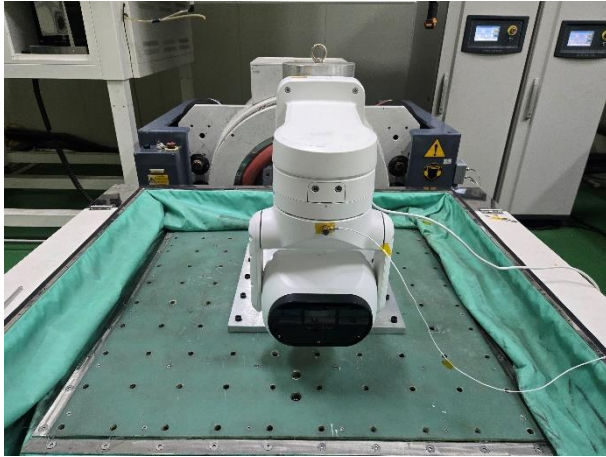
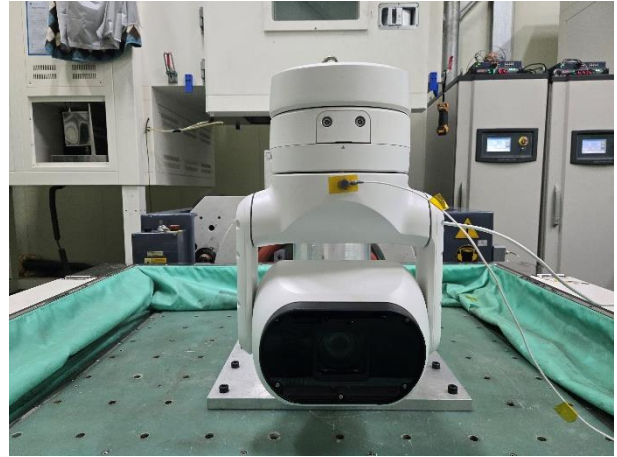
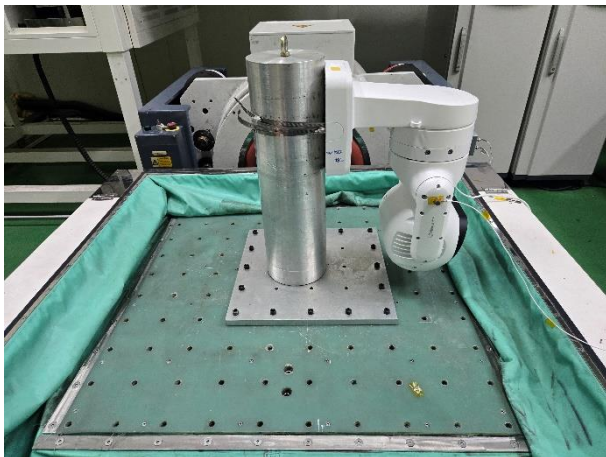
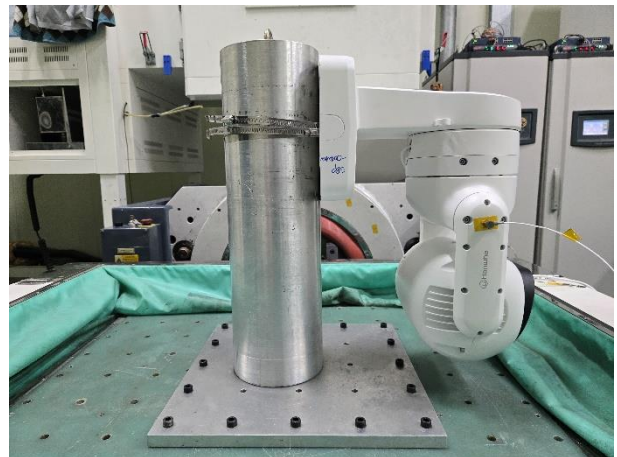
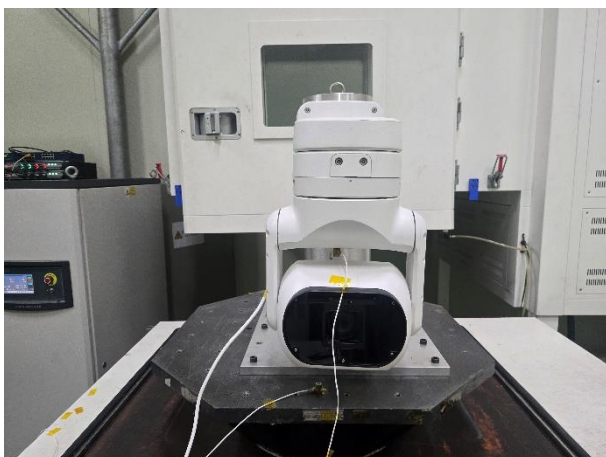
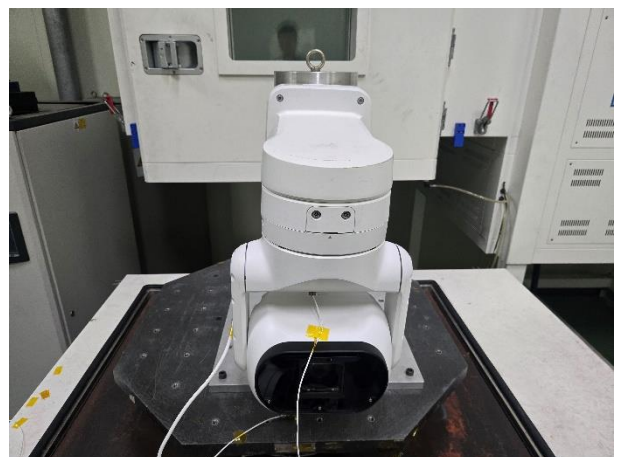
### 5.3.1 Evidence of test setting (NEMA TS 2-2013 2.1.10)

5.2.1 Sample status: unpackaged / not in operation

5.2.2 Applied waveform: Half sine

5.2.3 Acceleration(G): 10 G

5.2.4 Nominal duration (ms): 11

5.2.5 Applicable axis : X, Y, Z

5.2.6 Number of impacts: 1 per direction (total 6)

The major units of the CA shall suffer neither permanent mechanical deformation nor any damage that renders the unit inoperable, when subjected to a shock of 10g applied in each of three mutually perpendicular planes.

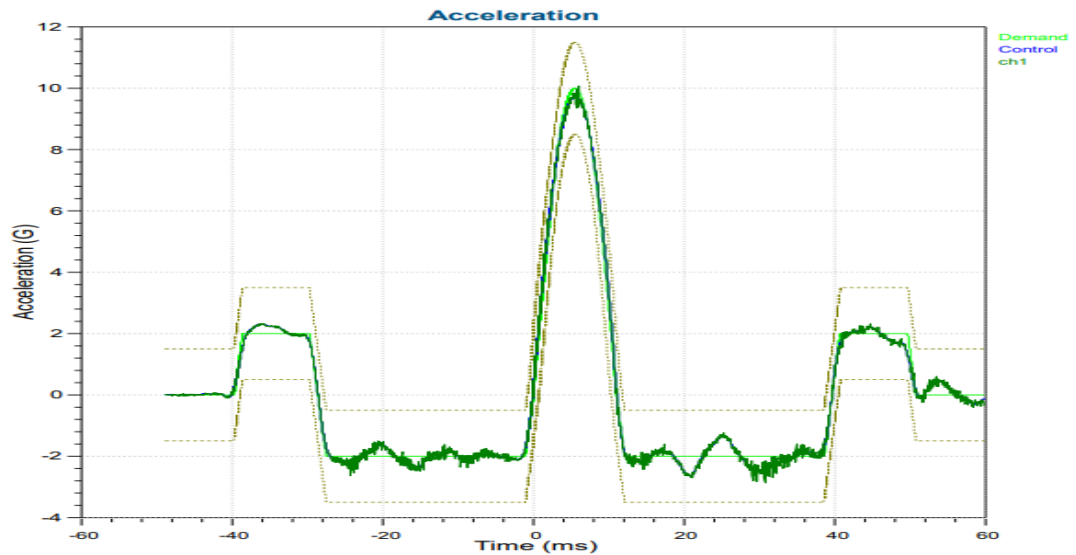
X+

8 19, 2025 09:02:52 Level 1) 100 % Output: 0.7462 Volts peak 한화비전 NEMA-TS 2.1.1

Demand: 10 G

Control: 9.737 G

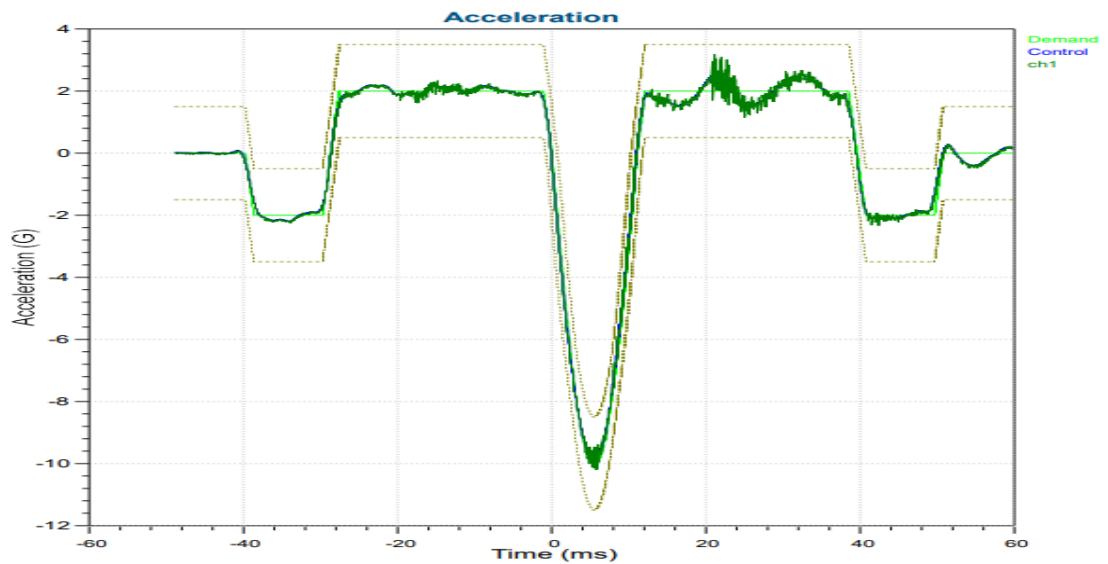
X-

8 19, 2025 09:02:57 Level 2) 100 % Output: 0.7426 Volts peak 한화비전 NEMA-TS 2.1.1

Demand: 10 G

Control: 9.812 G

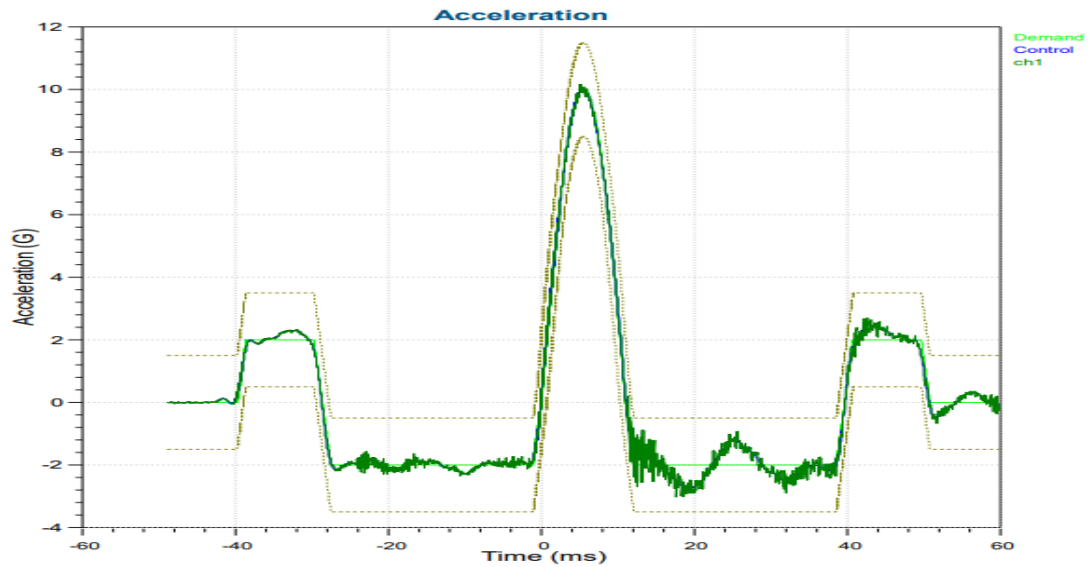
Y+

8 19, 2025 11:15:06 Level 1) 100 %

Output: 0.7569 Volts peak

Demand: 10 G

Control: 10.01 G

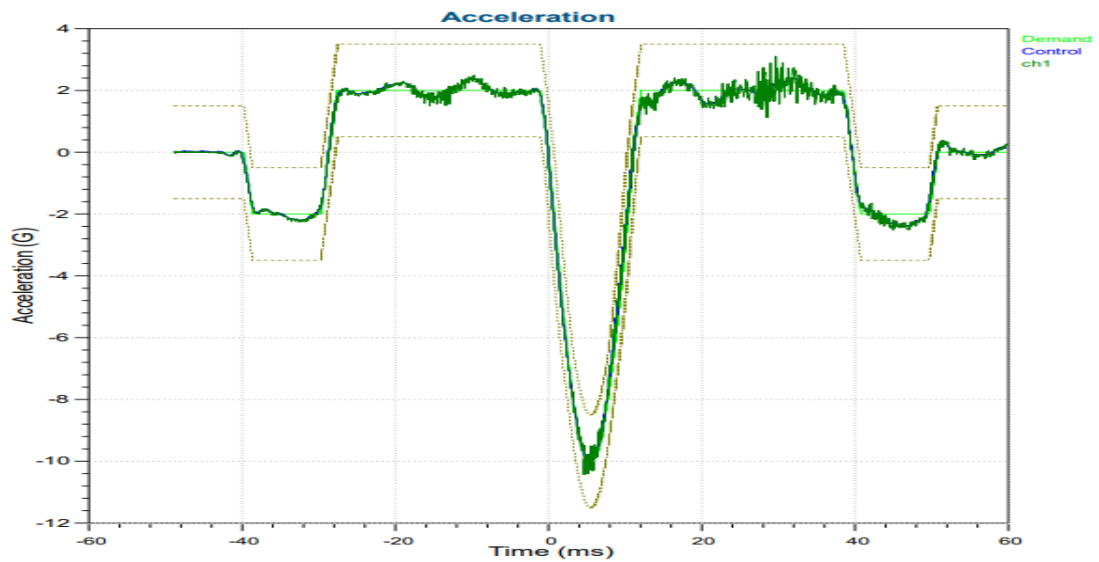
Y-

8 19, 2025 11:16:29 Level 2) 100 %

Output: 0.7574 Volts peak

Demand: 10 G

Control: 9.99 G

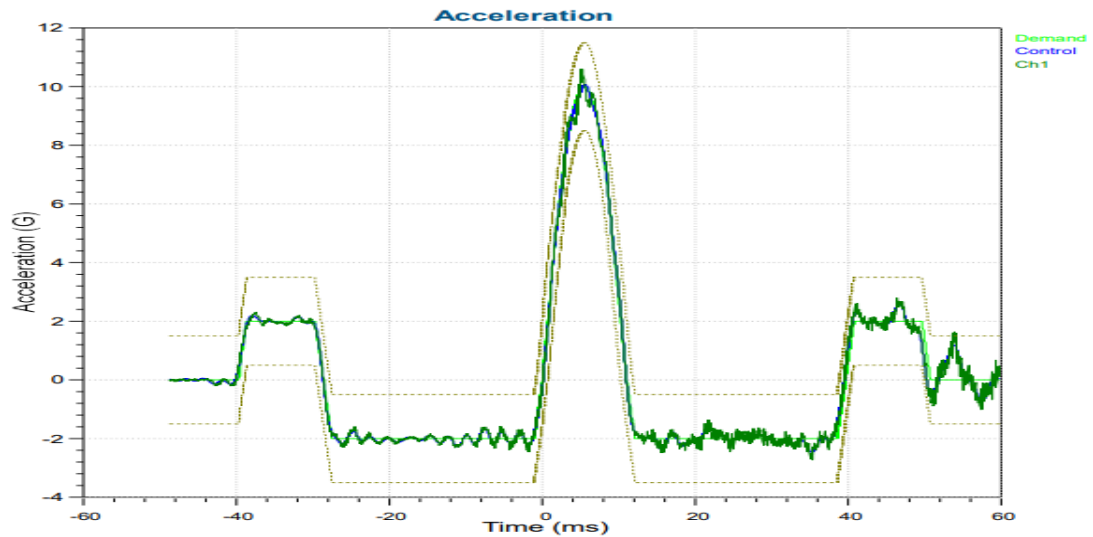
Z+

8 19, 2025 13:21:34 Level 1) 100 %

Output: 0.6916 Volts peak

Demand: 10 G

Control: 10.07 G

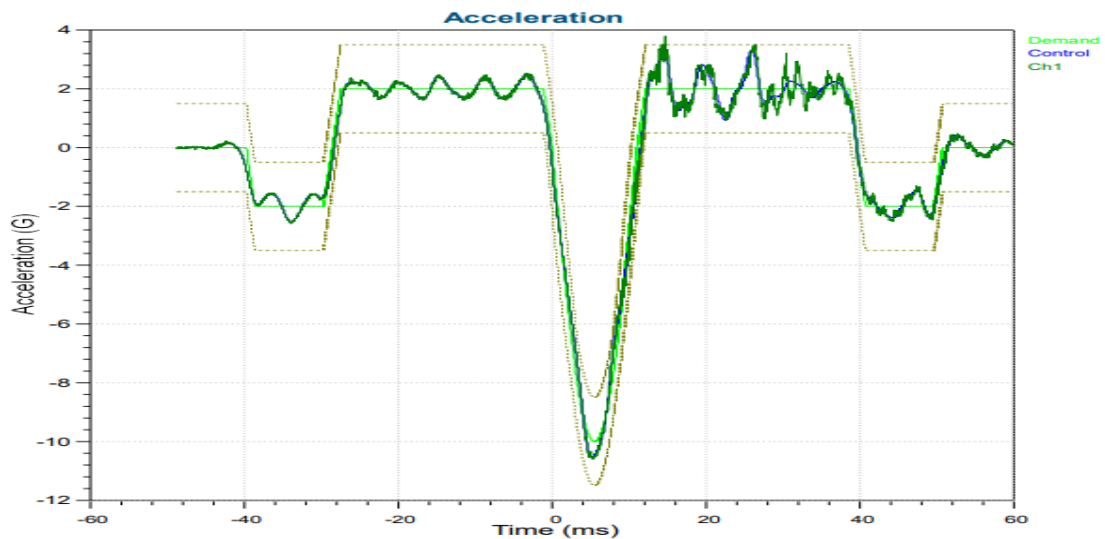
Z-

8 19, 2025 13:21:43 Level 2) 100 %

Output: 0.6676 Volts peak

Demand: 10 G

Control: 10.55 G

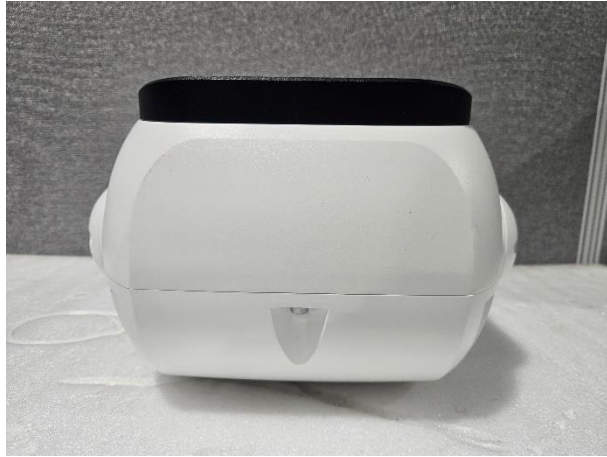
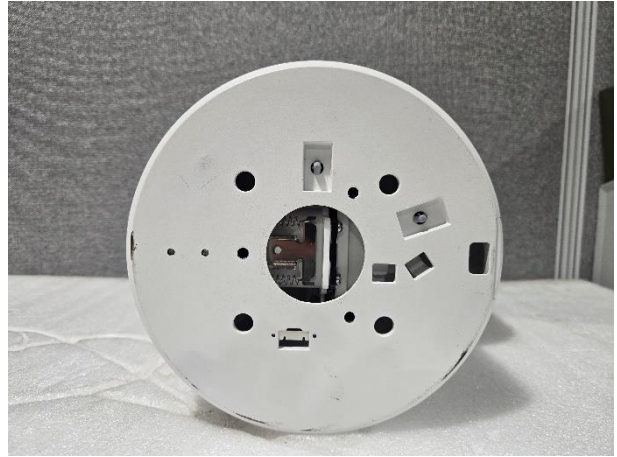
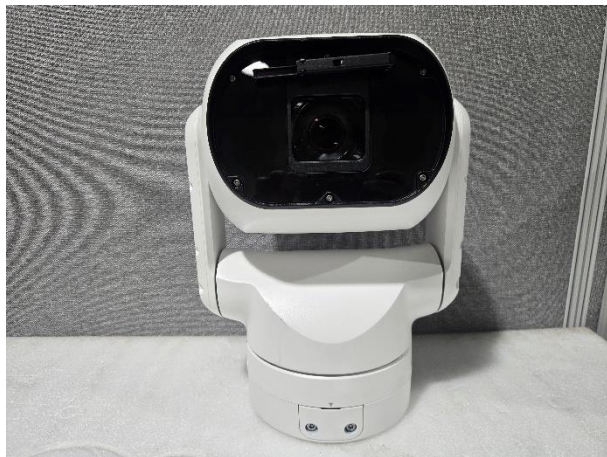
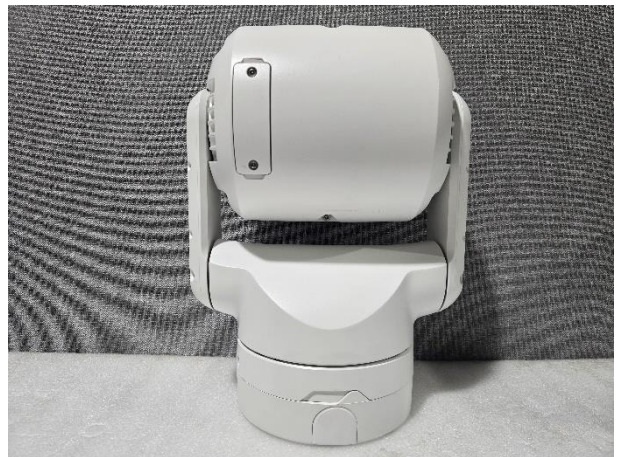
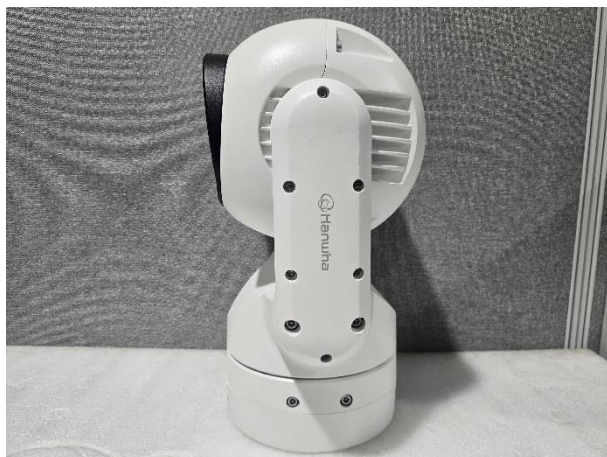
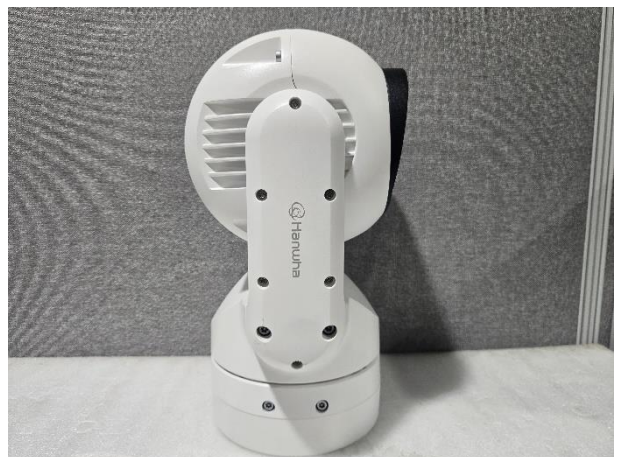
## 5.6 Post-test product images

### 5.6.1 Test sample

| Evaluation Criteria | | Test Results | Comment |
|---|---|---|---|
| | After | Normal | |
