# TEST REPORT

REPORT No.:  
CTK-2025-02423  
Page (1) / (24) pages

NETWORK CAMERA / TNP-A7430RW

NEMA TS 2-2013 2.2.7.3 Test C ~ 2.2.7.8 Test H,  
NEMA TS 2.1.9, NEMA TS 2.1.10

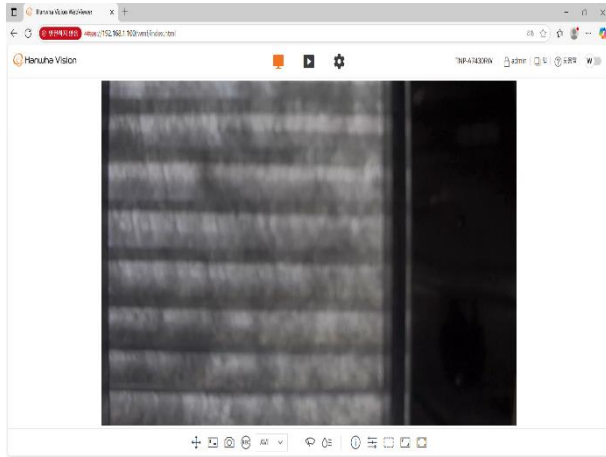
-34 °C 89 Vac

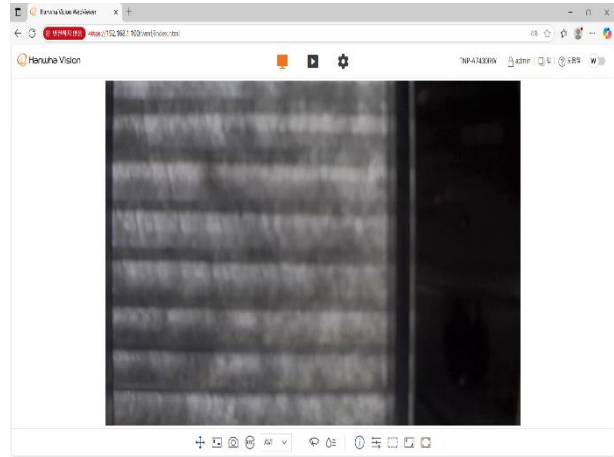
-34 °C 135 Vac

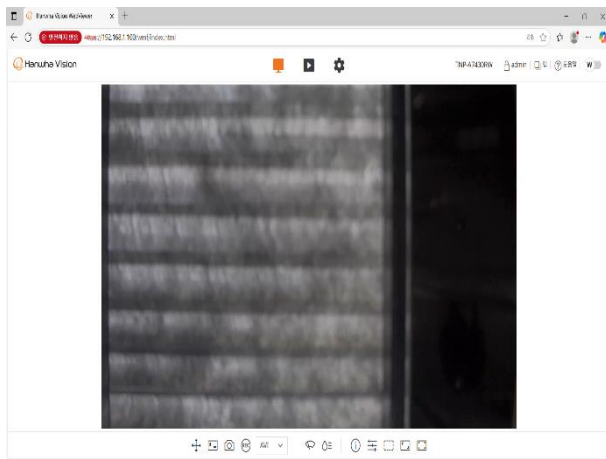
74 °C 135 Vac

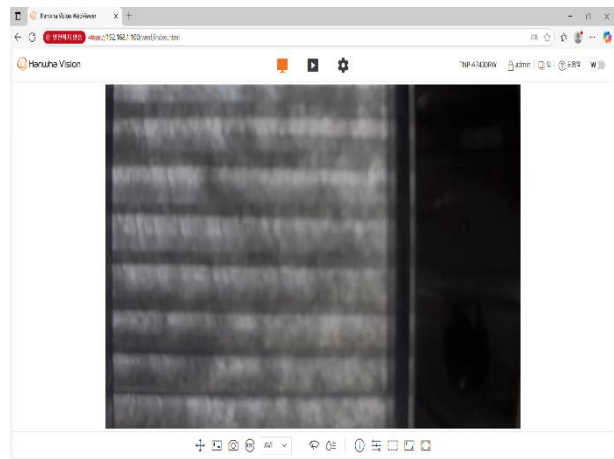
74 °C 89 Vac

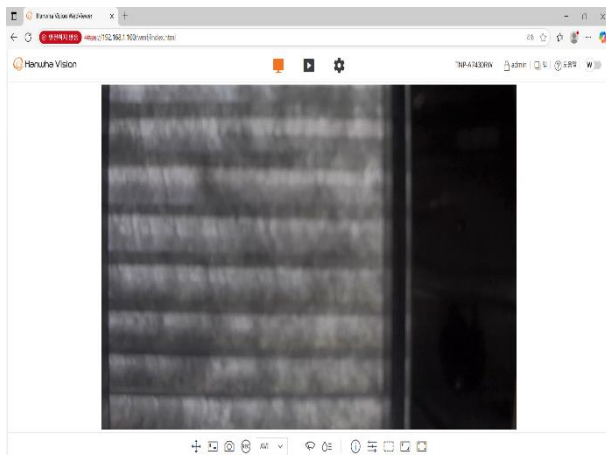
(21 ±6) °C 120 Vac

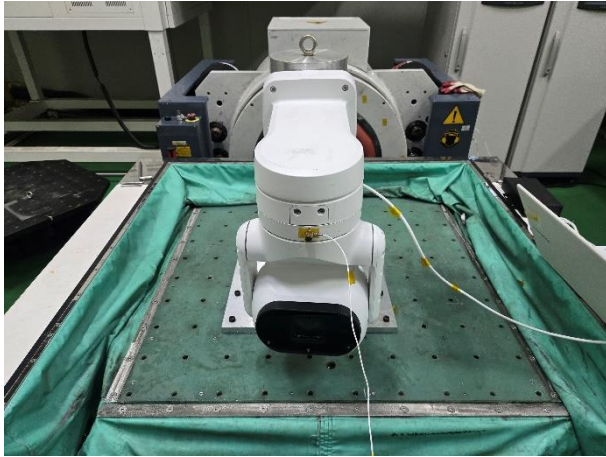
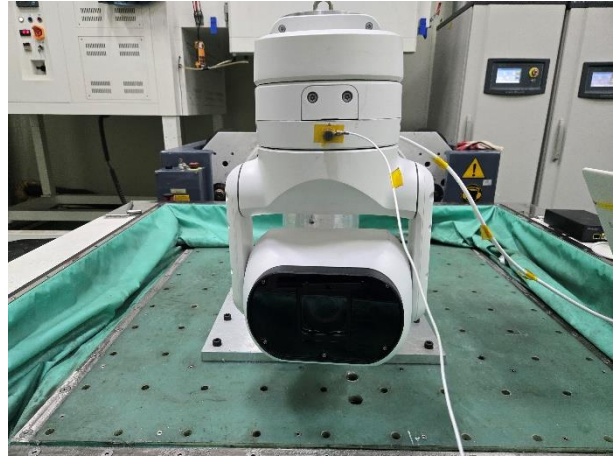
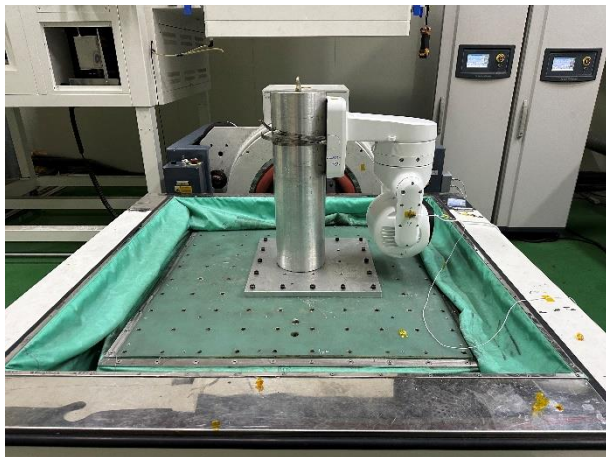
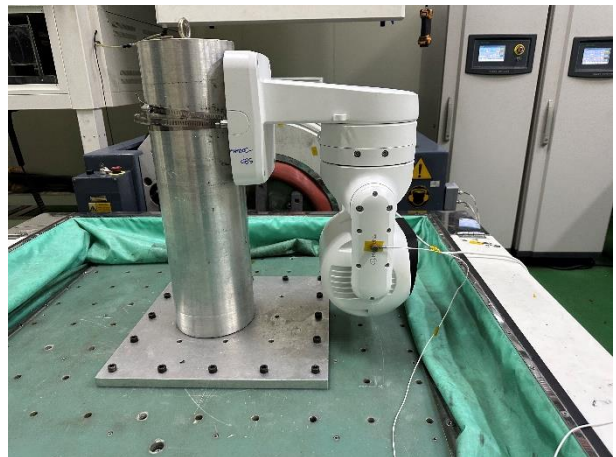
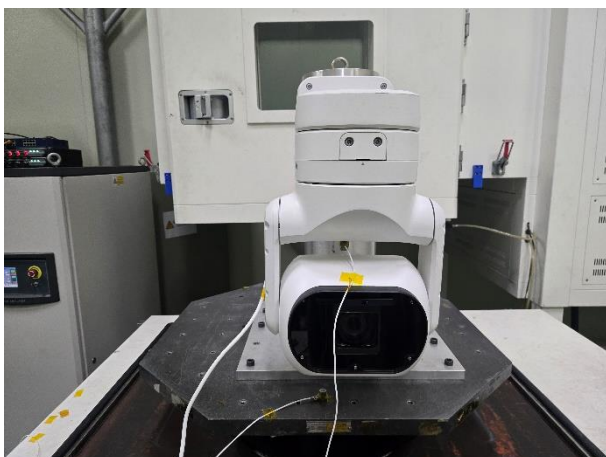
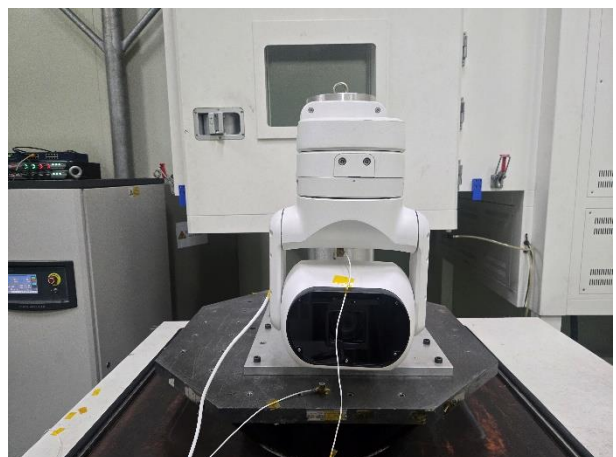
#### 4.3.1 Evidence of test setting (NEMA TS 2-2013 2.1.9)

- Sample status : unpackaged / operation
- Applied waveform : Sine
- Frequency(Hz) : 5 ~ 30
- Acceleration(G) : 0.5
- Applicable axis : X, Y, Z
- Test time(h) : All 3(Each axis 1)
- Evaluation items
  - Check for mechanical damage before and after testing
- Test methods
  - The major units of the CA shall maintain all programmed functions and physical integrity when subjected to a vibration of 5 to 30 Hz up to 0.5g's applied in each of three mutually perpendicular planes.

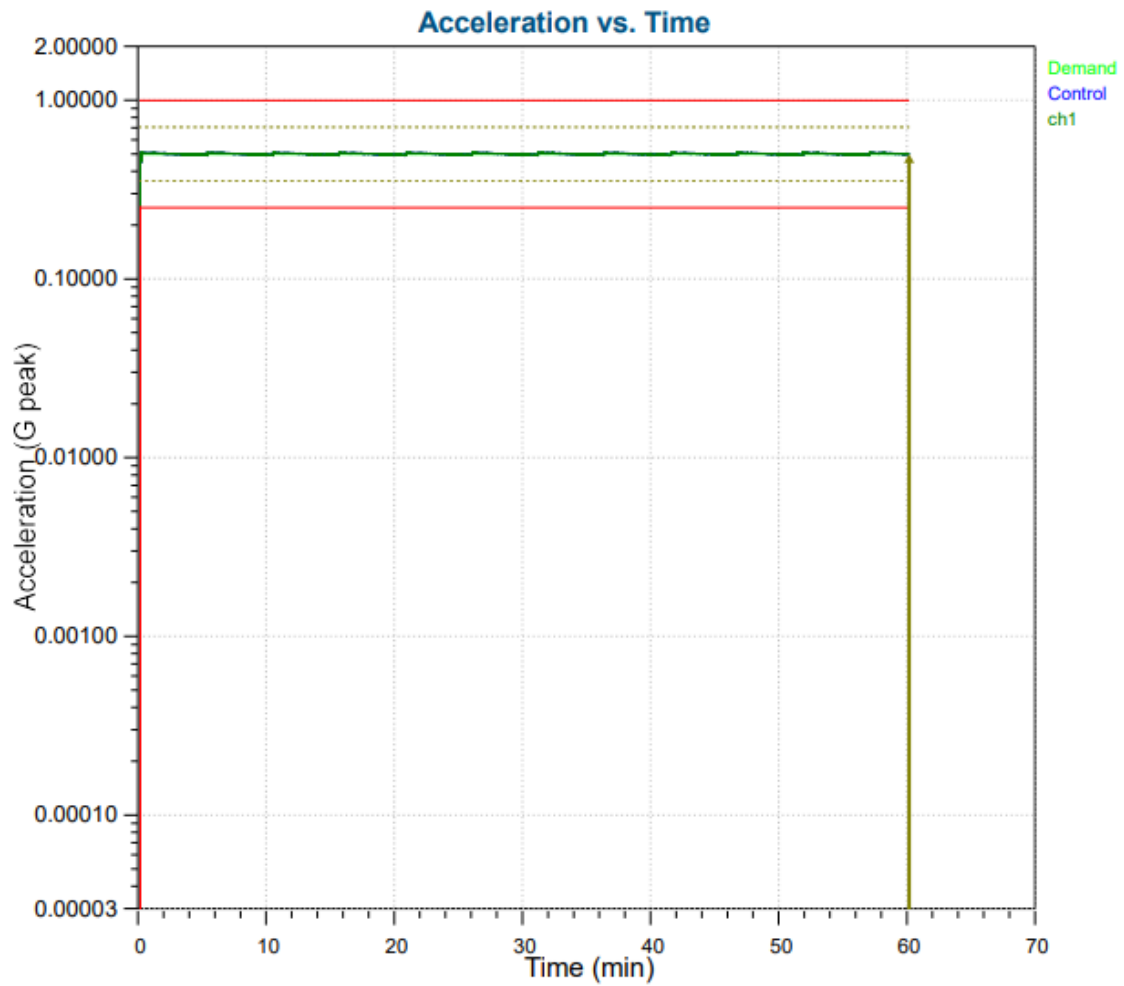
#### 4.5.1 Test Data X Axis

Demand: 0.5 G

Level Time: 1:00:00

Frequency: 30 Hz

Control: 0.001436 G

Total Time: 1:00:11

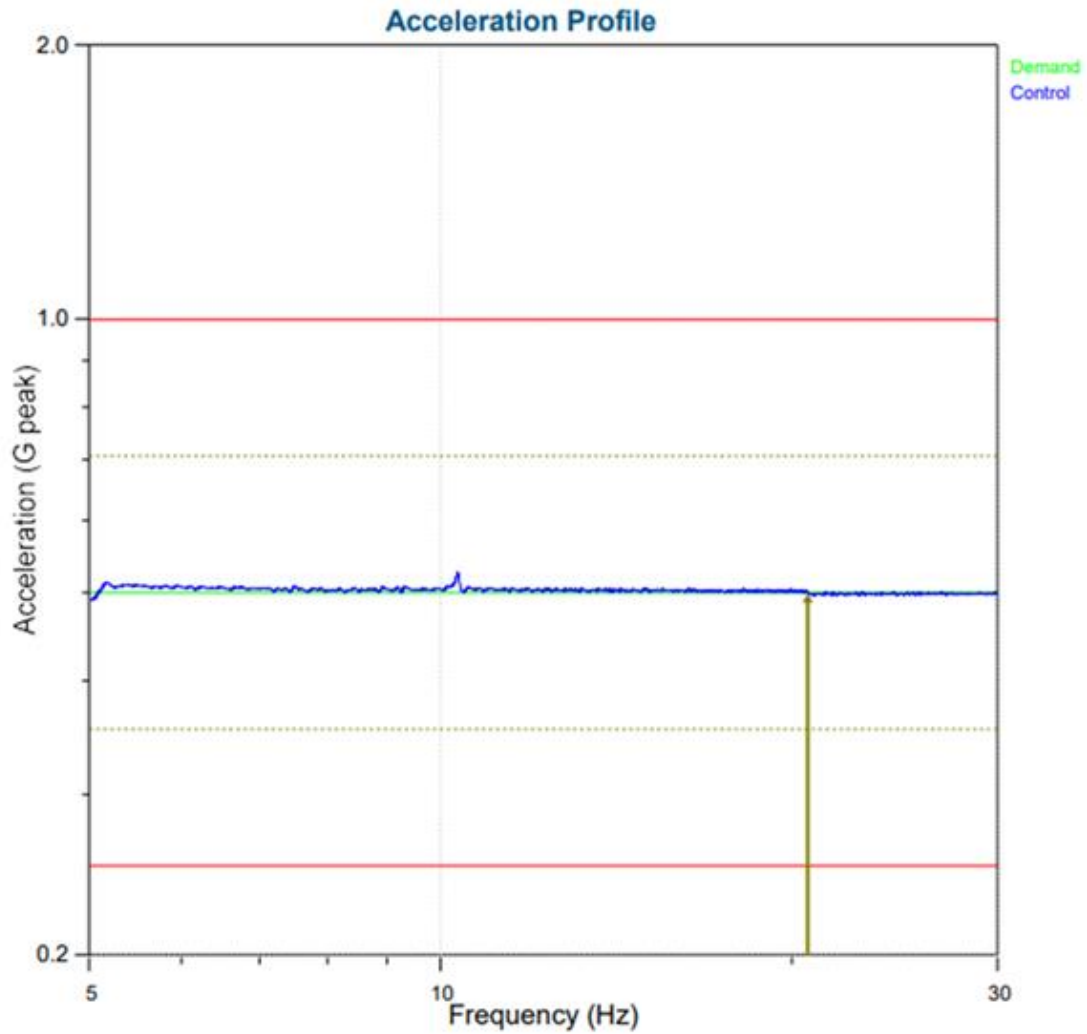
### 4.5.2 Test Data Y Axis

Demand: 0.5 G    Level Time: 1:00:00    Frequency: 30 Hz

Control: 0.0005356 G    Total Time: 1:00:11    End of Timed Test

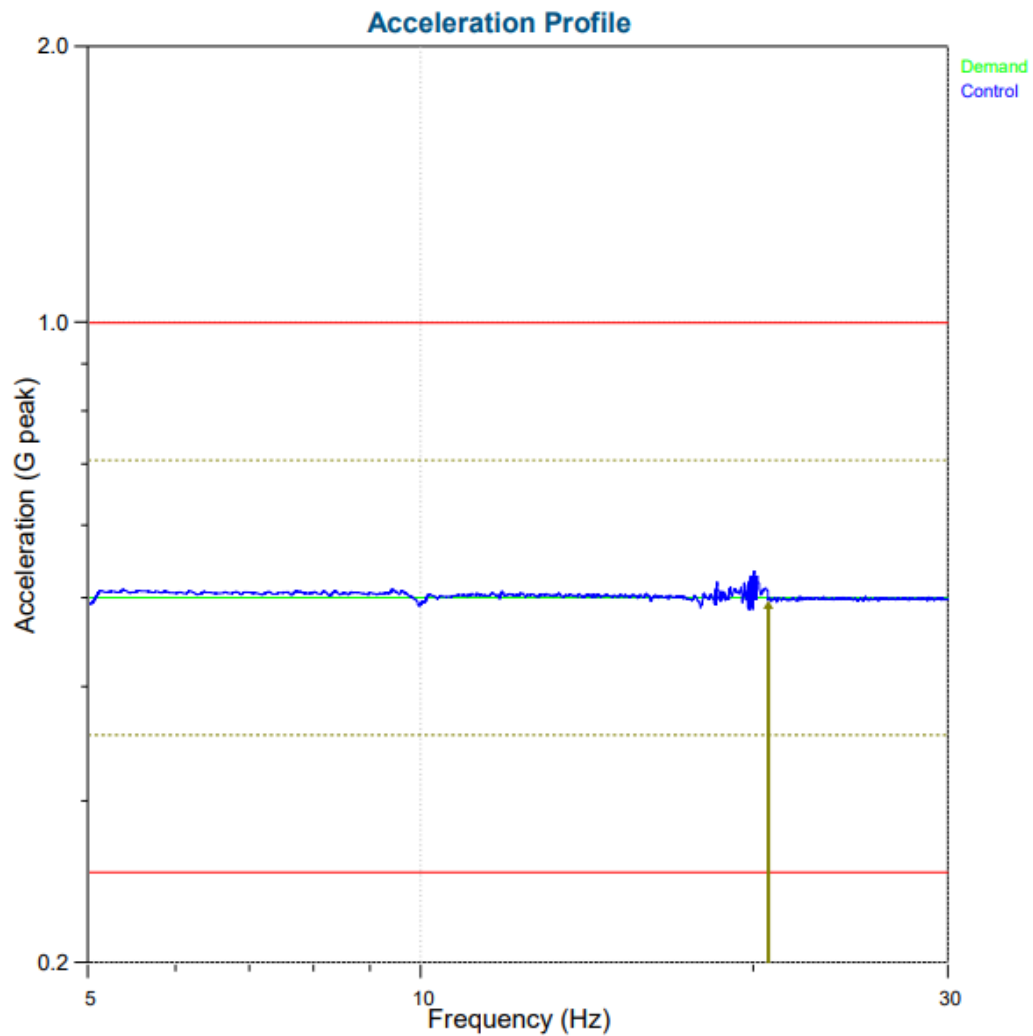
### 4.5.3 Test Data Z Axis

Demand: 0.5 G

Level Time: 1:00:00

Frequency: 30 Hz

Control: 0.001128 G Total Time: 1:00:11

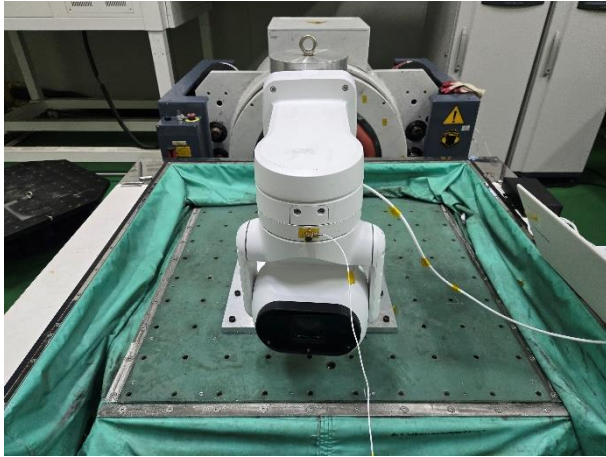
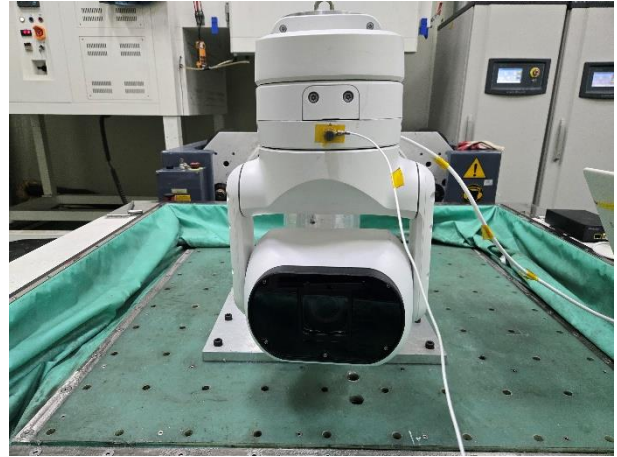
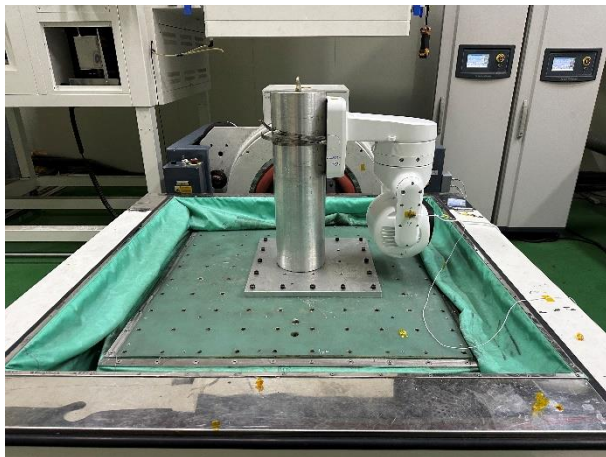
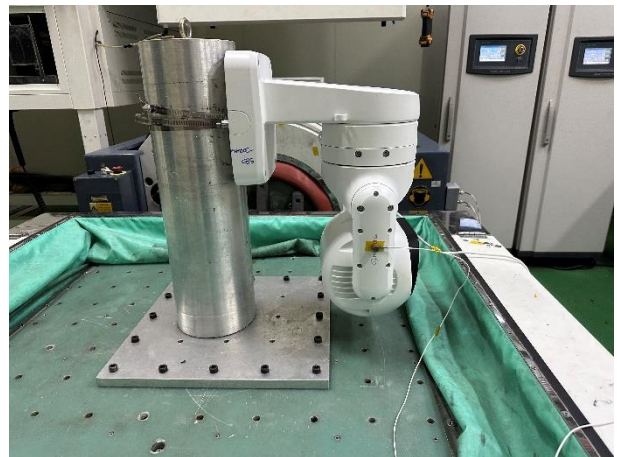
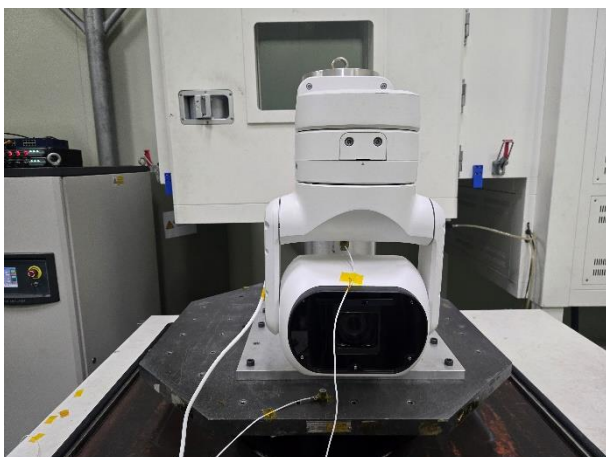
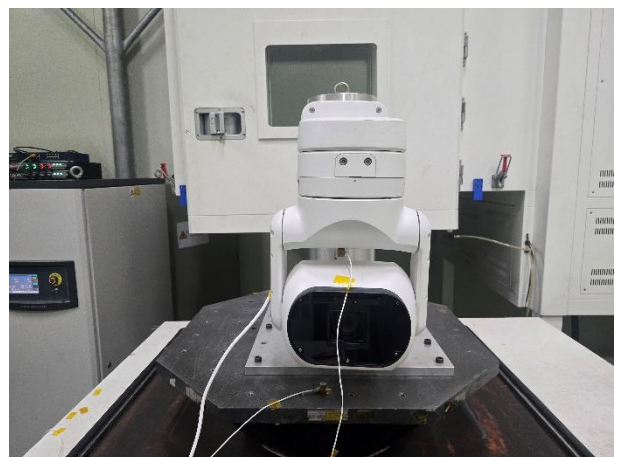
### 5.3.1 Evidence of test setting (NEMA TS 2-2013 2.1.10)

5.2.2 Applied waveform: Half sine

5.2.3 Acceleration(G): 10 G

5.2.4 Nominal duration (ms): 11

The major units of the CA shall suffer neither permanent mechanical deformation nor any damage that renders the unit inoperable, when subjected to a shock of 10g applied in each of three mutually perpendicular planes.

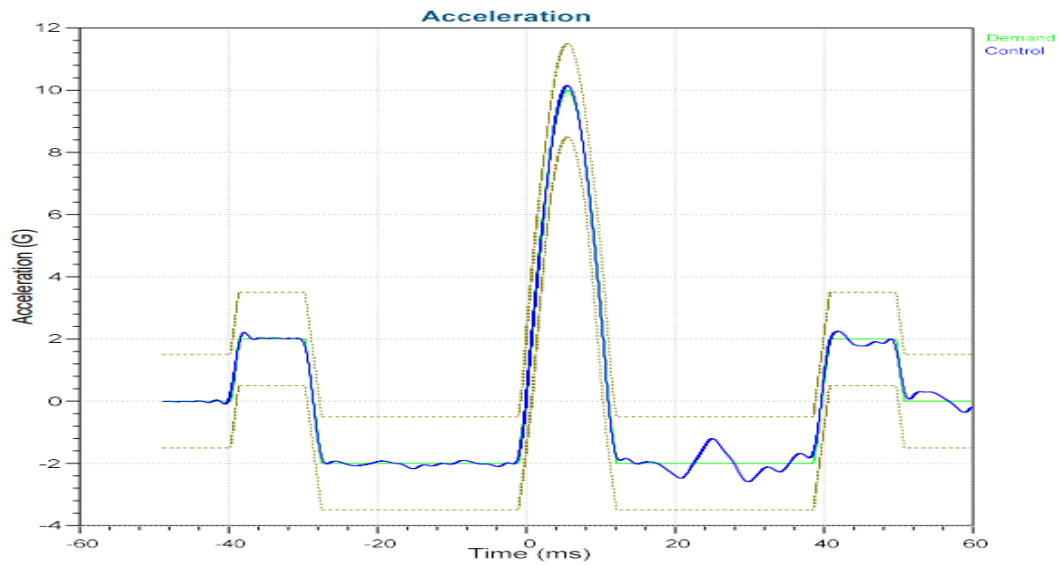
X+

Demand: 10 G

Control: 10.15 G

Pulse: 1 of 1

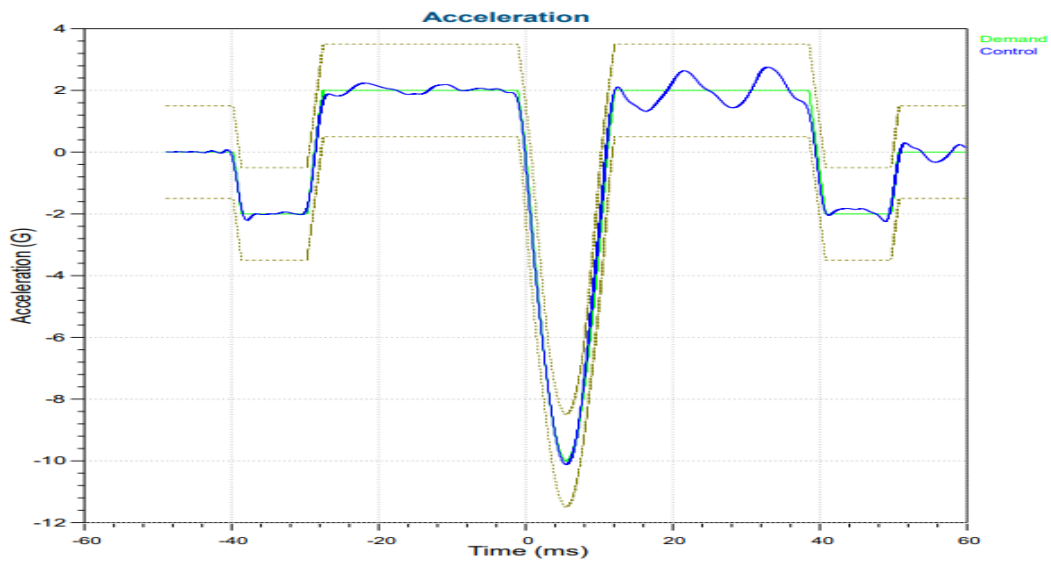
X-

Demand: 10 G

Control: 10.12 G

Pulse: 1 of 1

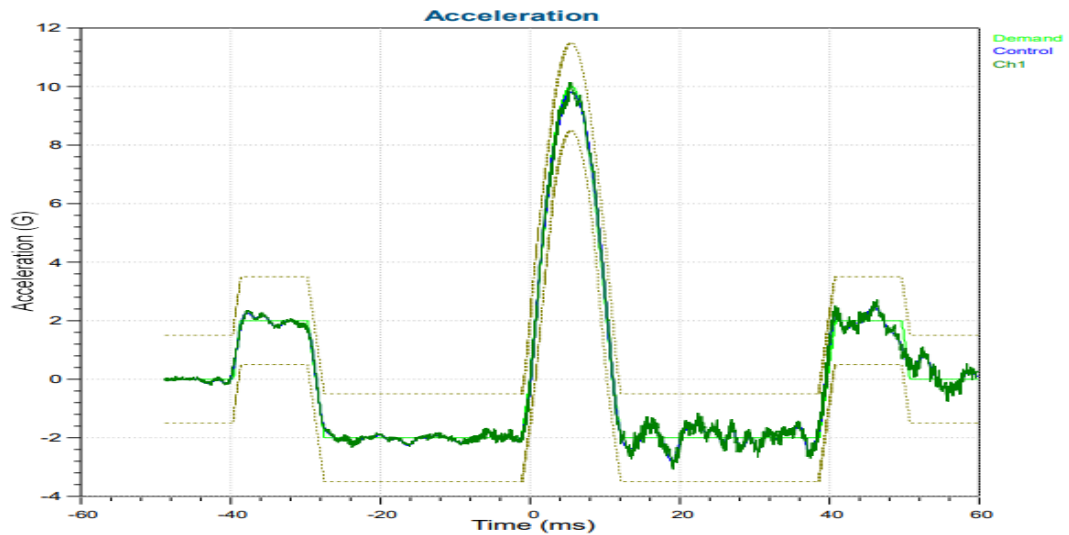
Z+

Demand: 10 G

Control: 9.811 G

Pulse: 1 of 1

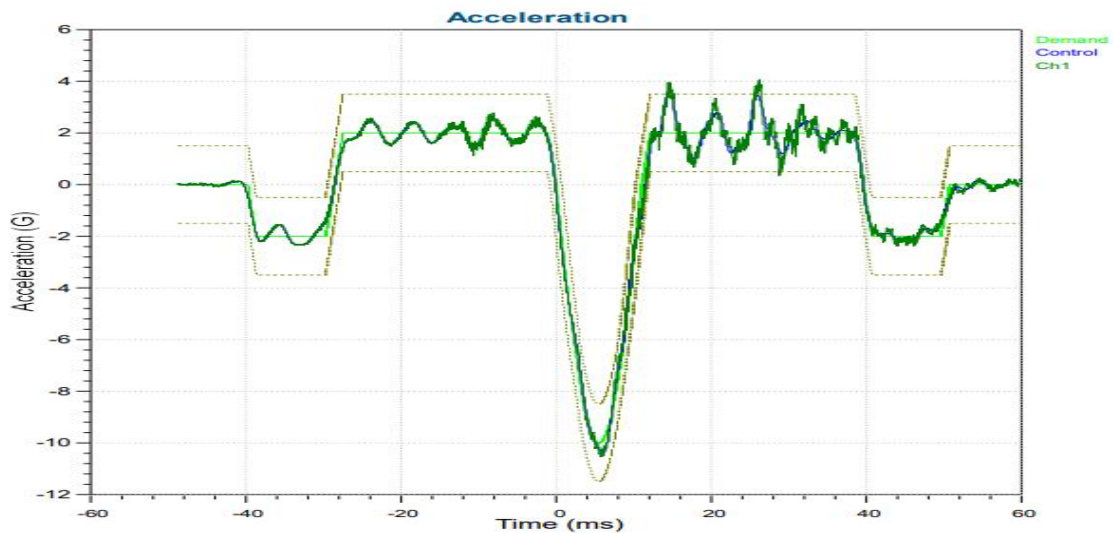
Z-

Demand: 10 G

Control: 10.38 G

Pulse: 1 of 1
