# TEST REPORT

REPORT No.:  
CTK-2025-02423  
Page (1) / (25) pages

NETWORK CAMERA / TNP-A7430RW

NEMA TS 2-2013 2.2.7.3 Test C ~ 2.2.7.8 Test H,  
NEMA TS 2.1.9, NEMA TS 2.1.10

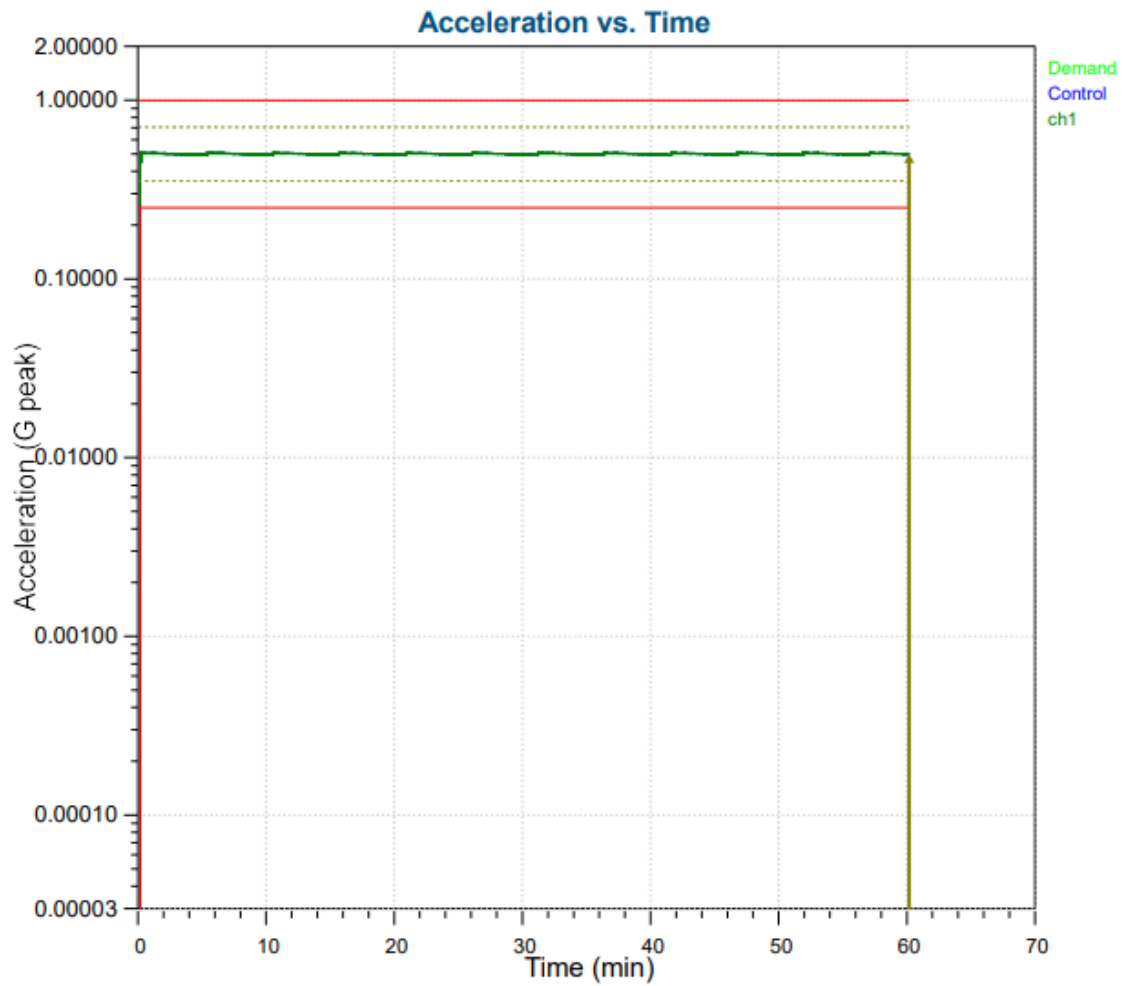
X axis

Demand: 0.5 G

Level Time: 1:00:00

Frequency: 30 Hz

Control: 0.001436 G

Total Time: 1:00:11

| Evaluation Criteria | | Test Results | Comment |
|---|---|---|---|
| Resonant search Test | Before | Normal | |
| | After | Normal | |
| Endurance Test | Before | Normal | |

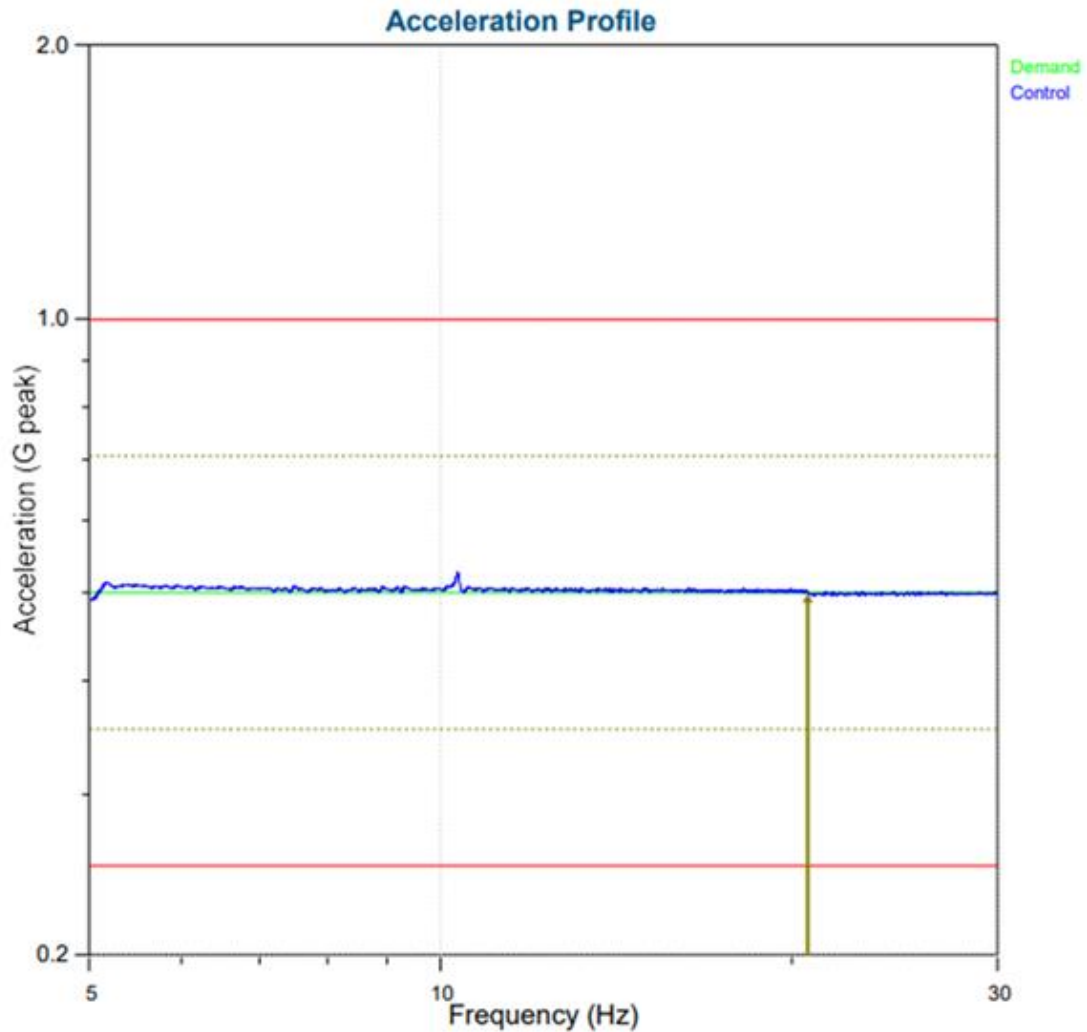
Y axis

8 18, 2025 15:32:46    Level 1) 100 %    Output: 0 Volts peak    NEMA-TS 2.1.9 진동

Demand: 0.5 G    Level Time: 1:00:00    Frequency: 30 Hz

Control: 0.0005356 G    Total Time: 1:00:11    End of Timed Test

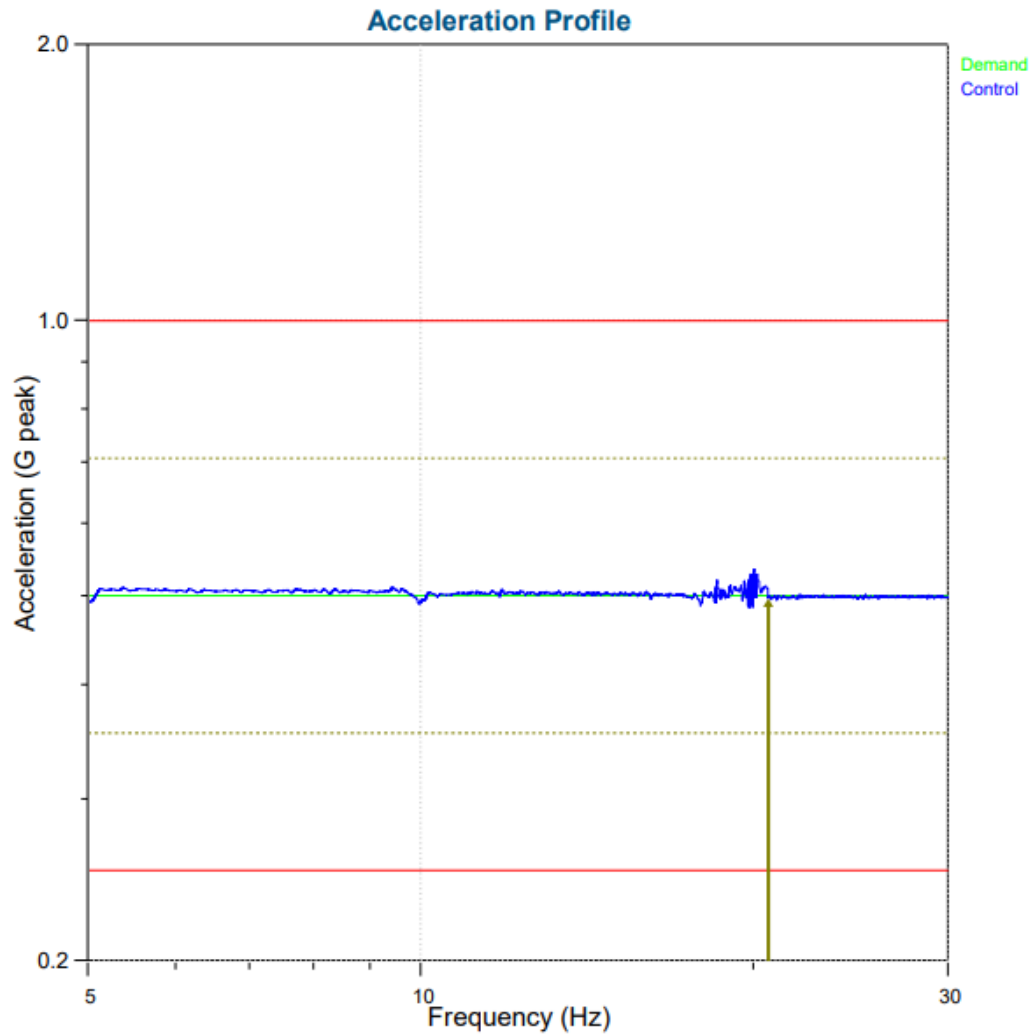
Z axis

Demand: 0.5 G

Level Time: 1:00:00

Frequency: 30 Hz

Control: 0.001128 G Total Time: 1:00:11

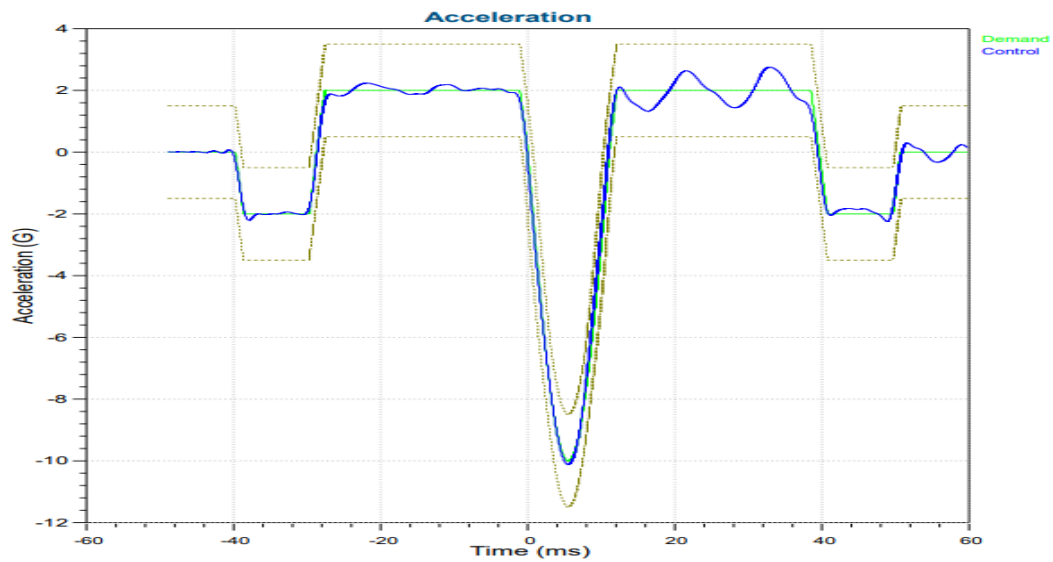
X-

8 18, 2025 13:19:54 Level 2) 100 % Output: 0.7443 Volts peak 2025-08-18 NEMA-TS 2.1.10

Demand: 10 G

Control: 10.12 G

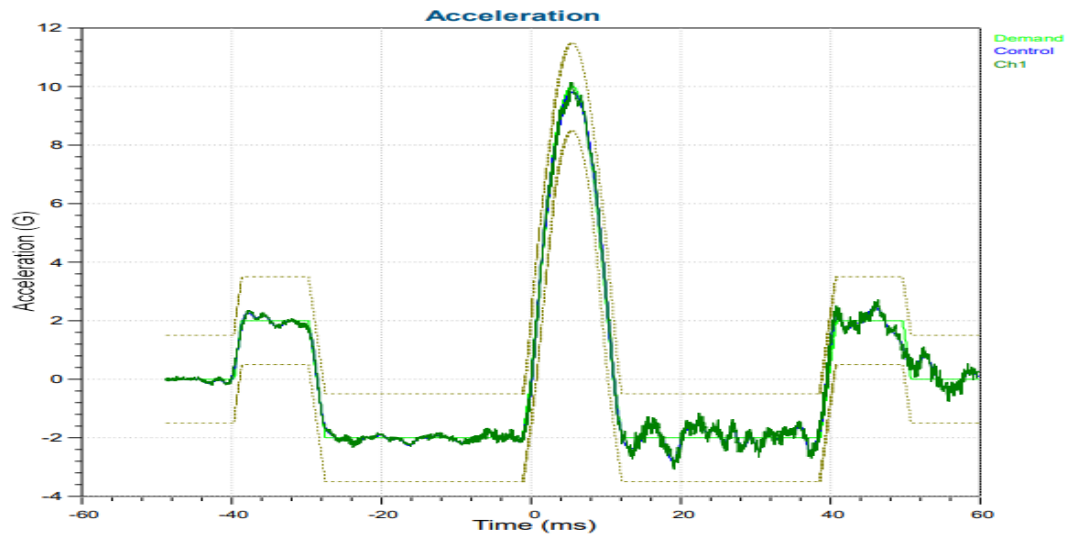
Z+

Output: 0.6949 Volts peak

Demand: 10 G

Control: 9.811 G

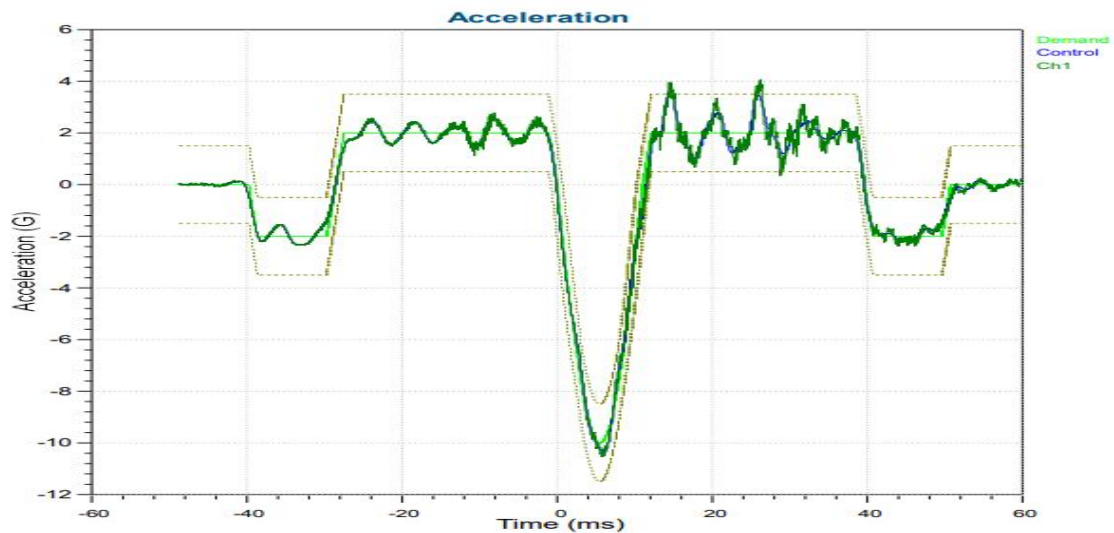
Z-

Output: 0.6793 Volts peak

Demand: 10 G

Control: 10.38 G
