# TEST REPORT

REPORT No.:  
CTK-2025-02422  
Page (1) / (20) pages

NETWORK CAMERA / TNP-A9430RW

NEMA TS 2.2.8, NEMA TS 2.2.9

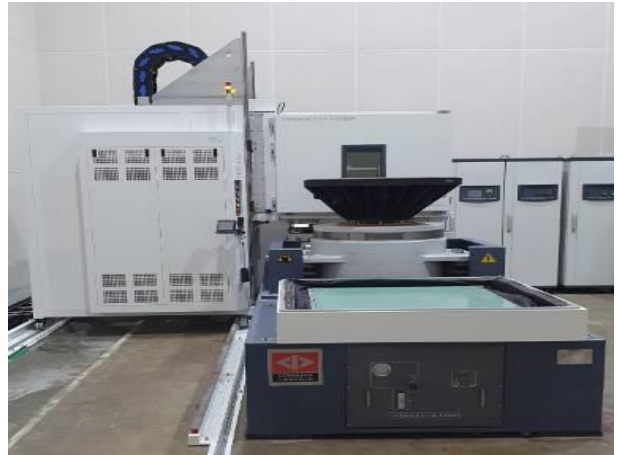
VIBRATION TESTING SYSTEM

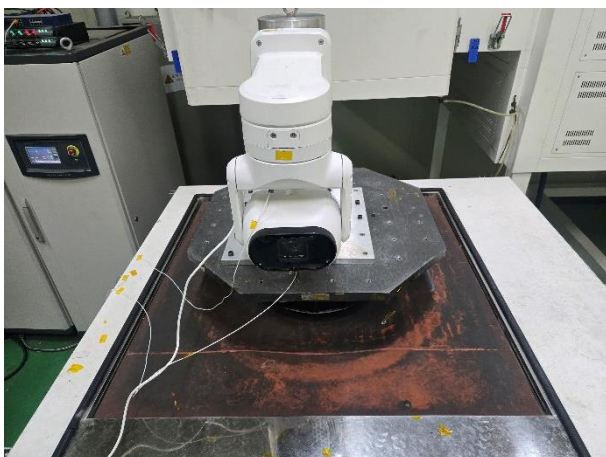
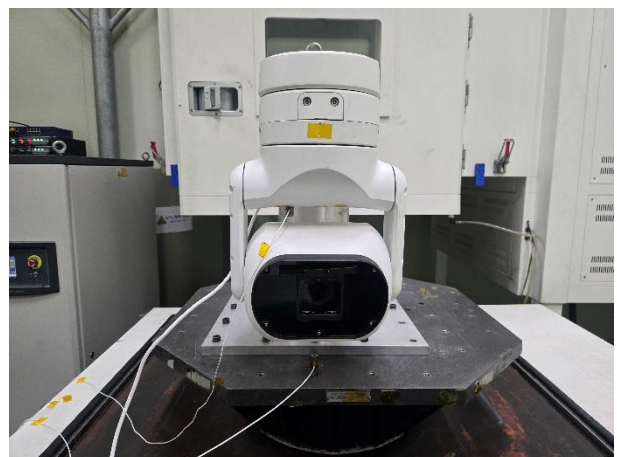
Z axis\_1

Z axis\_2

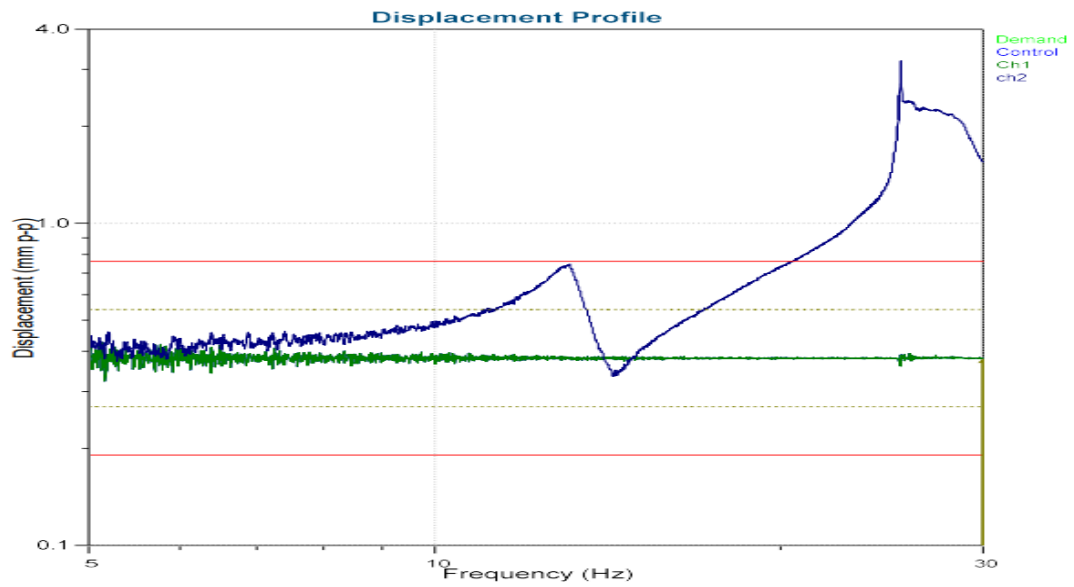
### Resonant search Test (Z Axis)

7 24, 2025 16:33:12 Level 1) 100 % Output: 0.06312 Volts peak NEMA-TS 2.2.8.3  
Demand: 0.381 mm Level Time: 0:12:30 Frequency: 30 Hz  
Control: 0.3803 mm Total Time: 0:12:37 End of Sweep Test

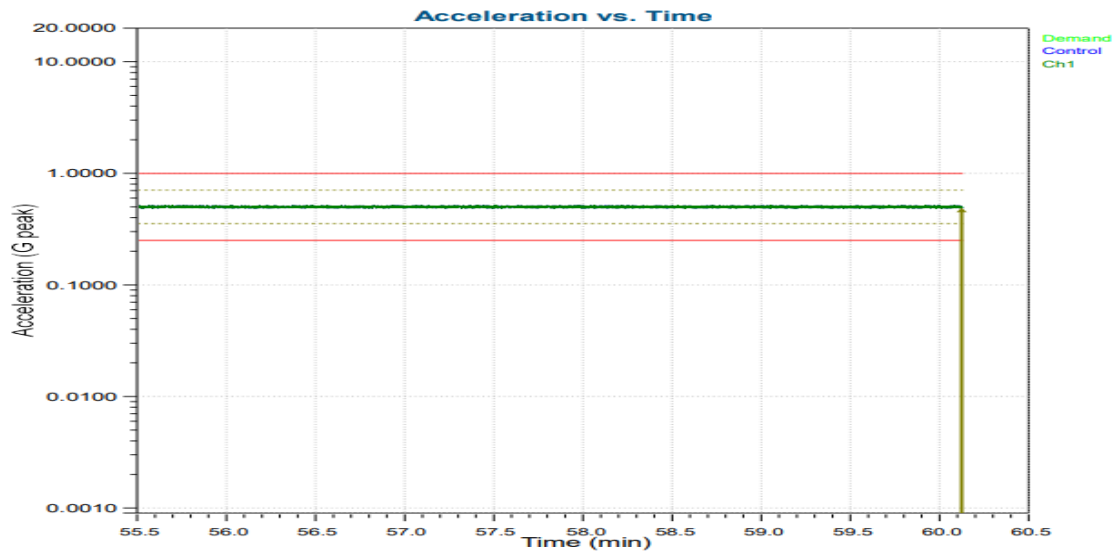
### Endurance Test (Z Axis)

7 24, 2025 17:38:27 Level 1) 100 % Output: 0.0707 Volts peak NEMA-TS 2.2.8.3.4  
Demand: 0.5 G Level Time: 1:00:00 Frequency: 25.46 Hz  
Control: 0.4909 G Total Time: 1:00:07 End of Timed Test

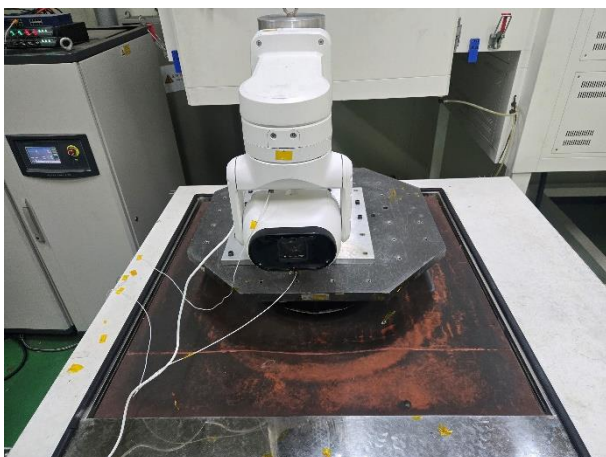
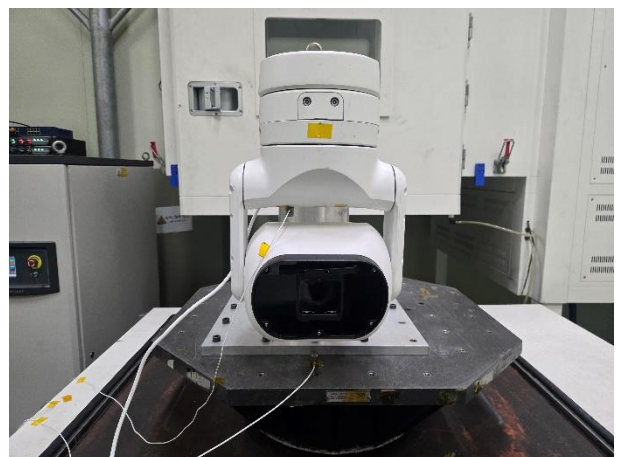
Z axis\_1

Z axis\_2

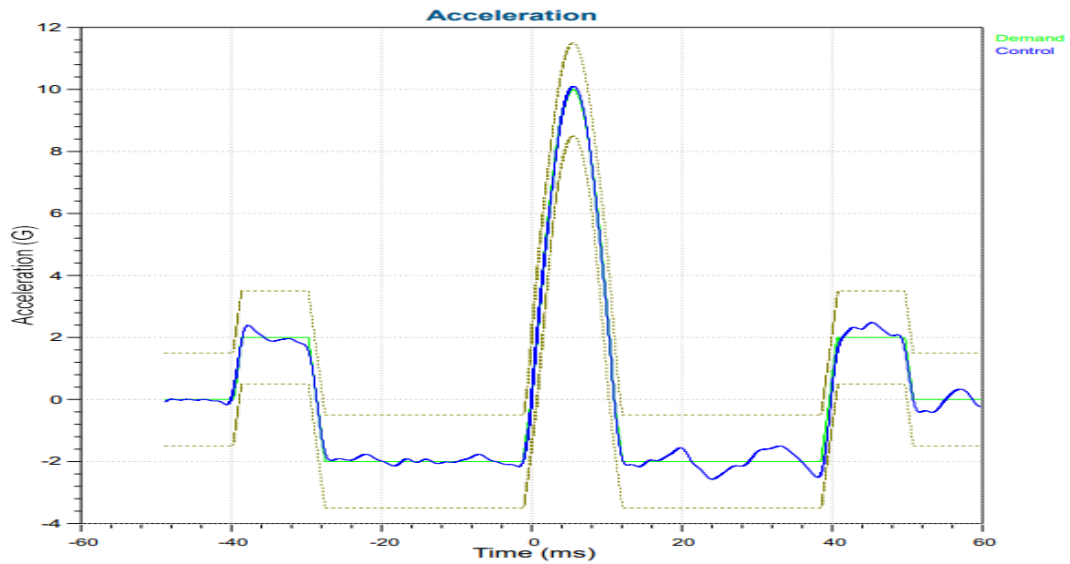
X+

7 24, 2025 10:27:34 Level 1) 100 % Output: 0.7656 Volts peak 2025-05-02 NEMA TS-2 2.2.5  
Demand: 10 G  
Control: 10.1 G Pulse: 1 of 1 Running

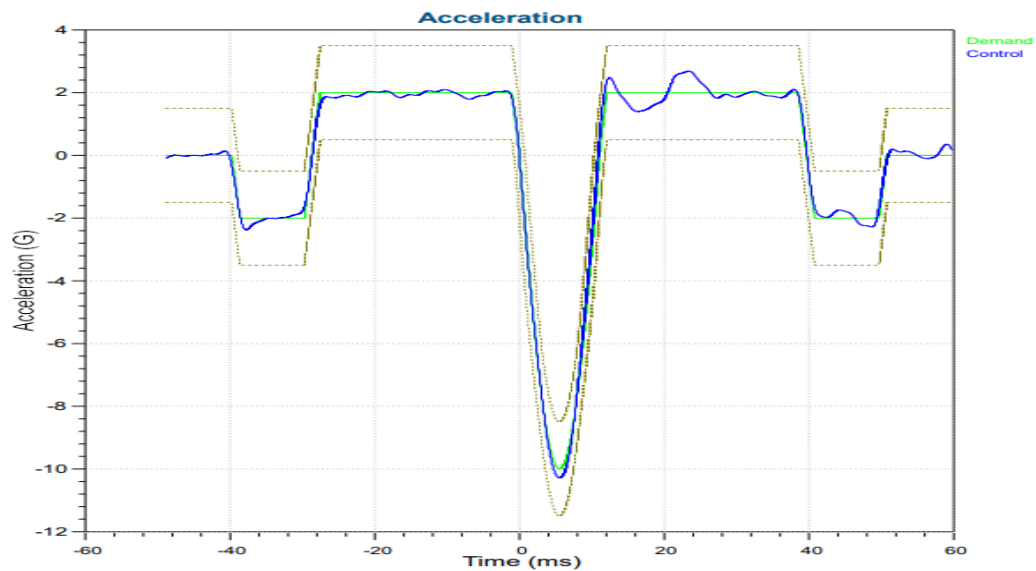
X-

7 24, 2025 10:28:04 Level 2) 100 % Output: 0.7629 Volts peak 2025-05-02 NEMA TS-2 2.2.5  
Demand: 10 G  
Control: 10.28 G Pulse: 1 of 1 End of Test

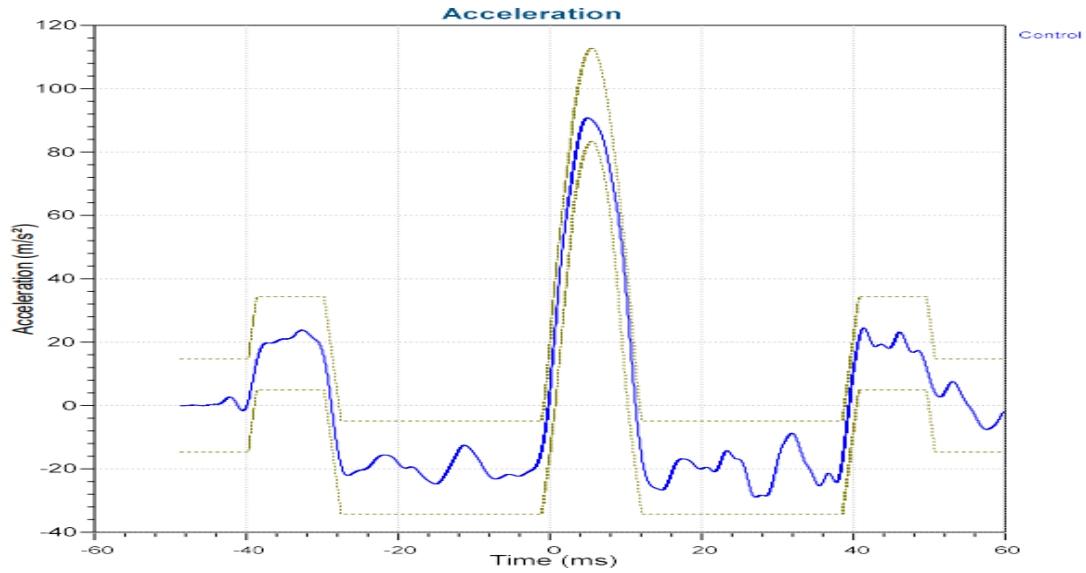
Y+

7 31, 2025 14:37:42 Level 1) 100 % Output: 0.743 Volts peak NEMA-TS 2.2.9

Demand: 98.07  $m/s^2$

Control: 90.82  $m/s^2$  Pulse: 1 of 1 Running

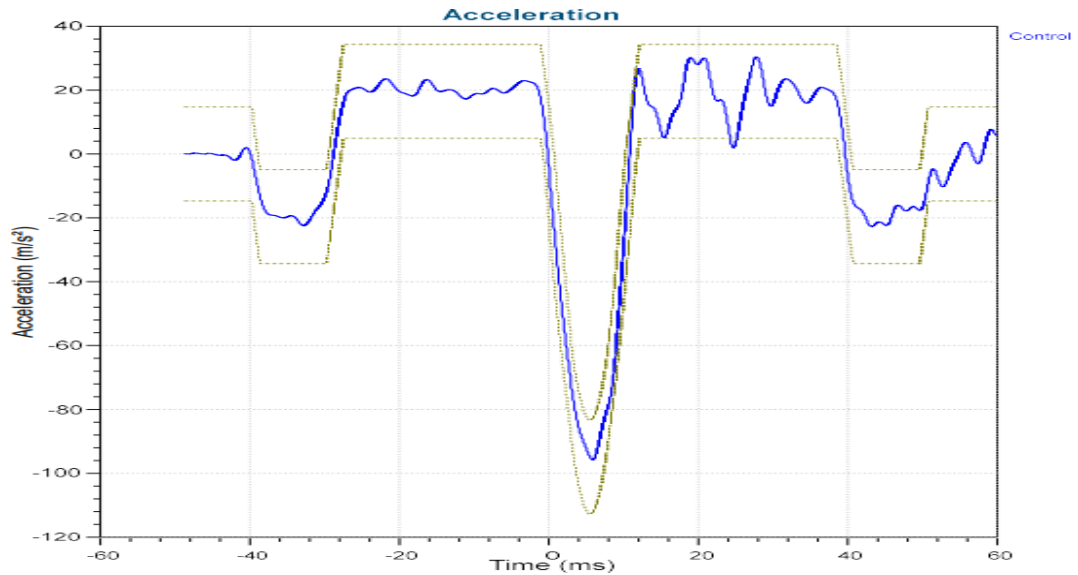
Y-

7 31, 2025 14:37:54 Level 2) 100 % Output: 0.7652 Volts peak NEMA-TS 2.2.9

Demand: 98.07  $m/s^2$

Control: 95.84  $m/s^2$  Pulse: 1 of 1 End of Test

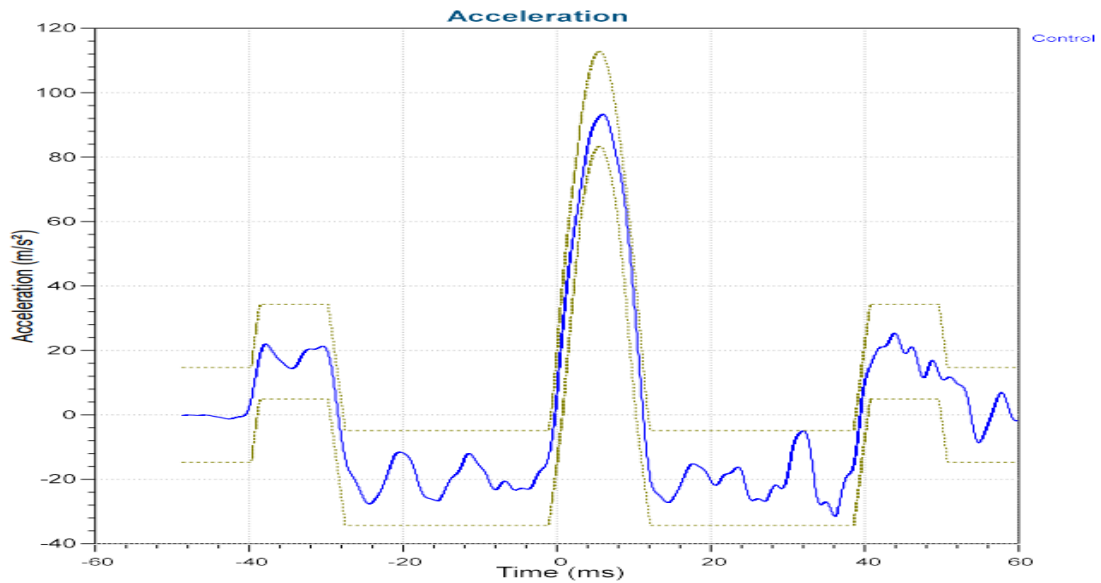
Z+

7 31, 2025 11:20:56 Level 1) 100 % Output: 0.7576 Volts peak NEMA-TS 2.2.9

Demand: 98.07  $m/s^2$

Control: 93.3  $m/s^2$  Pulse: 1 of 1 Running

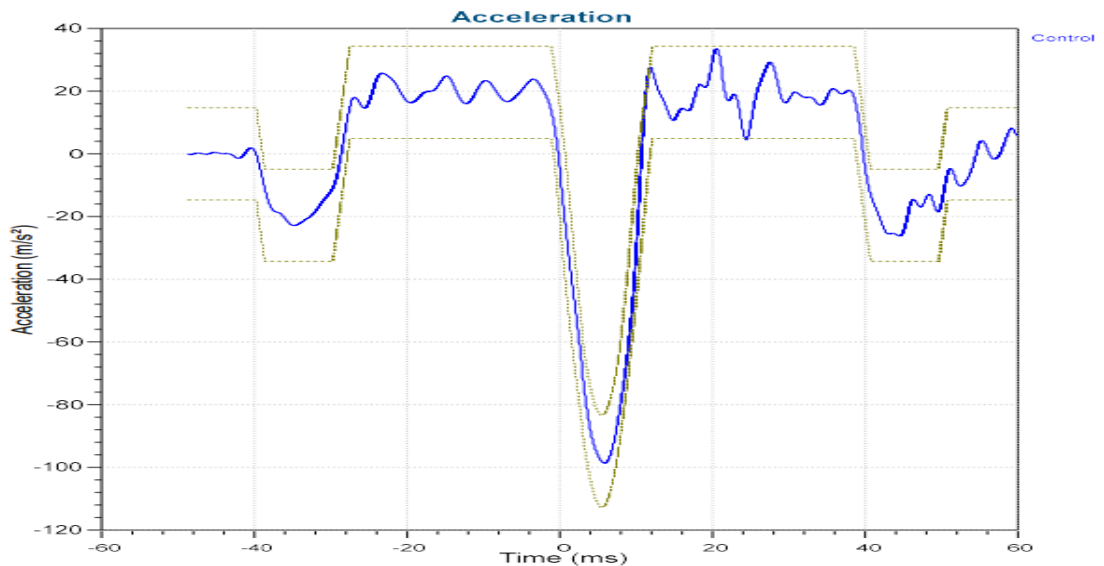
Z-

7 31, 2025 11:21:32 Level 2) 100 % Output: 0.7531 Volts peak NEMA-TS 2.2.9

Demand: 98.07  $m/s^2$

Control: 98.68  $m/s^2$  Pulse: 1 of 1 End of Test
