# TEST REPORT

REPORT No.:  
CTK-2025-02421  
Page (1) / (24) pages

NETWORK CAMERA / TNP-A9430RW

NEMA TS 2-2013 2.2.7.3 Test C ~ 2.2.7.8 Test H,  
NEMA TS 2.1.9, NEMA TS 2.1.10

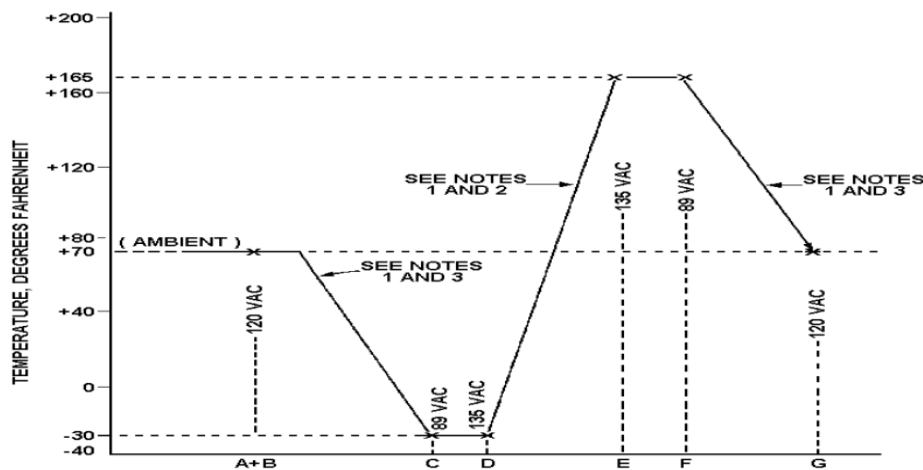
#### 3.2.7 Test Methods

- 3.2.1 2.2.7.3 Test C: - 34 °C, 89 Vac, 10 h (Check interim operation after 5 h and operation check after 10h)
- 3.2.2 2.2.7.4 Test D: - 34 °C, 135 Vac, 1 h (Operating state)
- 3.2.3 2.2.7.5 Test E: 74 °C, 18 %, 135 Vac, 15 h (Operating state)
- 3.2.4 2.2.7.6 Test F: 74 °C, 18 %, 89 Vac (Operation check after 2.2.7.5 Test E)
- 3.2.5 2.2.7.7 Test G: (21 ±6) °C, 120 Vac (Operating state)
- 3.2.6 2.2.7.8 Test H: Check for mechanical damage

- Evaluations Criteria :
  - Check for mechanical damage before and after testing
- Test methods

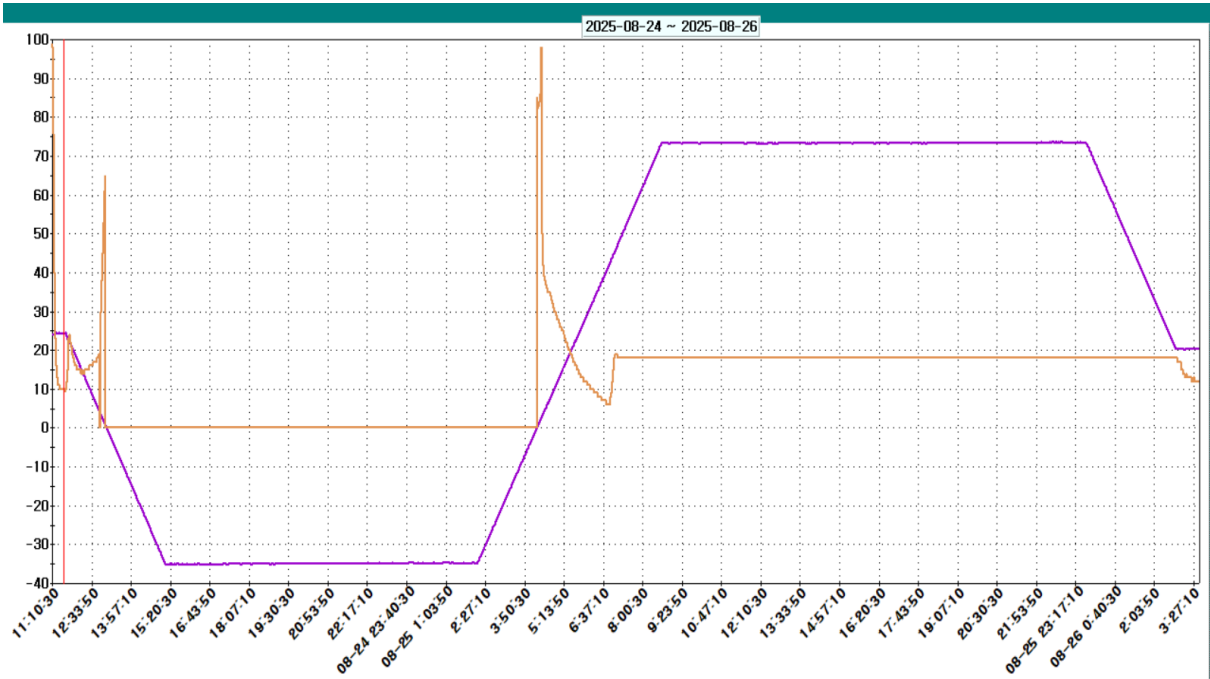
Temperature Data

#### 3.5.1 Test data and graph

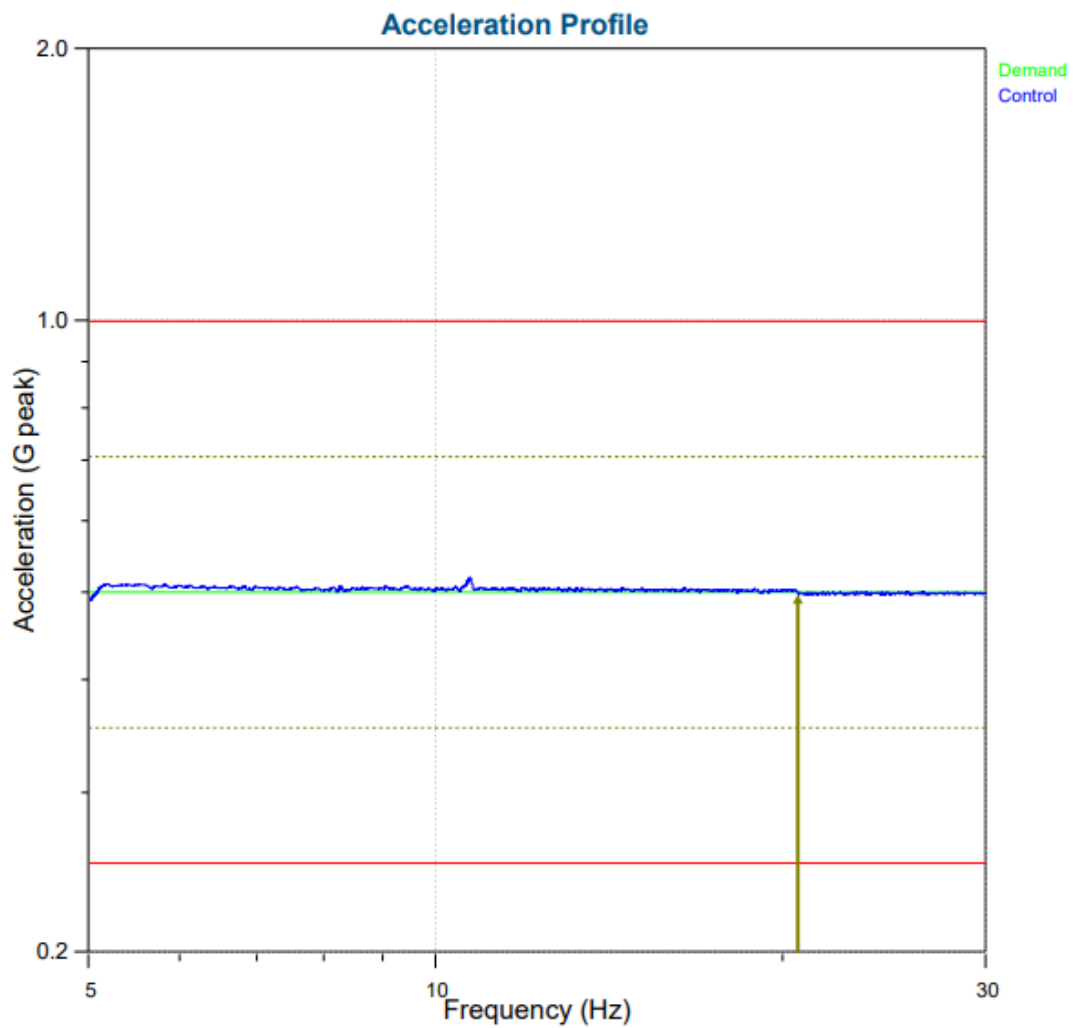
#### 4.5.1 Test Data X Axis

8 18, 2025 16:46:21    Level 1) 100 %    Output: 0.07373 Volts peak    NEMA-TS 2.1.9 진동

Demand: 0.5 G    Level Time: 1:00:00    Frequency: 30 Hz

Control: 0.4969 G    Total Time: 1:00:11    End of Timed Test

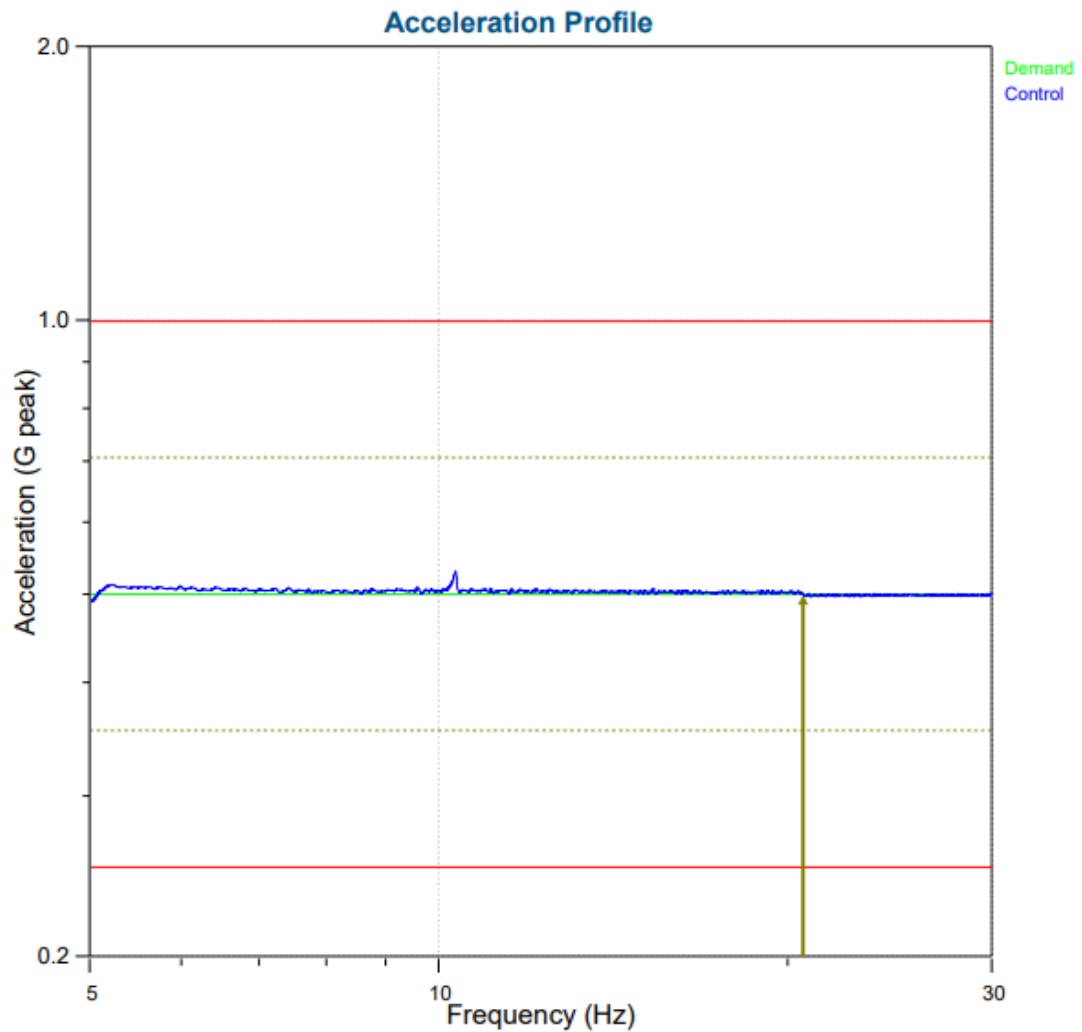
### 4.5.2 Test Data Y Axis

8 18, 2025 17:51:51    Level 1) 100 %    Output: 0 Volts peak    NEMA-TS 2.1.9 진동

Demand: 0.5 G    Level Time: 1:00:00    Frequency: 30Hz

Control: 0.001208 G    Total Time: 1:00:11    End of Timed Test

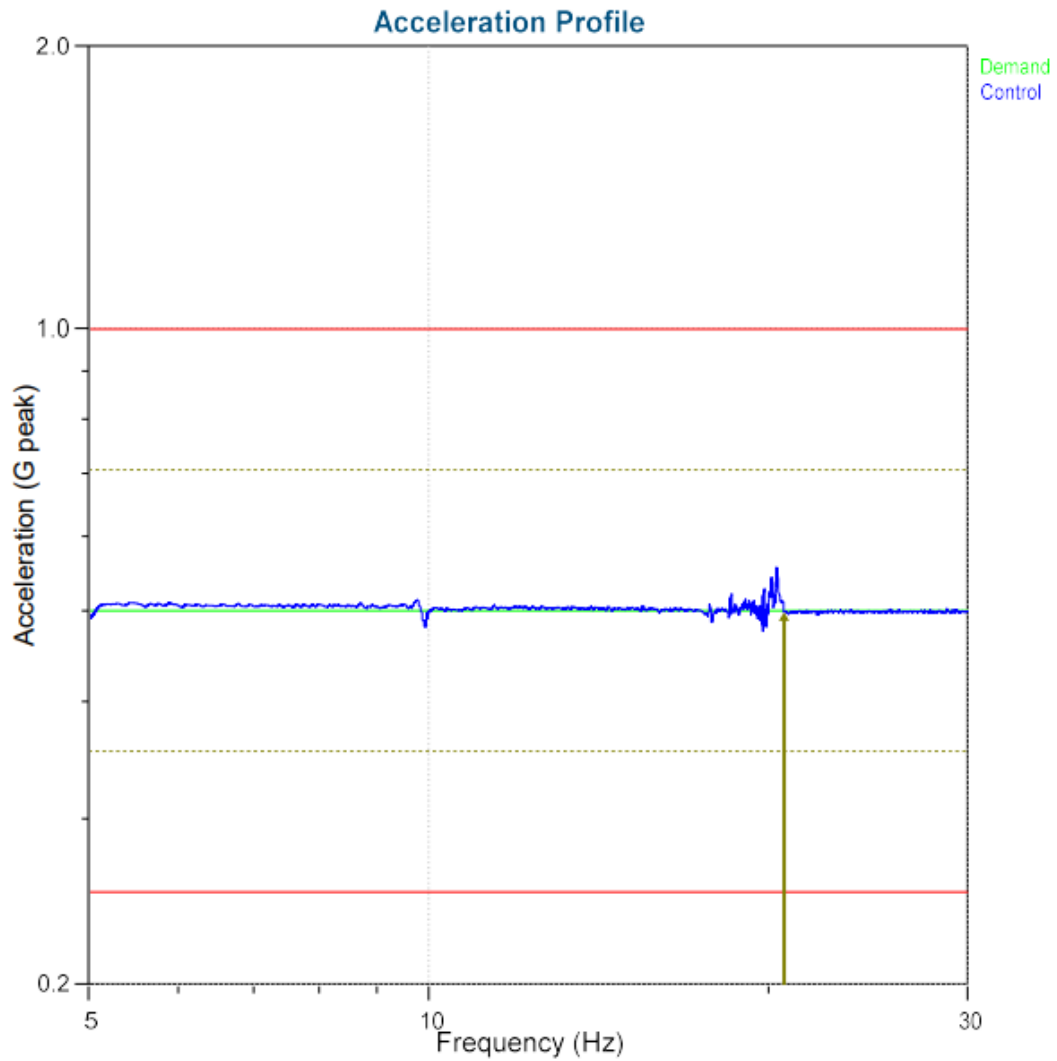
### 4.5.3 Test Data Z Axis

8 19, 2025 15:29:29 Level 1) 100 %

Output: 0 Volts peak

Demand: 0.5 G

Level Time: 1:00:00

Frequency: 30 Hz

Control: 0.0008126 G Total Time: 1:00:11

End of Timed Test

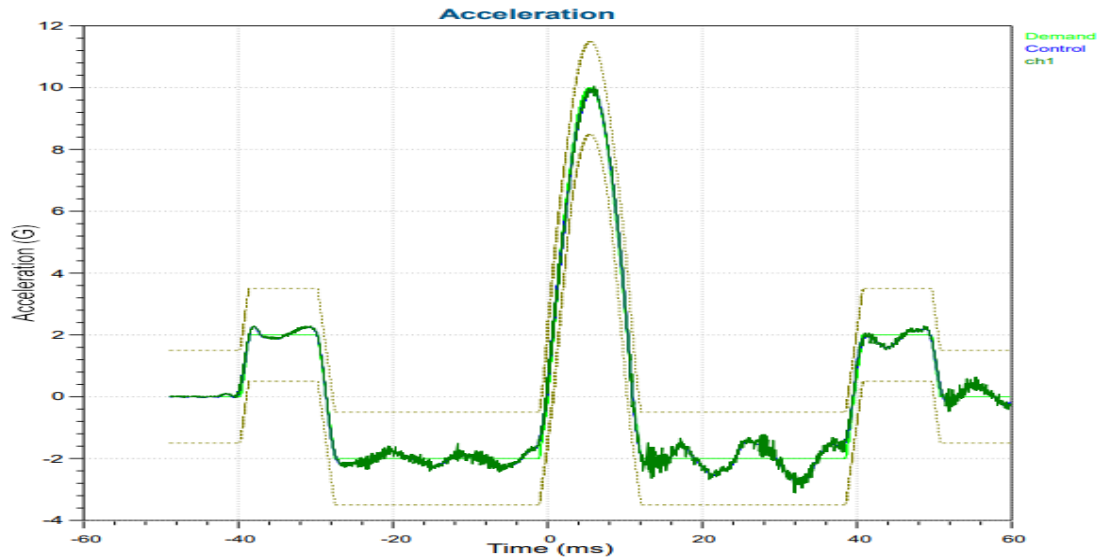
X+

8 18, 2025 16:47:04 Level 1) 100 % Output: 0.7565 Volts peak 한 화비전 NEMA-TS 2.1.  
Demand: 10 G  
Control: 9.933 G Pulse: 1 of 1 Running

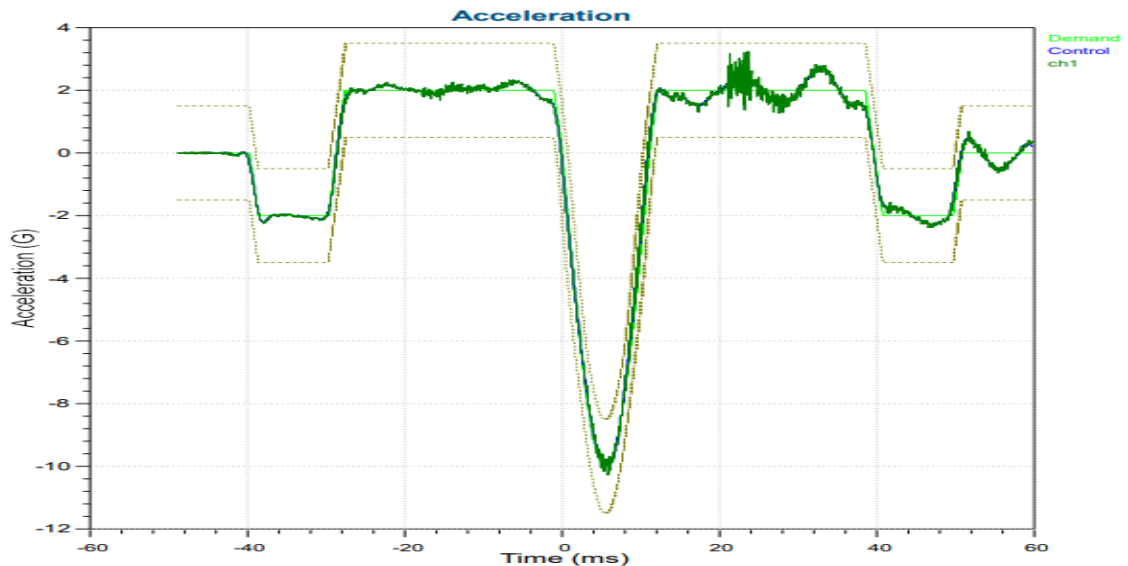
X-

8 18, 2025 16:47:12 Level 2) 100 % Output: 0.7558 Volts peak 한 화비전 NEMA-TS 2.1.  
Demand: 10 G  
Control: 9.95 G Pulse: 1 of 1 End of Test

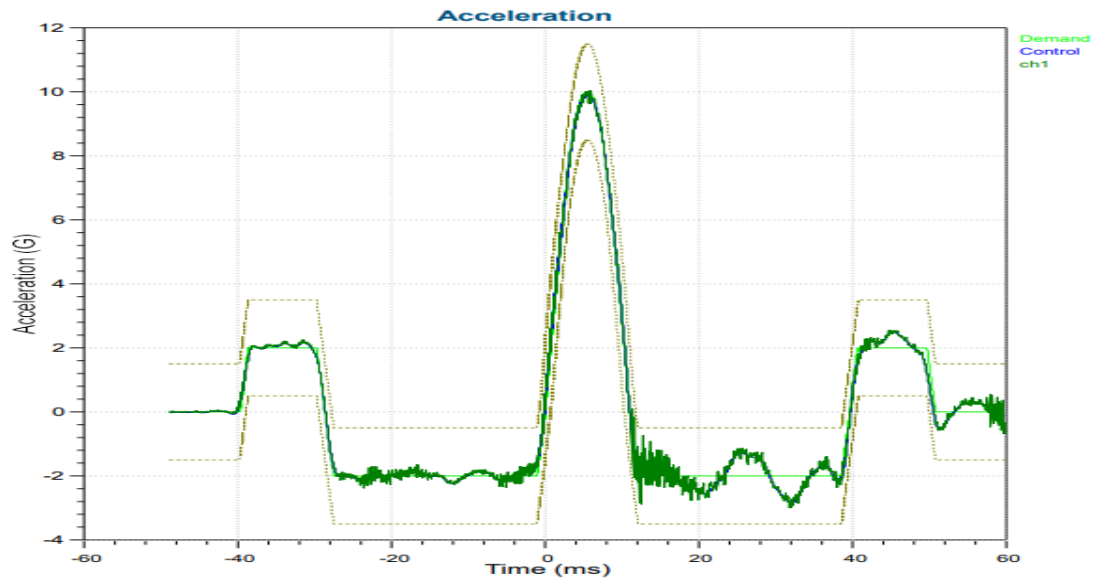
Y+

8 18, 2025 17:50:01 Level 1) 100 % Output: 0.7647 Volts peak 한화비전 NEMA-TS 2.1.  
Demand: 10 G  
Control: 9.881 G Pulse: 1 of 1 Running

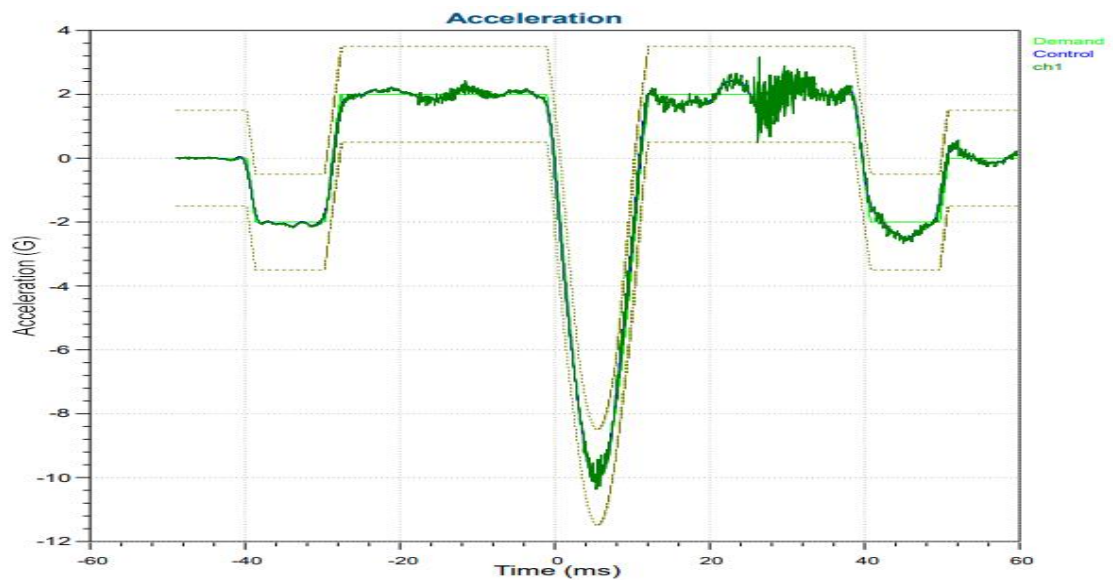
Y-

8 18, 2025 17:50:20 Level 2) 100 % Output: 0.7662 Volts peak 한화비전 NEMA-TS 2.1.  
Demand: 10 G  
Control: 9.973 G Pulse: 1 of 1 End of Test

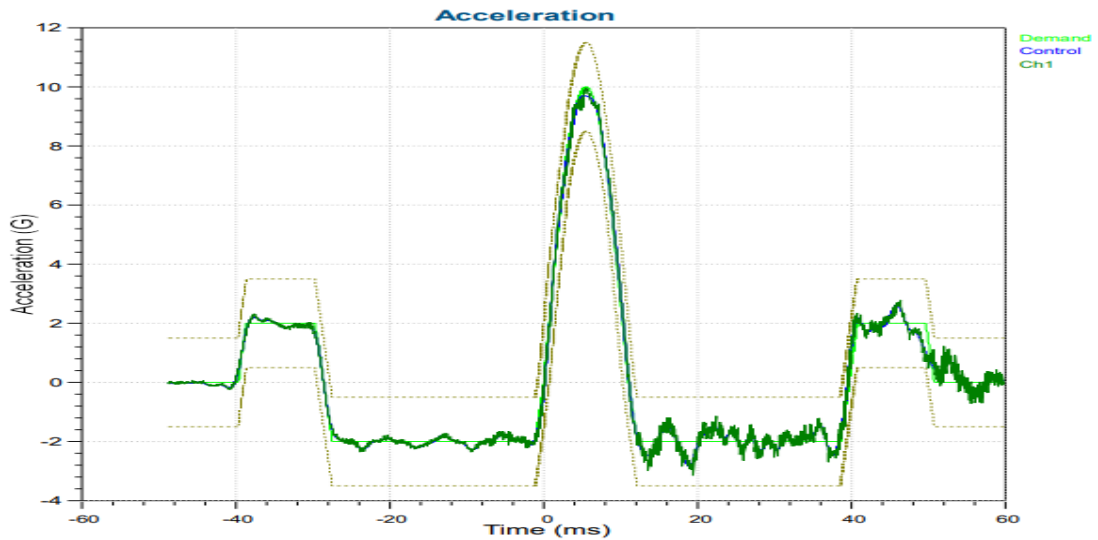
Z+

8 19, 2025 15:30:05 Level 1) 100 %

Output: 0.6868 Volts peak

Demand: 10 G

Control: 9.7 G

Pulse: 1 of 1

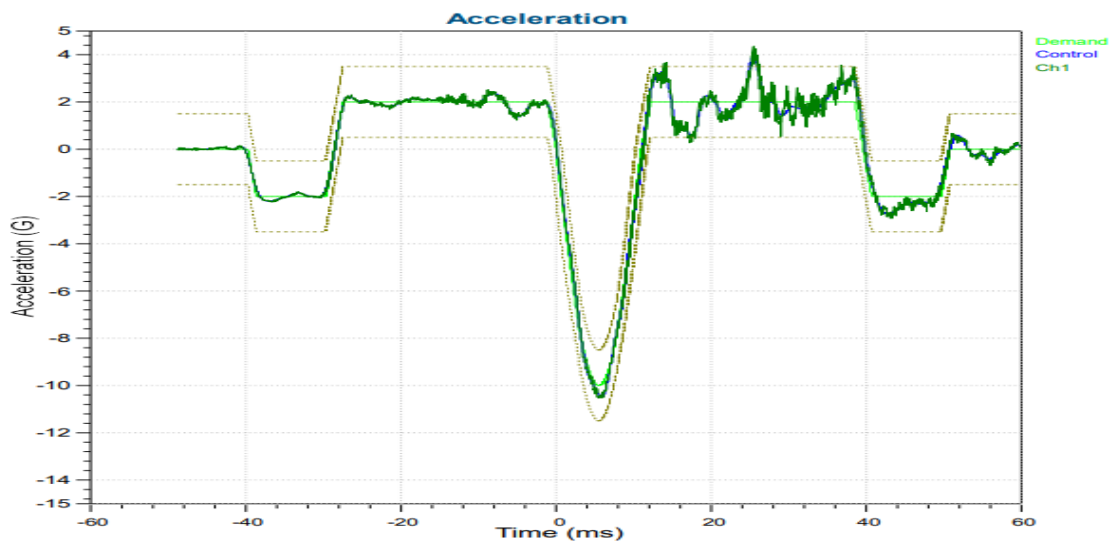
Z-

8 19, 2025 15:30:11 Level 2) 100 %

Output: 0.6854 Volts peak

Demand: 10 G

Control: 10.47 G

Pulse: 1 of 1
