# TEST REPORT

REPORT No.:  
CTK-2025-01511  
Page (1) / (27) pages

BARCODE READER / TNS-7000M

EN 60068-2-6, EN 60068-2-27, IEC 60068-2-6, IEC 60068-2-27

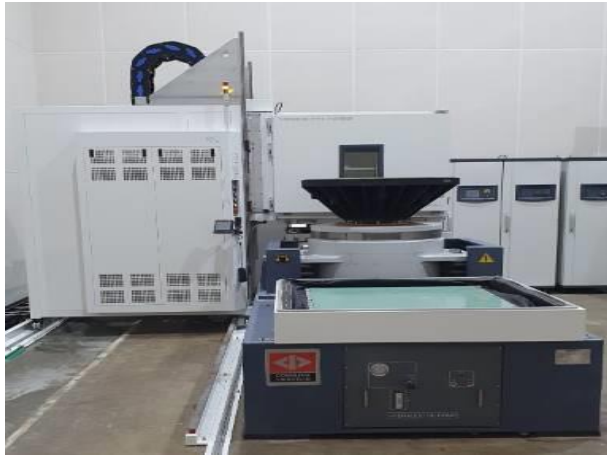
VIBRATION TESTING SYSTEM

| Testing equipment | Model Name | Manufacturer | Manufacturing Number | Calibration Date |
|---|---|---|---|---|
| VIBRATION TESTING SYSTEM | LT1010 | FAMTECH | D2012335 | N/A |

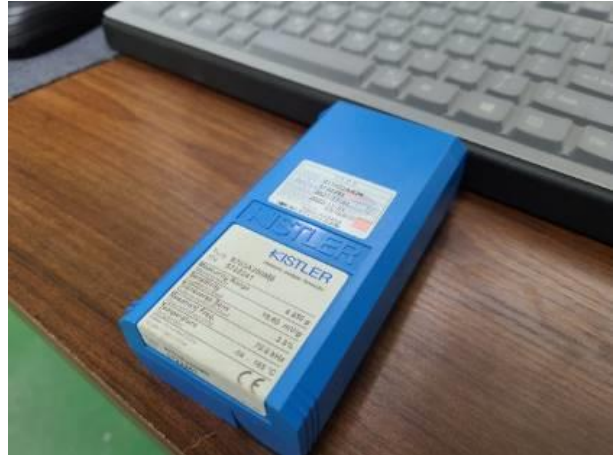
8703A250M5

| Testing equipment | Model Name | Manufacturer | Manufacturing Number | Calibration Date |
|---|---|---|---|---|
| Acceleration sensor | 8703A250M5 | KISTLER | 5830236 | Jan. 16, 2026 |

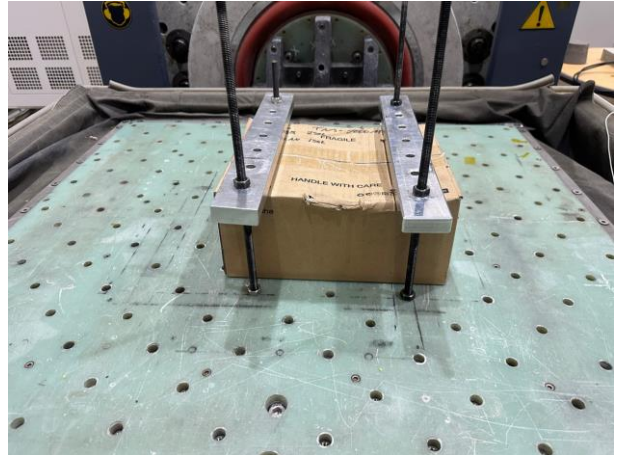
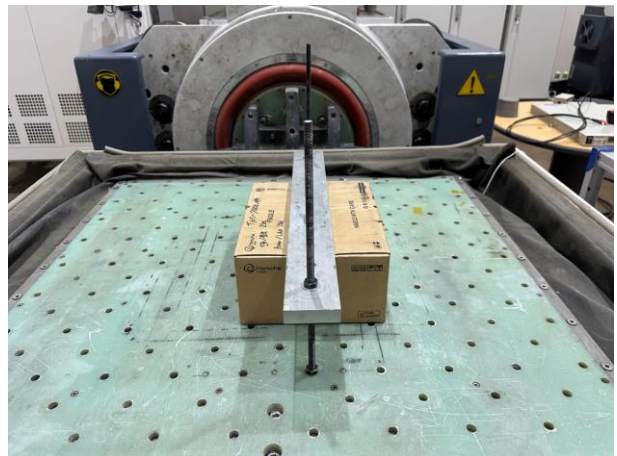
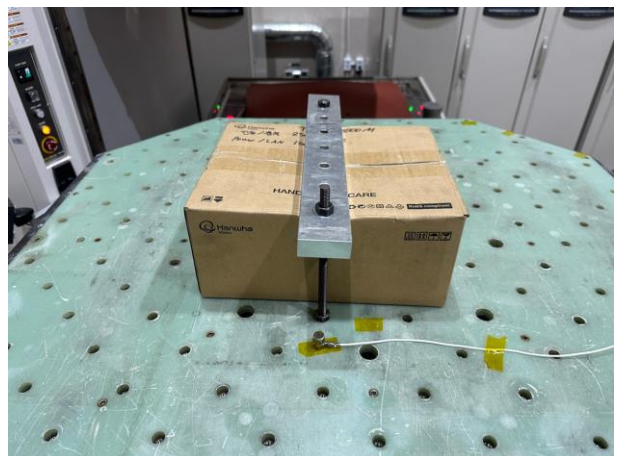
#### 3.3.1 Evidence of test setting

3.2.1 Sample status: Full packaging

3.2.2 Acceleration: 2 G

3.2.3 Test Axis: X, Y, Z

3.2.4 Test time: each axis 1 hours

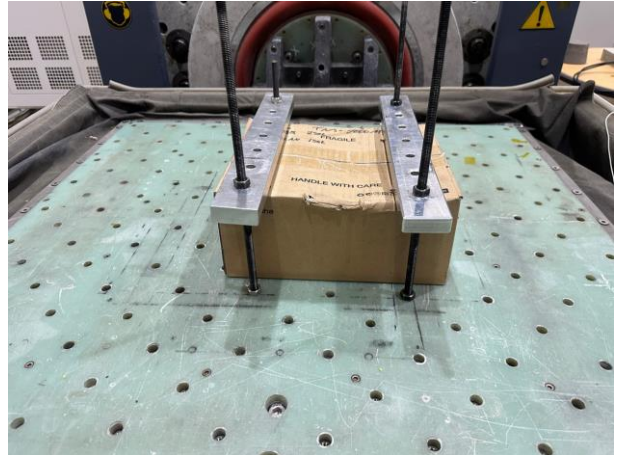
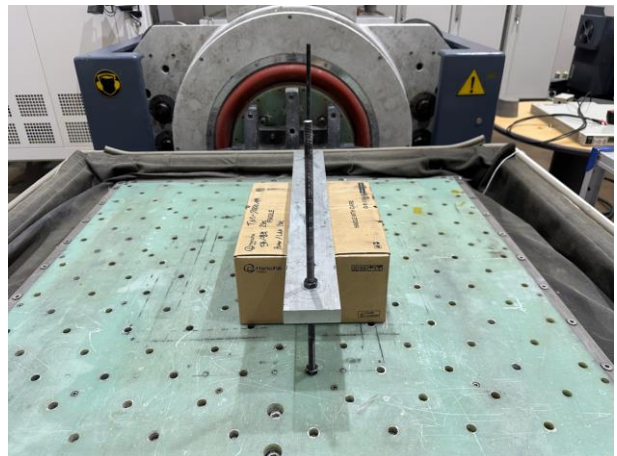
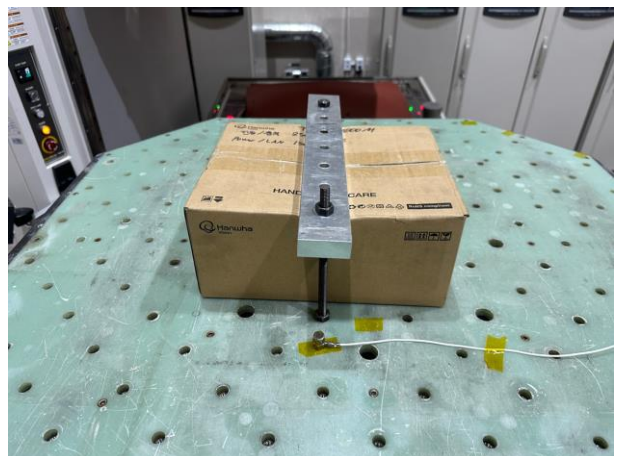
#### 4.3.1 Evidence of test setting

4.2.1 Sample status: Full packaging

4.2.2 Applied waveform: Half sine

4.2.3 Acceleration: 80 G

4.2.4 Amplitude: 11 ms

4.2.5 Test Axis: X, Y, Z

4.2.6 Test time: Total 24 Cycles (4 cycles per axis)
