# TEST REPORT

## 4. Test sample / Model : Network Positioning Camera / TNU-6321

## 7. Test Standard (Method) used : KS C IEC 62262: 2005

## 1. Degrees of protection provided by enclosures for electrical equipment against external mechanical impacts (IK code)

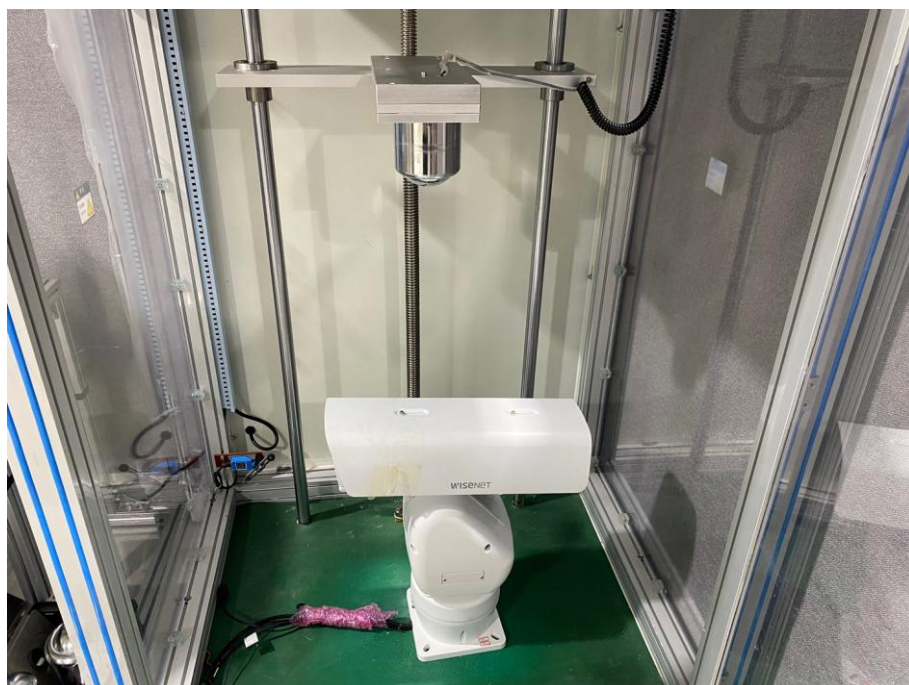
## 2.2. Test photos

| IK code | Impact Energy (J) | Equivalent mass (kg) | Drop height (mm ± 1%) | Application |
|---|---|---|---|---|
| 10 | 20.00 | 5.00 | 400 | <input checked="" type="checkbox"/> |
| - Impact times: five times for each of the exposed surface. (Do not impact more than 3 times in the same spot) | | | | |

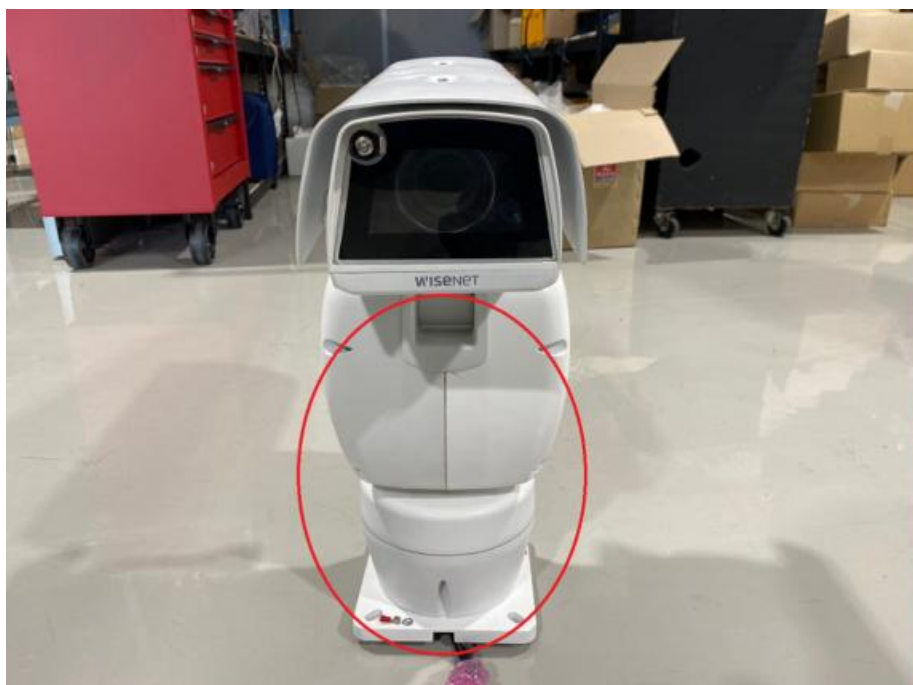
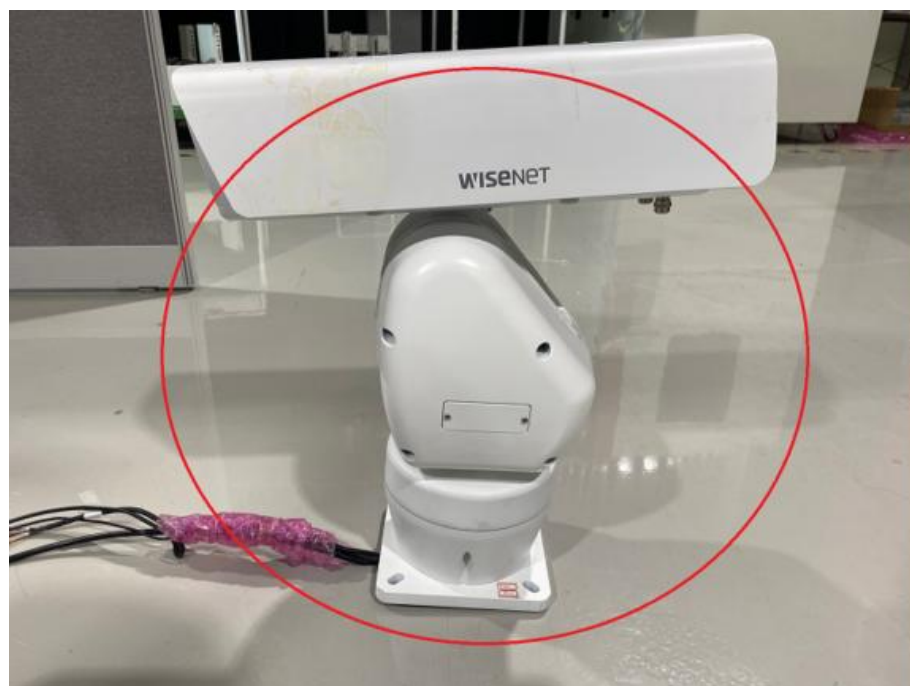
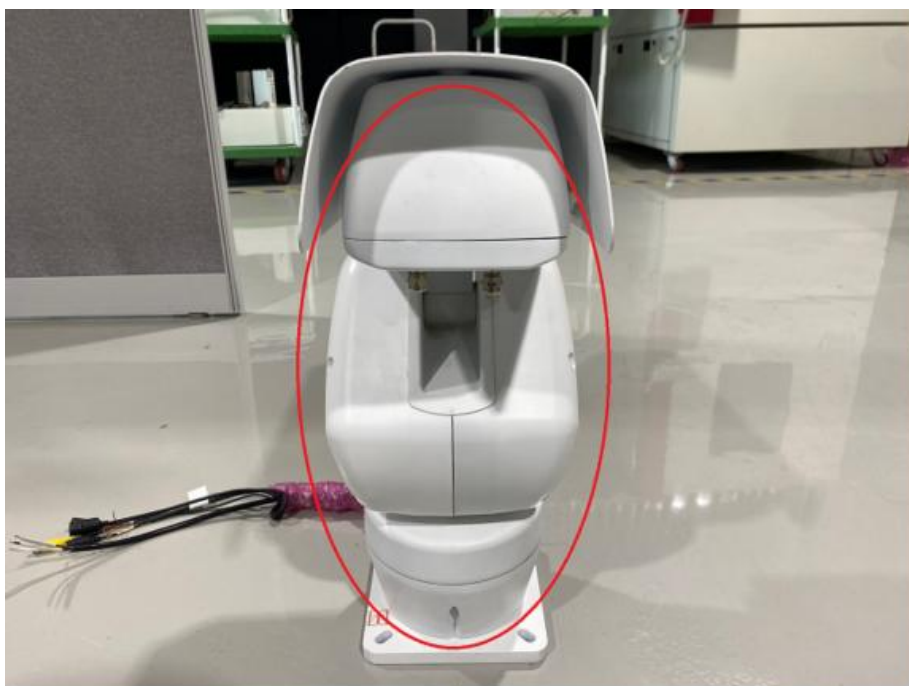
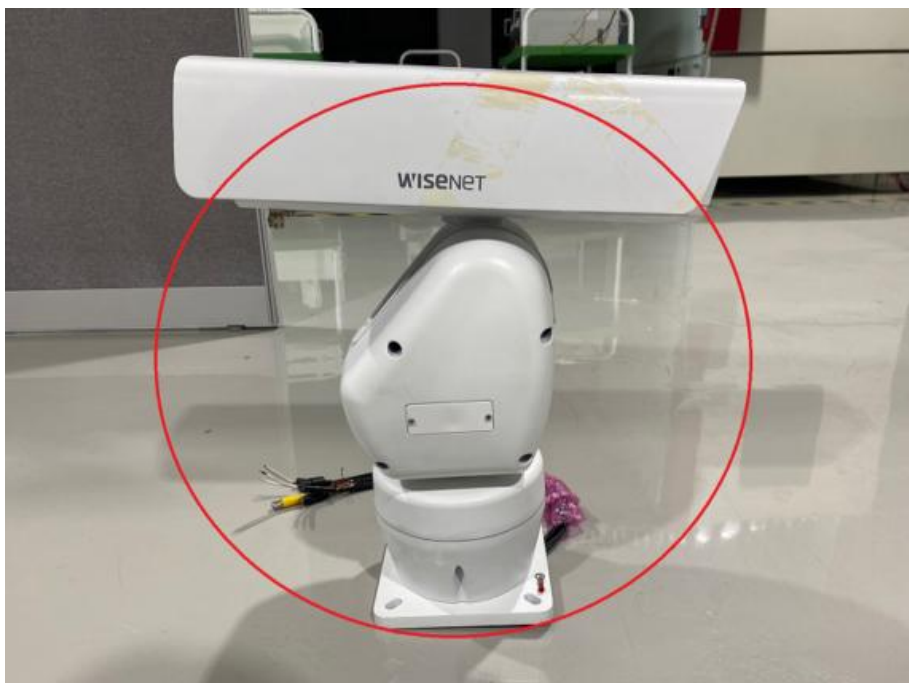
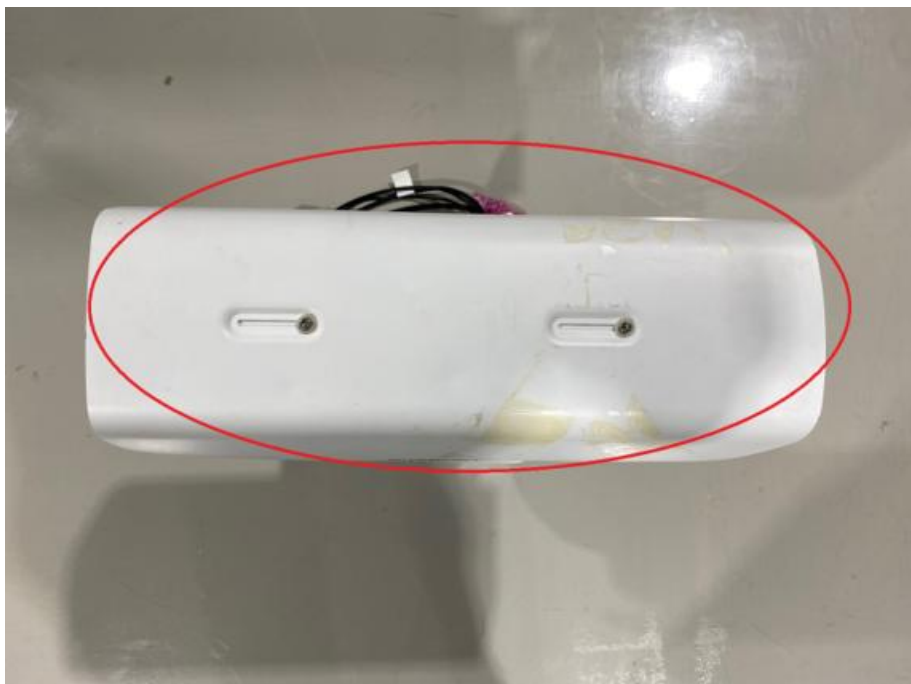
### 2.3. Photos after test

| Item | Contents | Result |
|---|---|---|
| External protection Enclosure | No damage | Pass |
| Comment<br><br>- Some scratches were generated on the outside of the product.<br>- Excluding windshield and wiper parts testing | | |
