# TEST REPORT

REPORT No.:  
CTK-2025-02983  
Page (1) / (38) pages

REMOTE HEAD CAMERA / XNB-A8004B

EN 60068-2-1, EN 60068-2-2, EN 60068-2-14, EN 60068-2-6, EN 60068-2-27, EN 60068-2-78, IEC 60068-2-1, IEC 60068-2-2, IEC 60068-2-14, IEC 60068-2-6, IEC 60068-2-27, IEC 60068-2-78

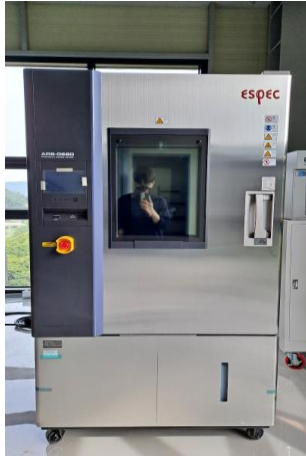
Temperature & Humidity Chamber

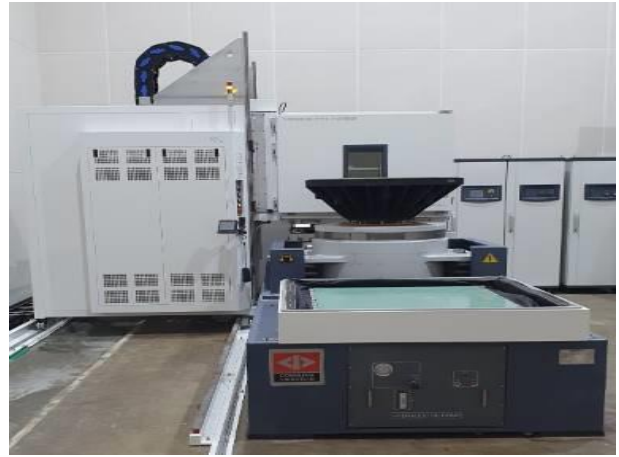
VIBRATION TESTING SYSTEM

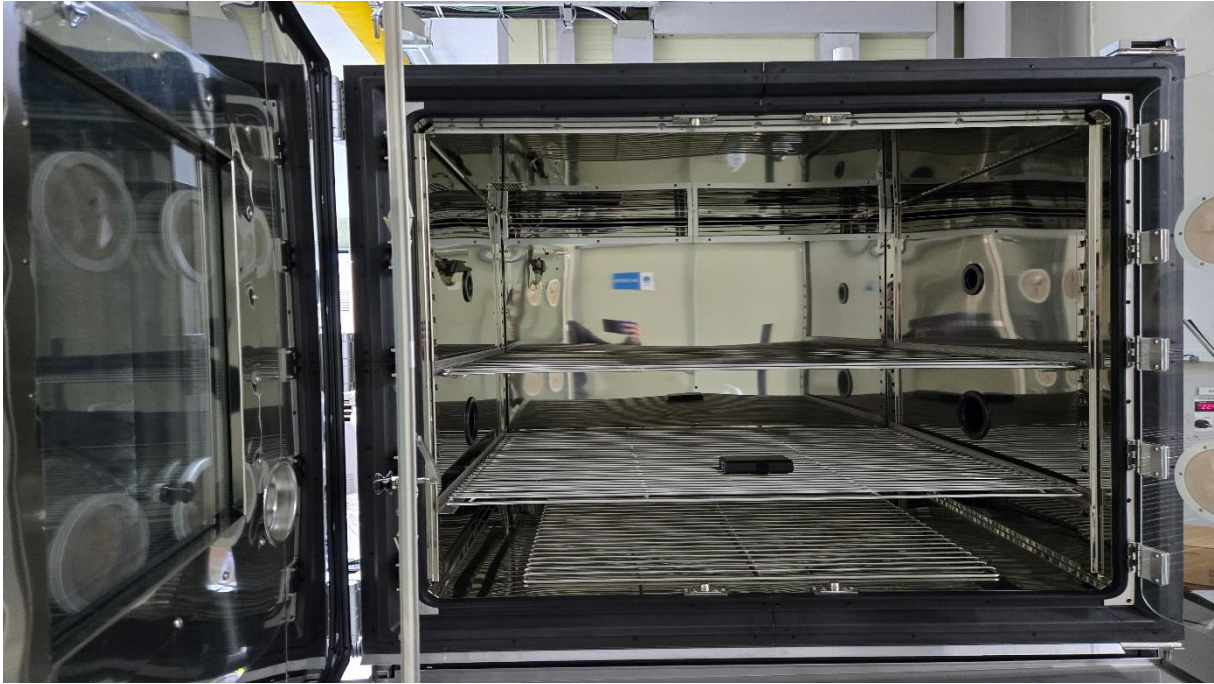
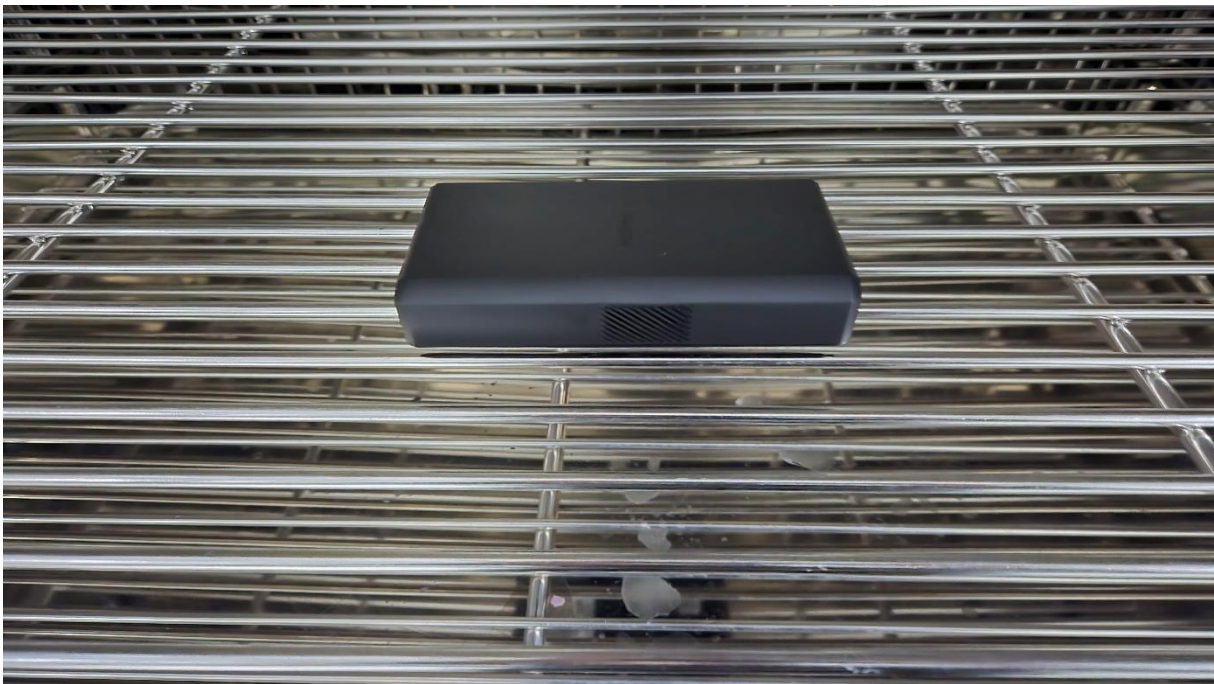
#### 3.3.1 Evidence of test setting

3.2.1 Sample status: Non-operation

3.2.2 Test temperature: -33 °C

3.2.3 Test time: 16 h

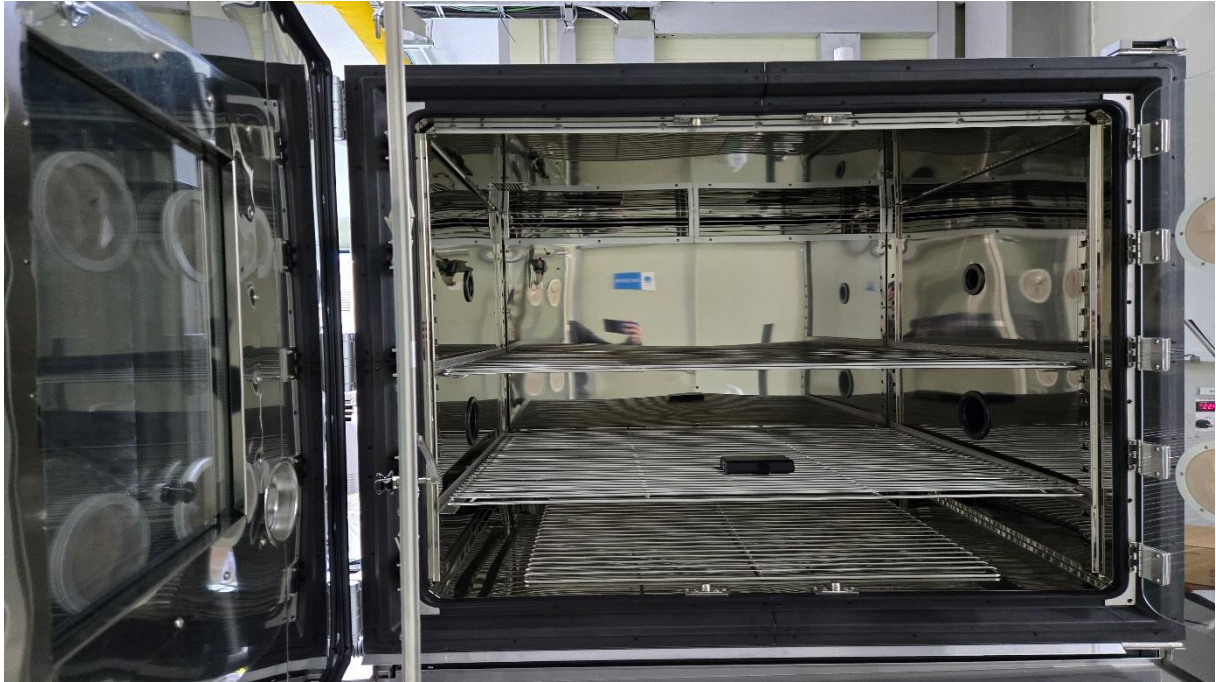
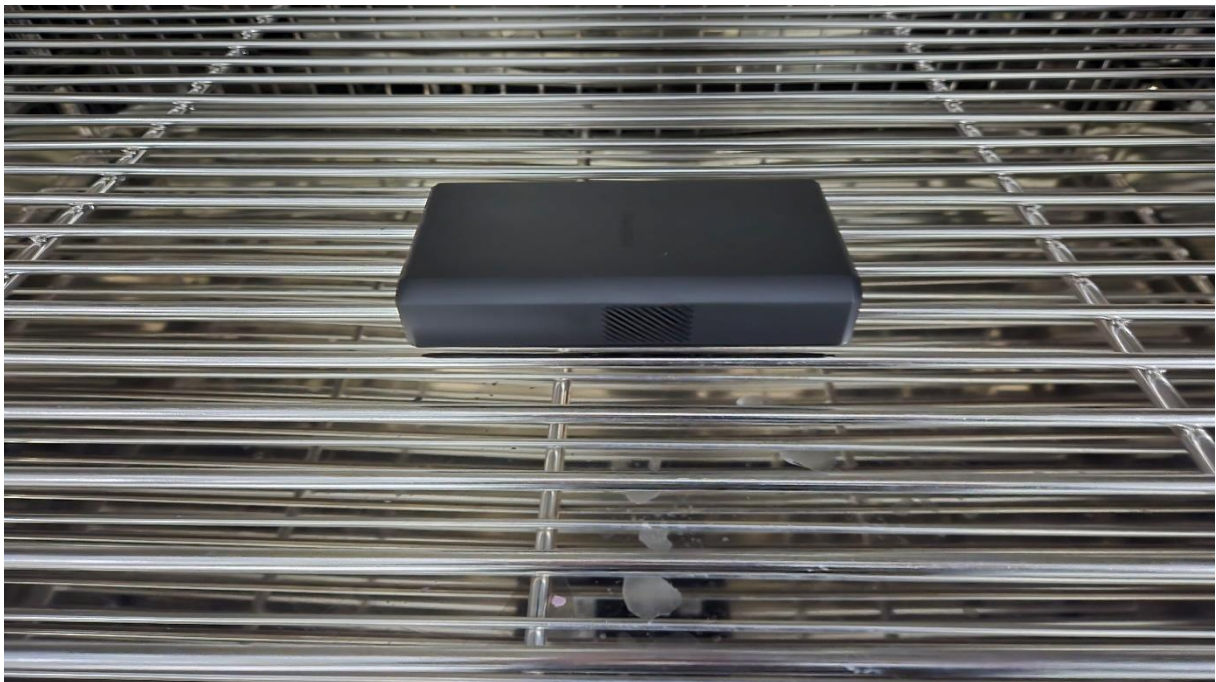
#### 4.3.1 Evidence of test setting

4.2.1 Sample status: Non-operation

4.2.2 Test temperature: 60 °C

4.2.3 Test time: 96 h

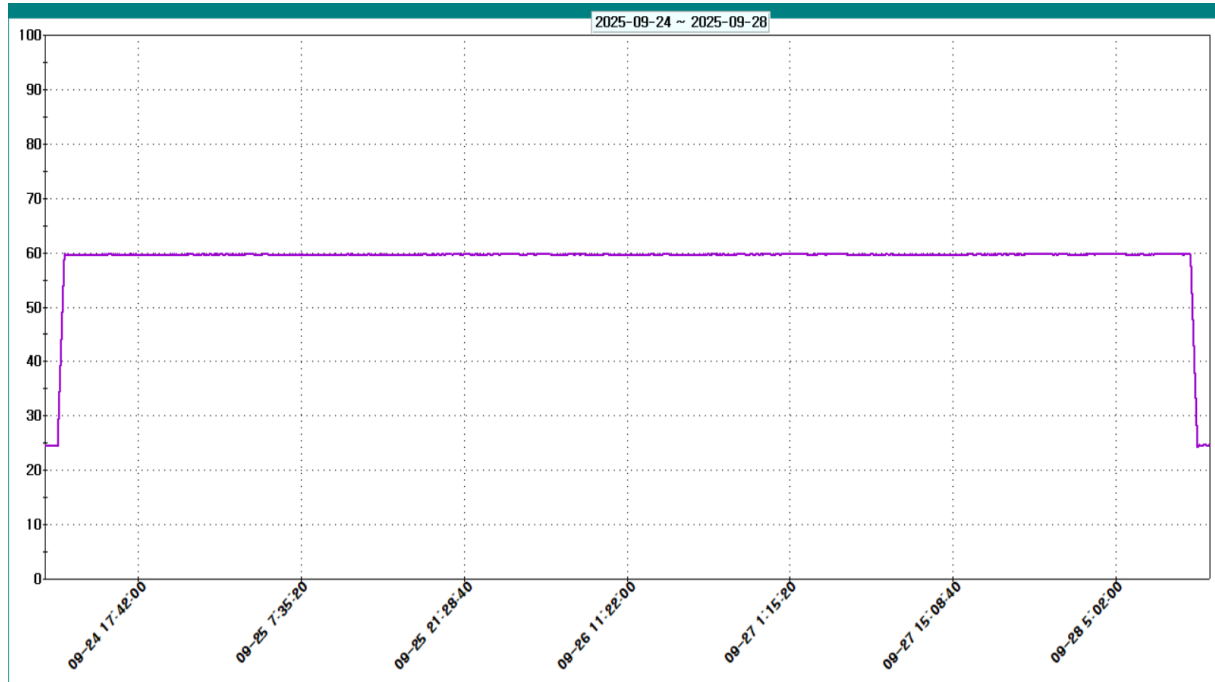
#### 4.5.1 Test data and graph

Temperature Data

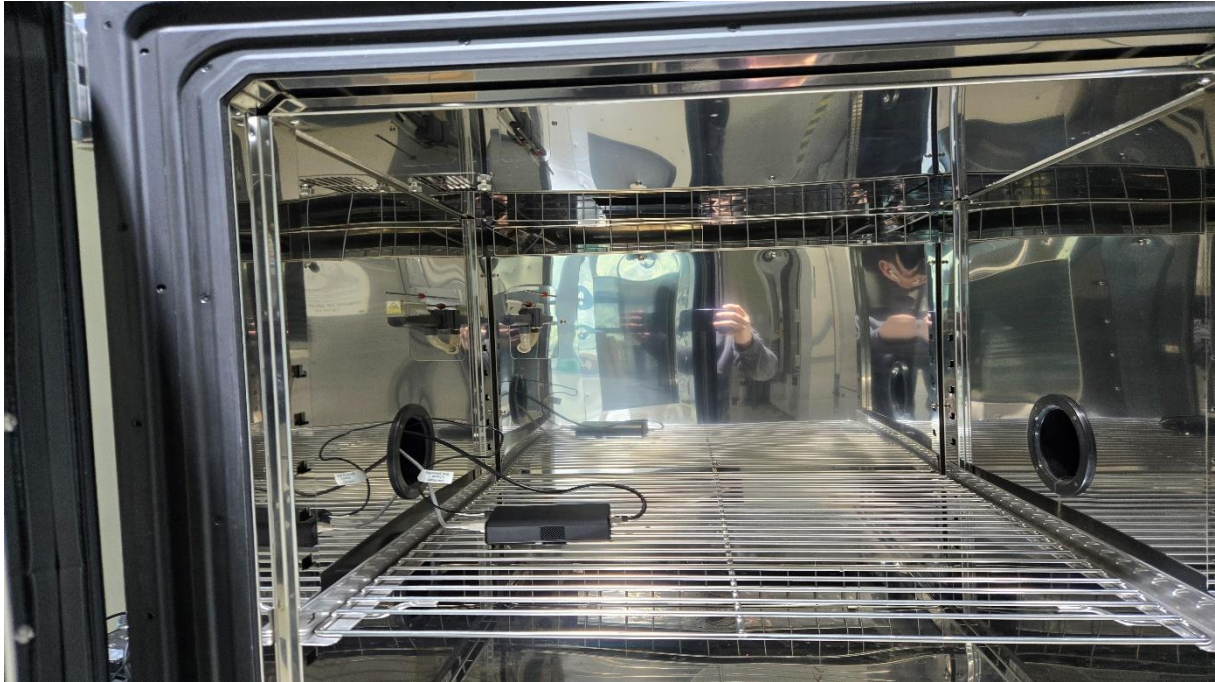
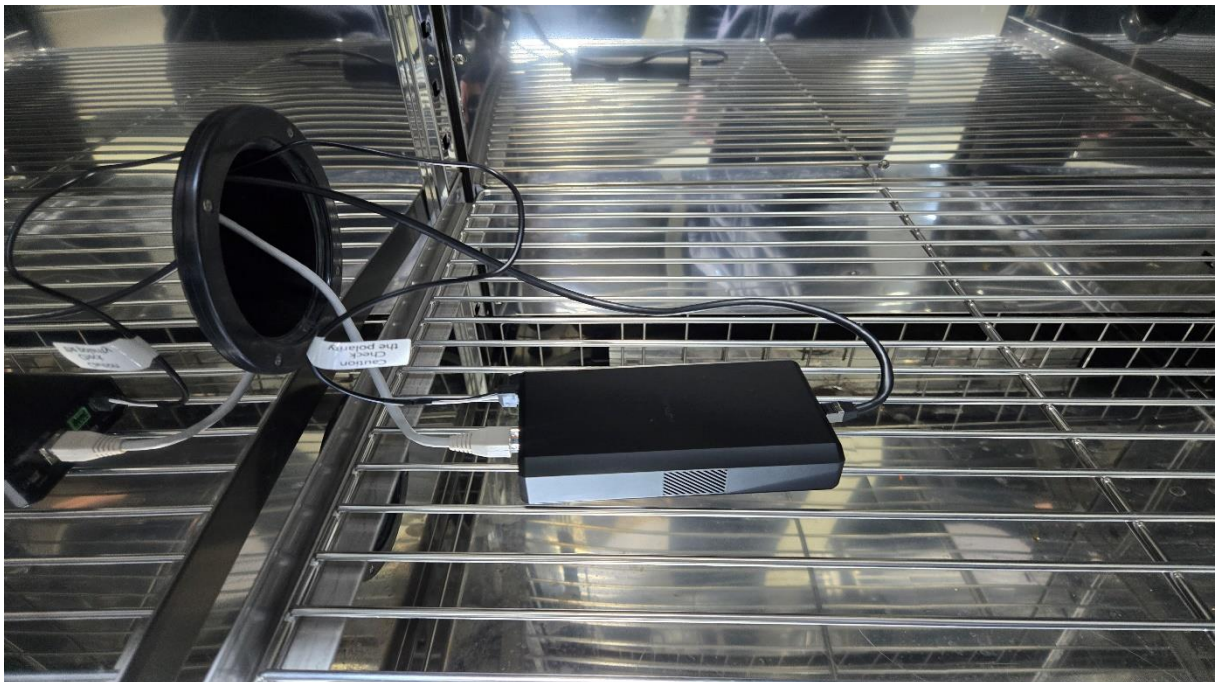
### 5.3.1 Evidence of test setting

5.2.1 Sample status: operation

5.2.2 Test temperature: -33 °C, 50 °C

| Temp↵ | Temperature change rate(°C/min)↵ | t <sub>1</sub> (idle time)↵ | Cycles↵ |
| High↵ | 5 °C/min↵ | 3 h↵ | 3↵ |
| Low↵ | 1 °C/min↵ | 3 h↵ | 3↵ |

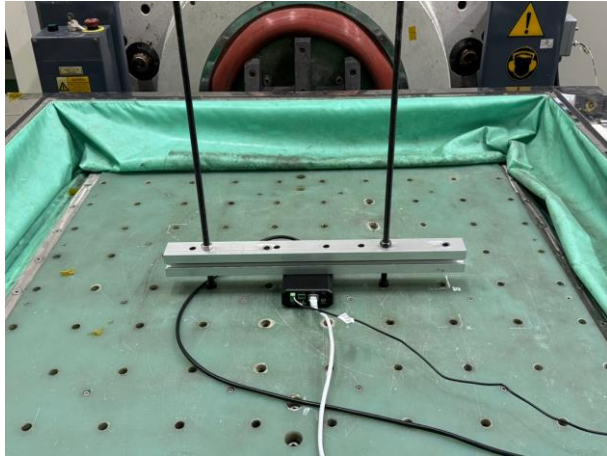
X axis

- Sample status: operation
- Frequency(Hz): 5 Hz ~ 200 Hz
- Acceleration(G): 1 G
- Sweep rate: 1 oct/min
- Test Axis: X, Y, Z
- Test time(h): Total 30 min (10 min. per each axis)

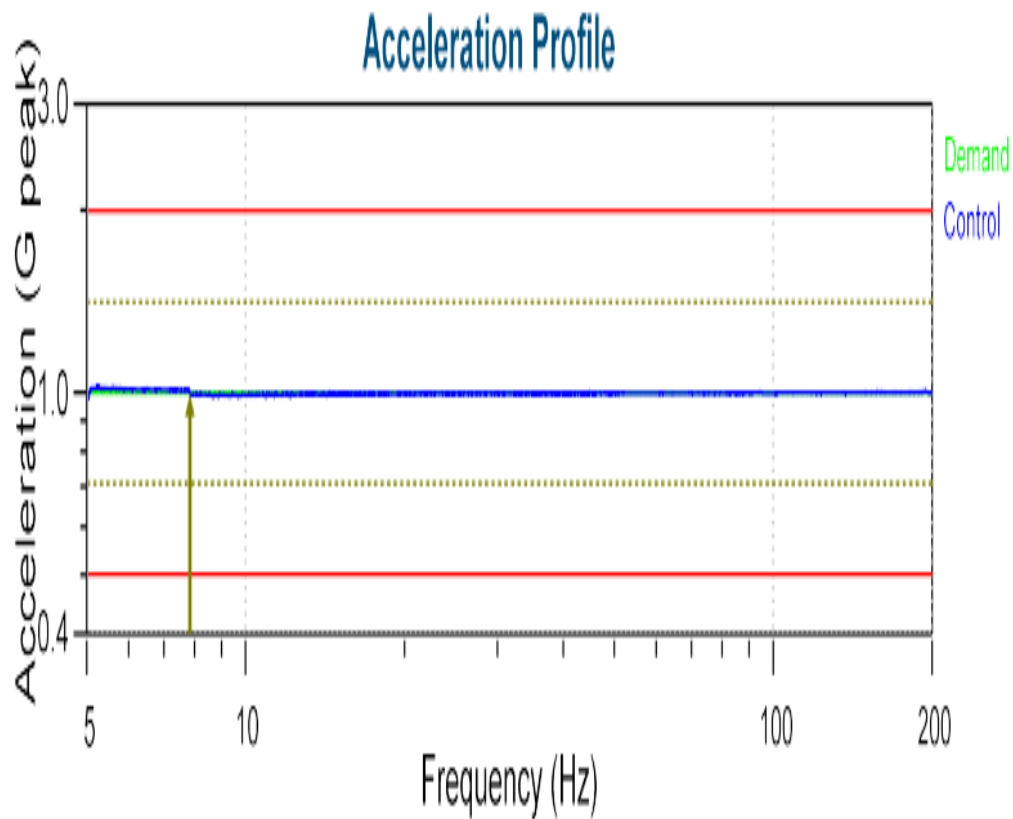
#### 6.5.1 Test data and graph (Vibration Test X Axis)

10 21, 2025 13:16:5 Level 1) 100 %  
Demand: 1 G Level Time: 0:10:0  
Control: 0.003651 G Total Time: 0:10:1

Output: 0 Volts peak  
Frequency: 7.841 Hz  
End of Timed Test

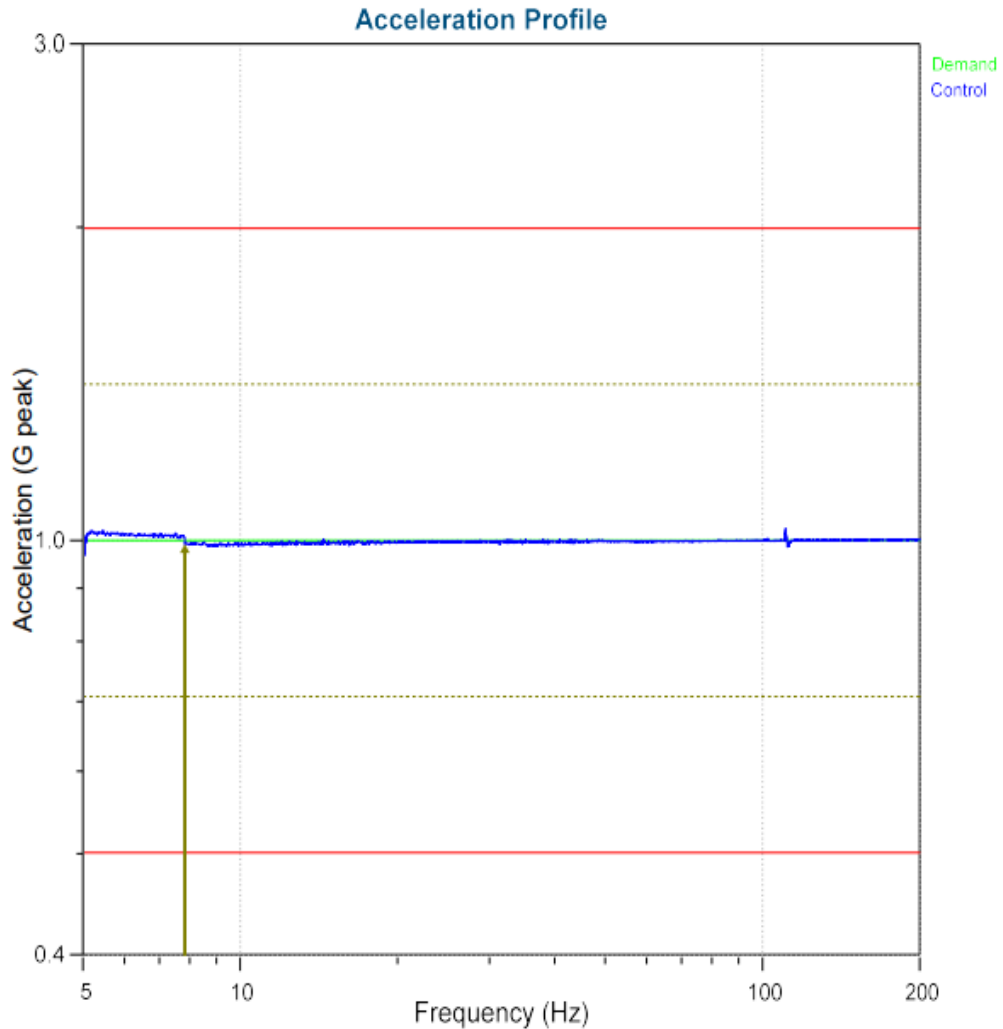
### 6.5.2 Test data and graph (Vibration Test Y Axis)

10 21, 2025 13:52:3 Level 1) 100 %

Demand: 1 G

Level Time: 0:10:0

Frequency: 7.835 Hz

Control: 0.00163 G

Total Time: 0:10:1

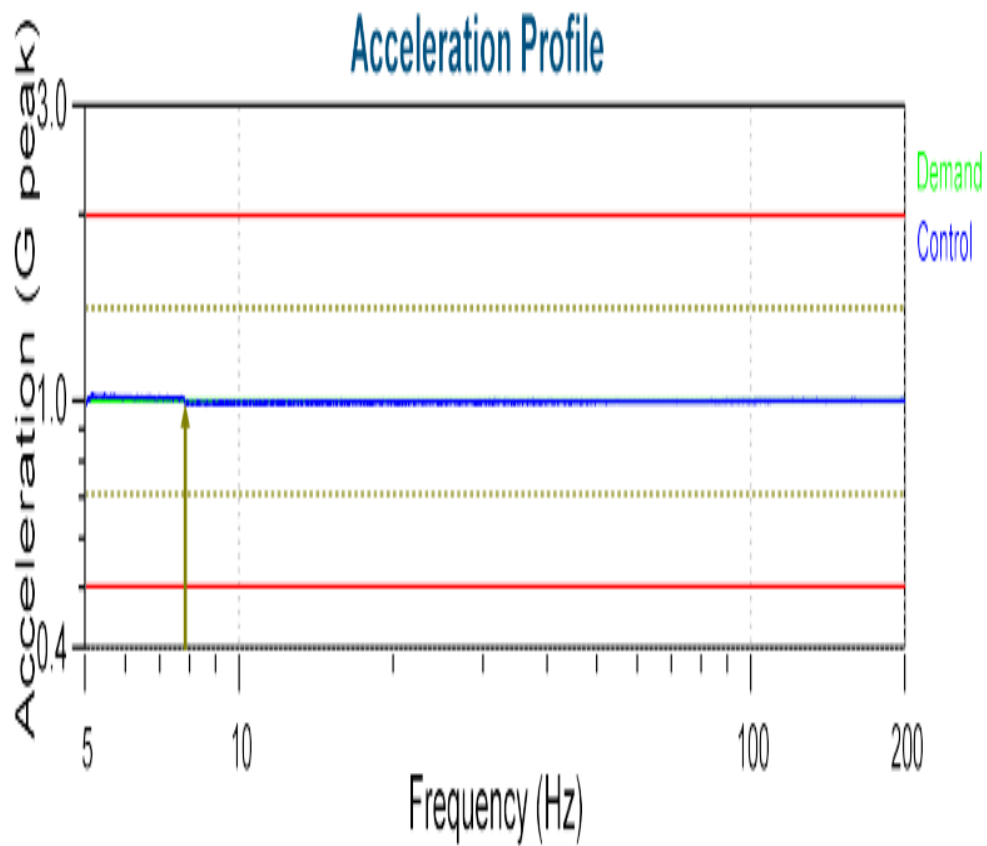
### 6.5.3 Test data and graph (Vibration Test Z Axis)

10 27, 2025 16:11:33 Level 1) 100 % Output: 0.3807 Volts peak 60068-2-6  
Demand: 1 G Level Time: 0:10:00 Frequency: 7.852 Hz  
Control: 0.9912 G Total Time: 0:10:12 End of Timed Test

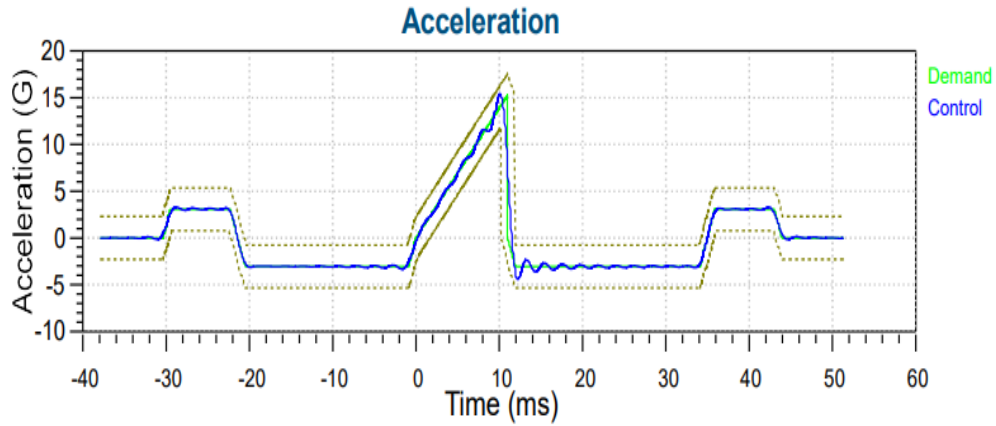
X+

10 21, 2025 13:17:5 Level 1) 100 %  
Demand: 15.3 G  
Control: 15.4 G

Output: 1.136 Volts peak 한화비전 60068-2  
Running

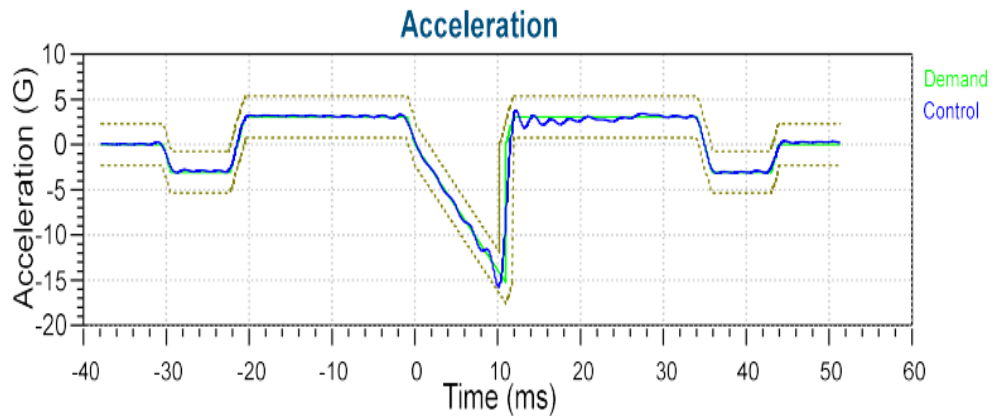
X-

10 21, 2025 13:18:2 Level 2) 100 %  
Demand: 15.3 G  
Control: 15.74 G

Output: 1.159 Volts peak 한화비전 60068-2  
End of Test

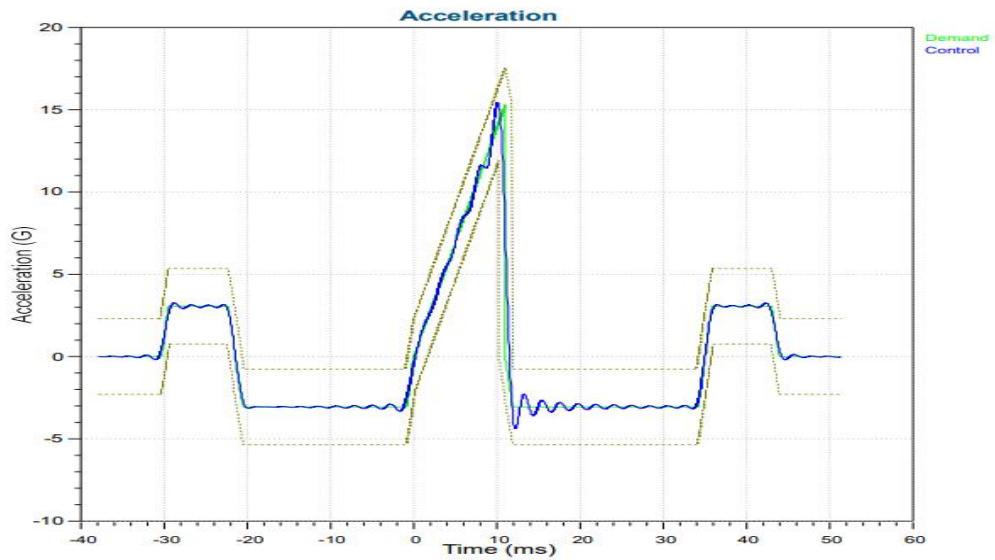
Y+

### 7.5.2 Test data and graph (Shock Test Y Axis)

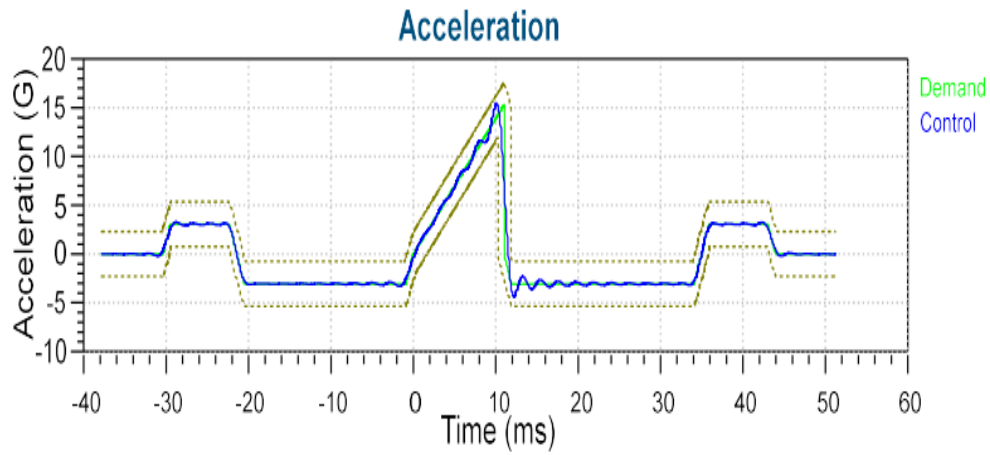
Z+

10 27, 2025 16:16:42 Level 1) 100 % Output: 1.149 Volts peak 60068-2-27  
Demand: 15.3 G  
Control: 15.13 G Pulse: 10 of 10 Running

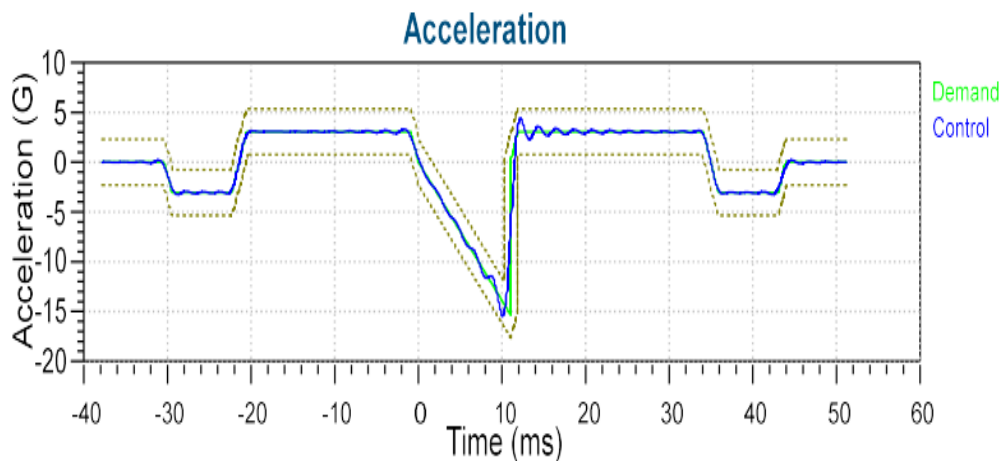
Z-

10 27, 2025 16:17:12 Level 2) 100 % Output: 1.146 Volts peak 60068-2-27  
Demand: 15.3 G  
Control: 15.13 G Pulse: 10 of 10 End of Test

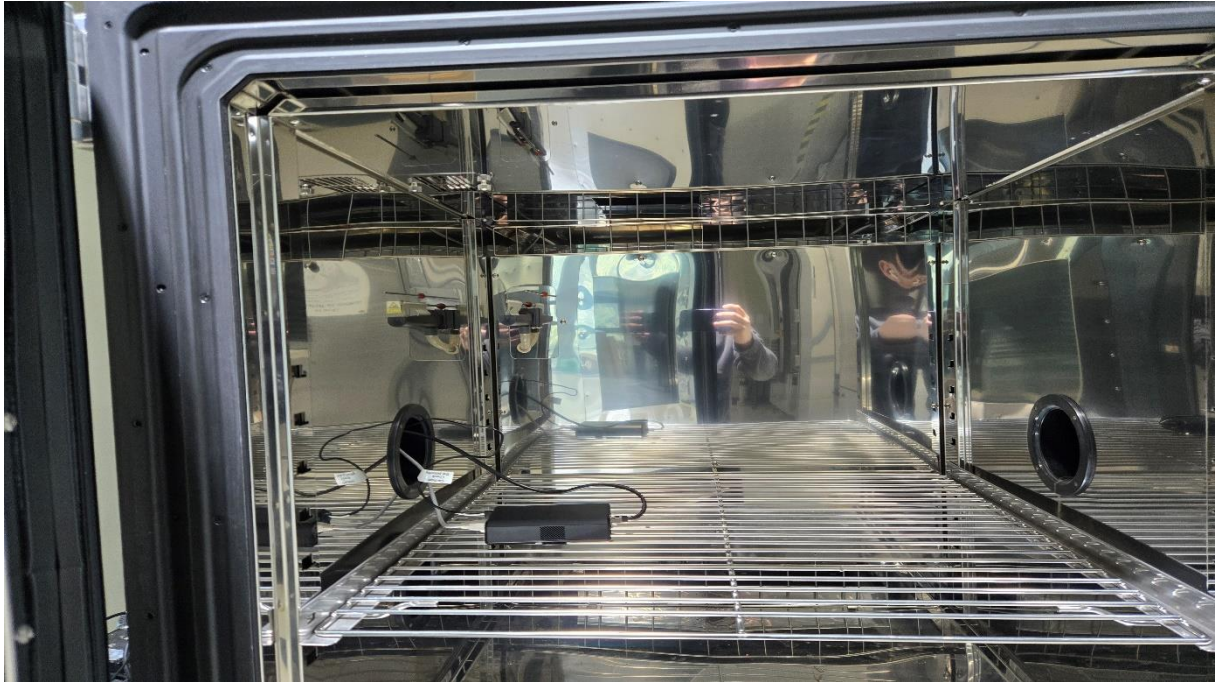
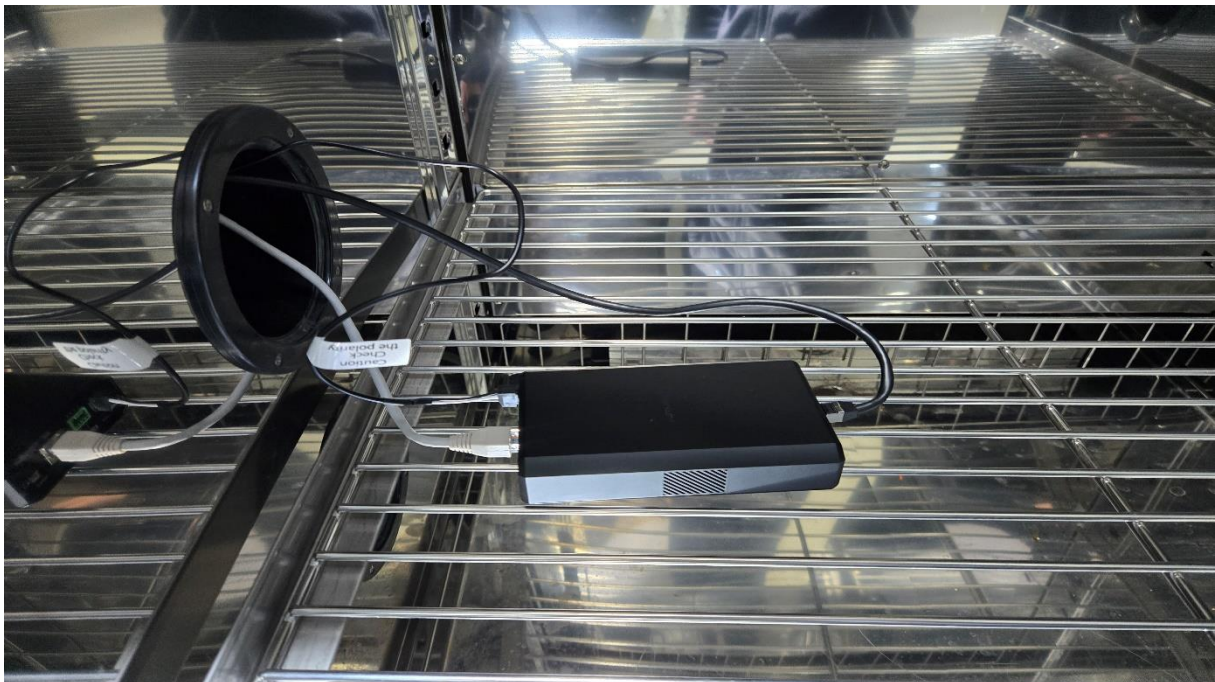
#### 8.3.1 Evidence of test setting

8.2.1 Sample status: operation

8.2.2 Test temperature:  $40 \pm 2$  °C

8.2.3 Test Humidity:  $93 \pm 3$  % R.H.

8.2.4 Test time: 240 h

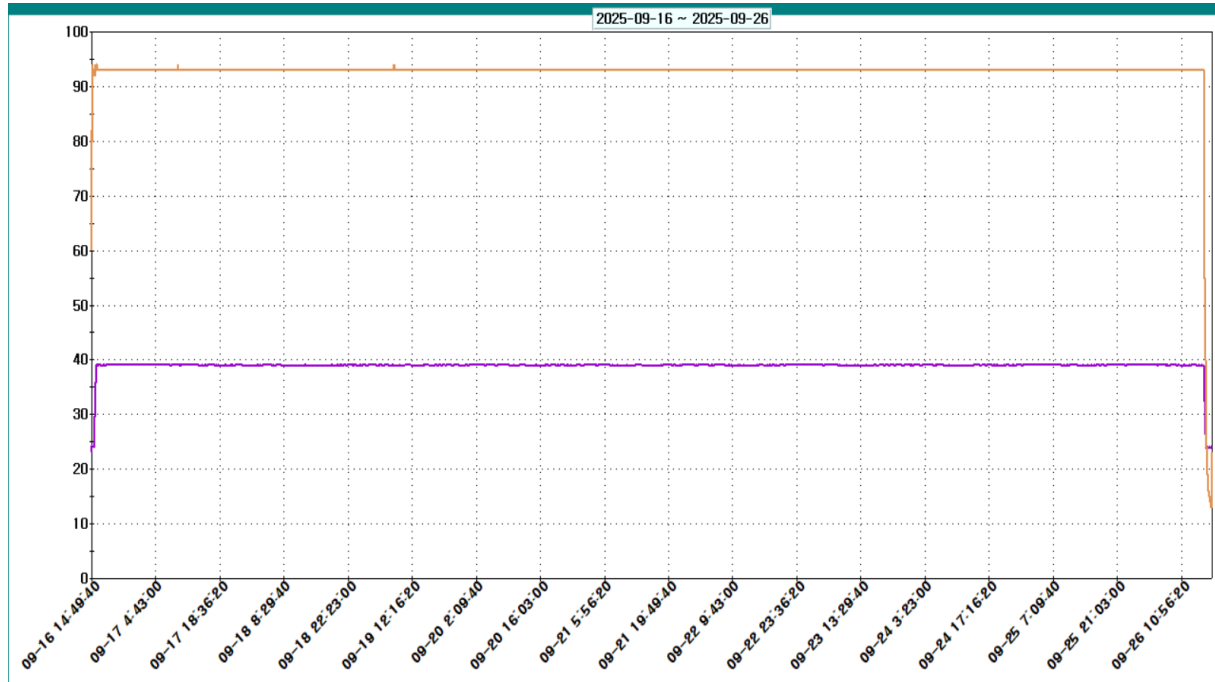
#### 8.5.1 Test data and graph

Temperature Data
