# TEST REPORT

REPORT No.:  
CTK-2025-01952  
Page (1) / (39) pages

NETWORK CAMERA / XNB-A9004

EN 60068-2-1, EN 60068-2-2, EN 60068-2-14, EN 60068-2-6, EN  
60068-2-27, EN 60068-2-78, IEC 60068-2-1, IEC 60068-2-2, IEC  
60068-2-14, IEC 60068-2-6, IEC 60068-2-27, IEC 60068-2-78

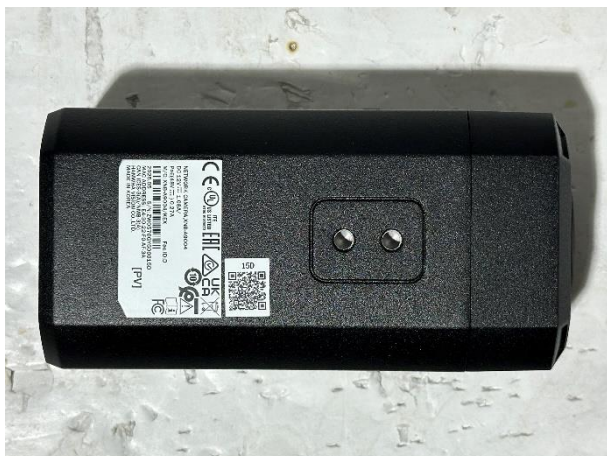
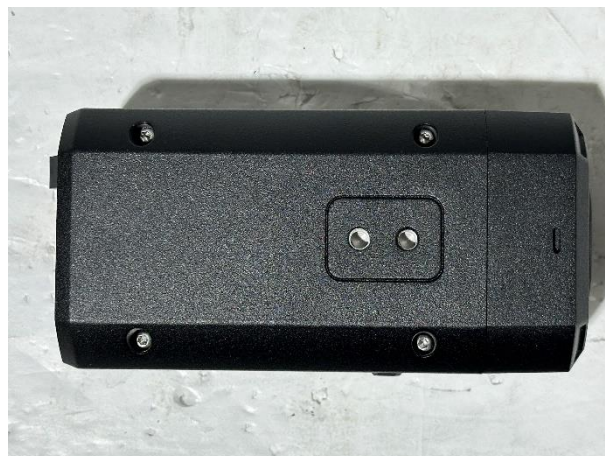
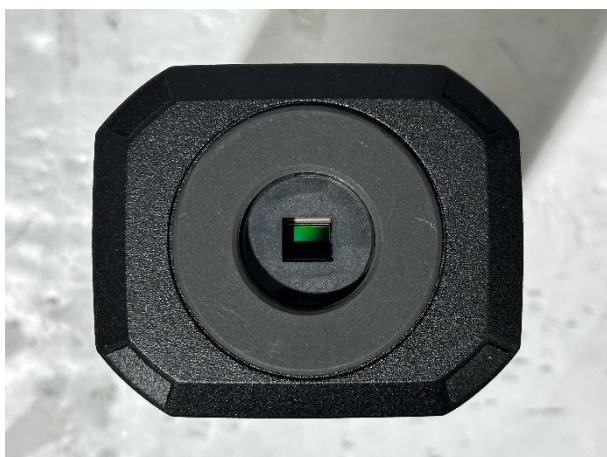
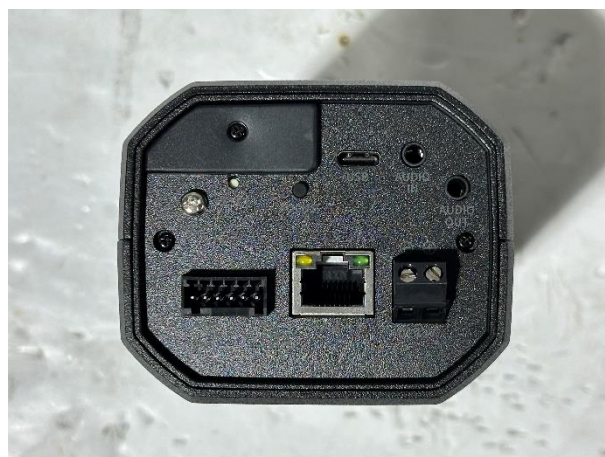
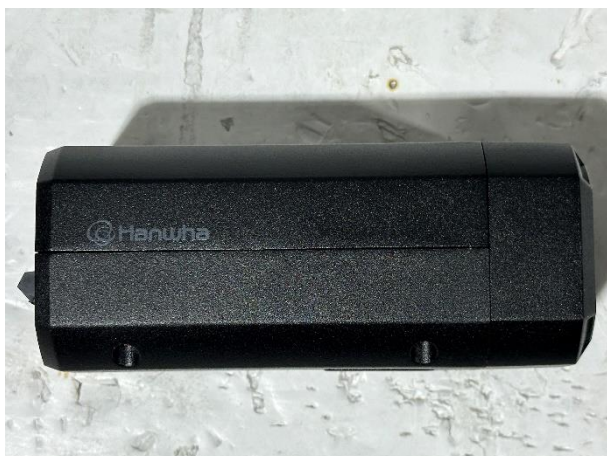
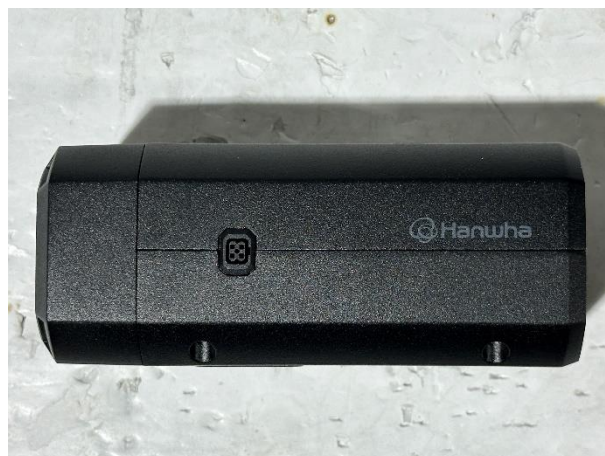
### 2.4.1 Test sample

## 2.4 Pre-test product images

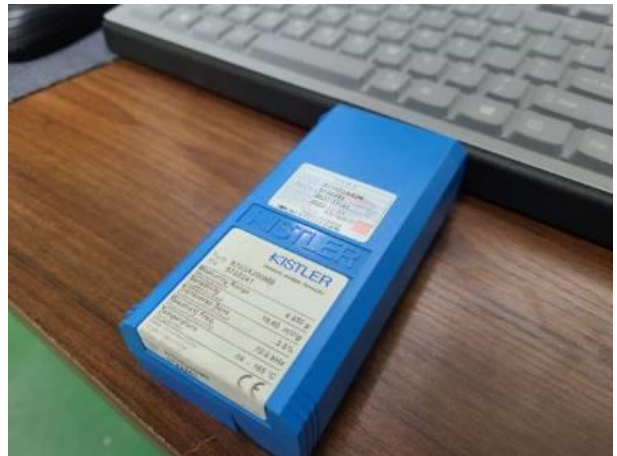
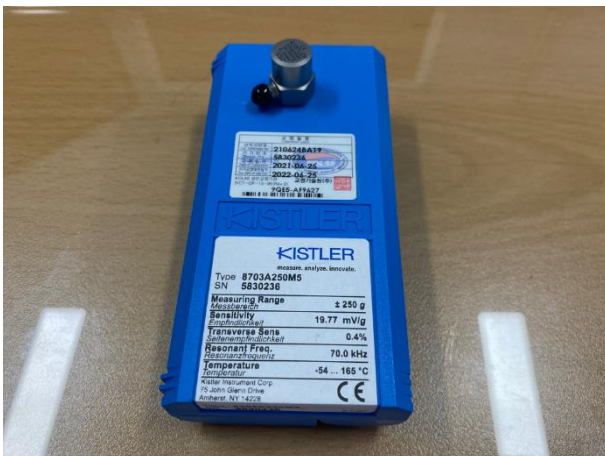
| Testing equipment | Model Name | Manufacturer | Manufacturing Number | Calibration Date |
|---|---|---|---|---|
| Acceleration sensor | 8703A250M5 | KISTLER | 5830236 | Jan. 16, 2026 |
| Acceleration sensor | 8703A250M5 | KISTLER | 5722241 | Jan. 16, 2026 |

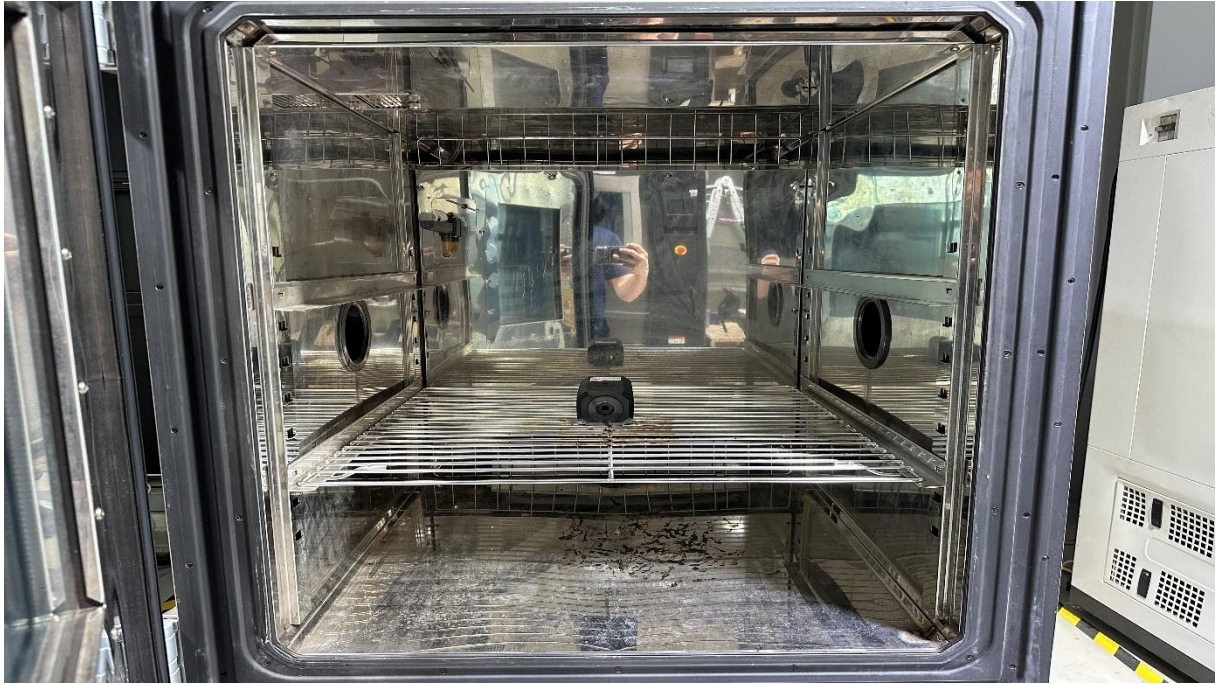
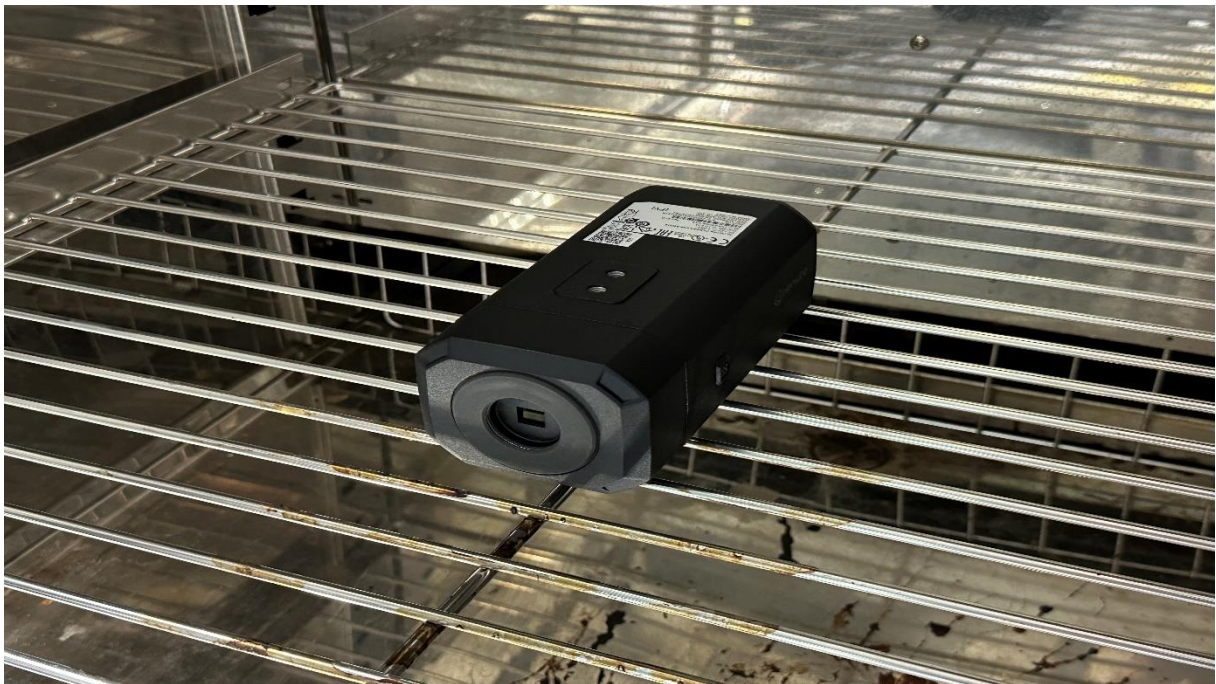
#### 3.3.1 Evidence of test setting

3.2.1 Sample status: Non-operation

3.2.2 Test temperature: -10 °C

3.2.3 Test time: 16 h

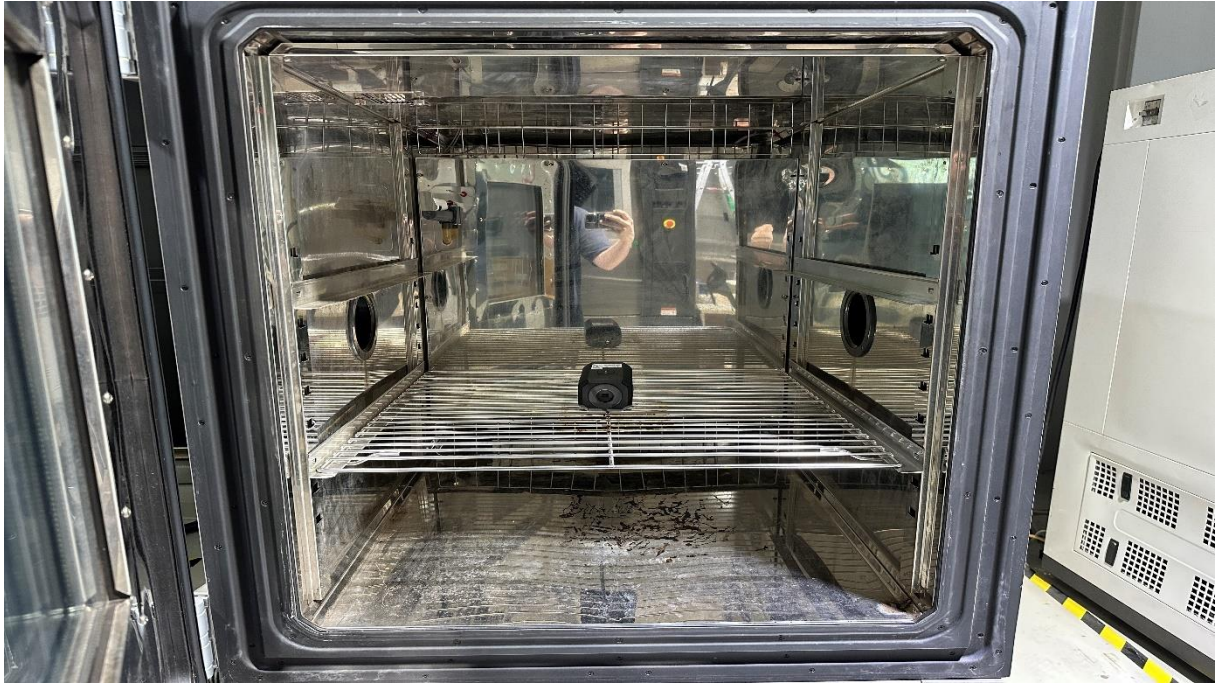
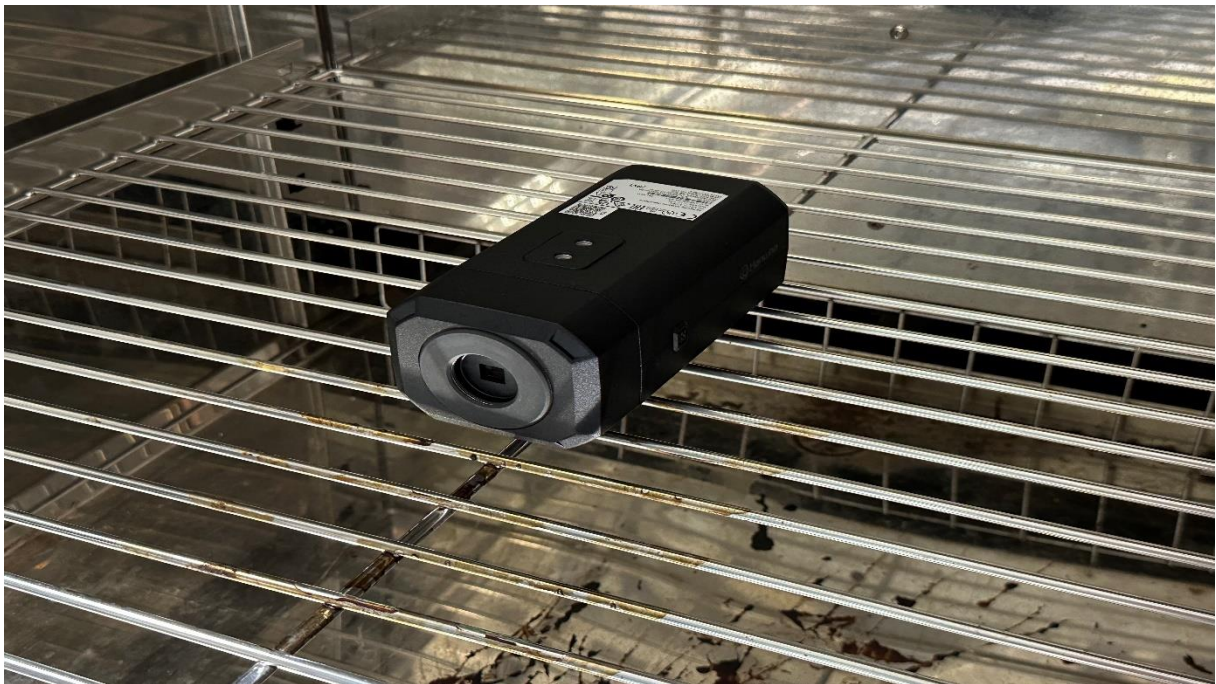
#### 4.3.1 Evidence of test setting

4.2.1 Sample status: Non-operation

4.2.2 Test temperature: 60 °C

4.2.3 Test time: 96 h

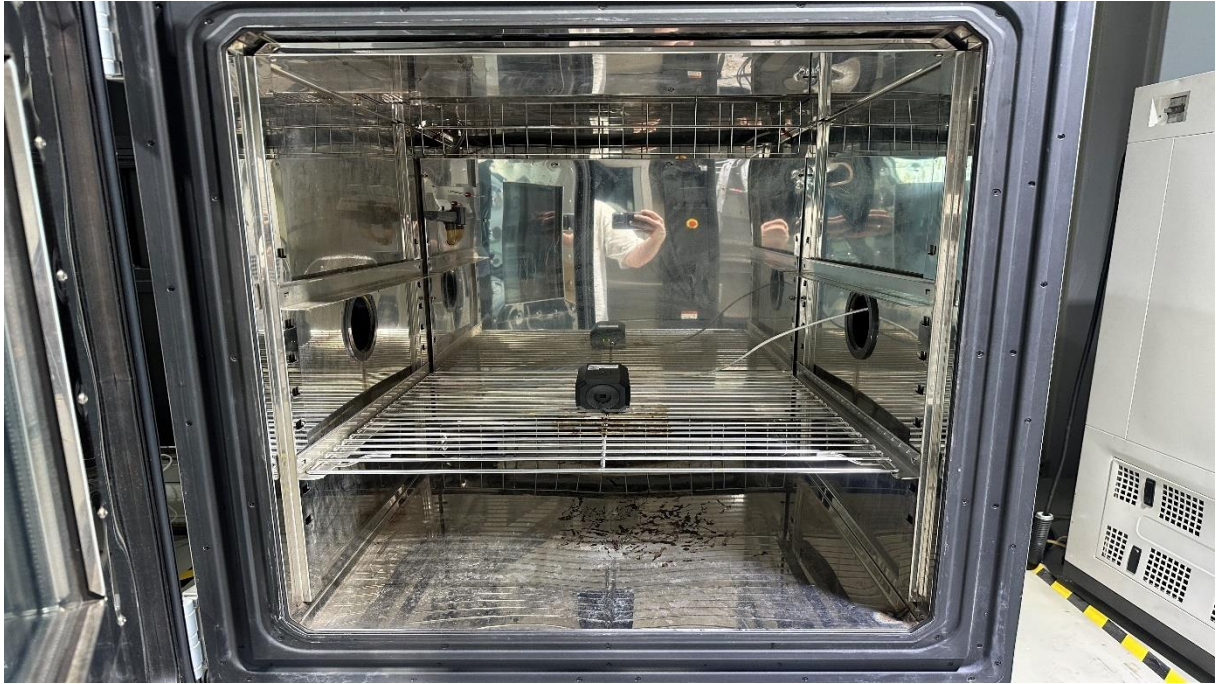
#### 5.3.1 Evidence of test setting

5.2.1 Sample status: operation

5.2.2 Test temperature: -10 °C, 55 °C

| Temp↵ | Temperature change rate(°C/min)↵ | t <sub>1</sub> (idle time)↵ | Cycles↵ |
| High↵ | 5 °C/min↵ | 3 h↵ | 3↵ |
| Low↵ | 1 °C/min↵ | 3 h↵ | 3↵ |

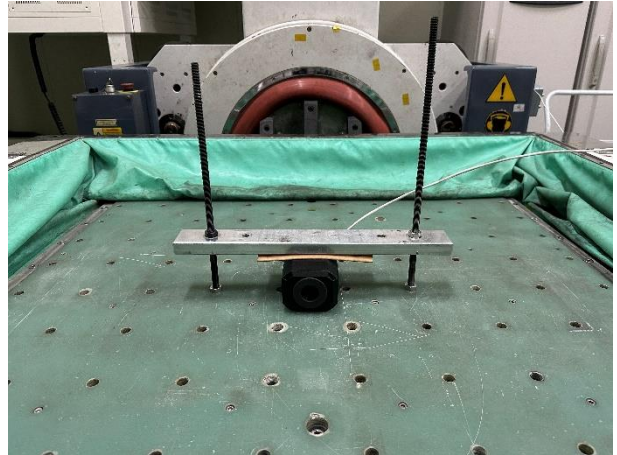
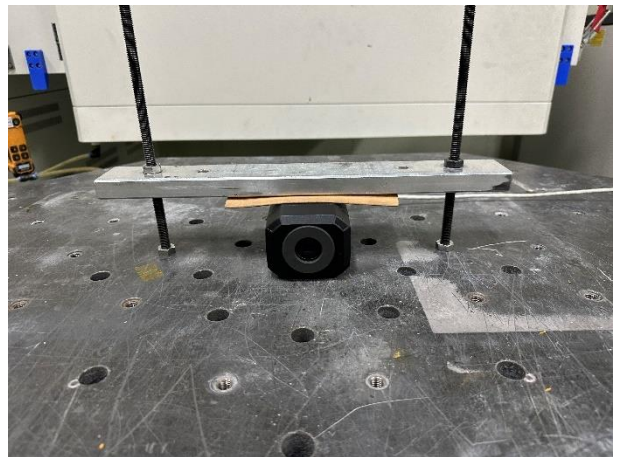
### 6.3.1 Evidence of test setting

- Sample status: operation
- Frequency(Hz): 5 Hz ~ 200 Hz
- Acceleration(G): 1 G
- Sweep rate: 1 oct/min
- Test Axis: X, Y, Z
- Test time(h): Total 30 min (10 min. per each axis)

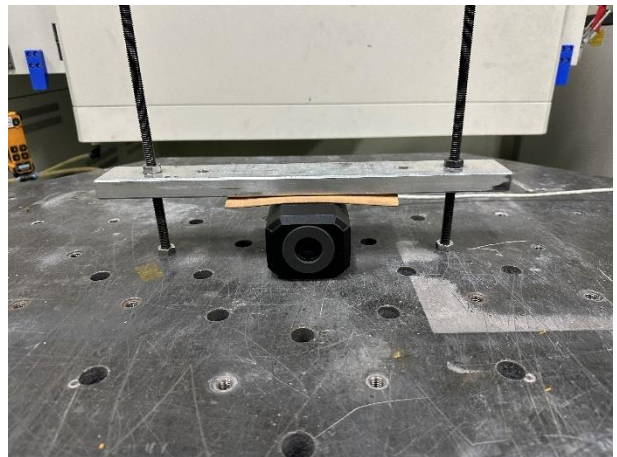
### 7.3.1 Evidence of test setting

7.2.1 Sample status: Non-operation

7.2.2 Acceleration(G): 10 G

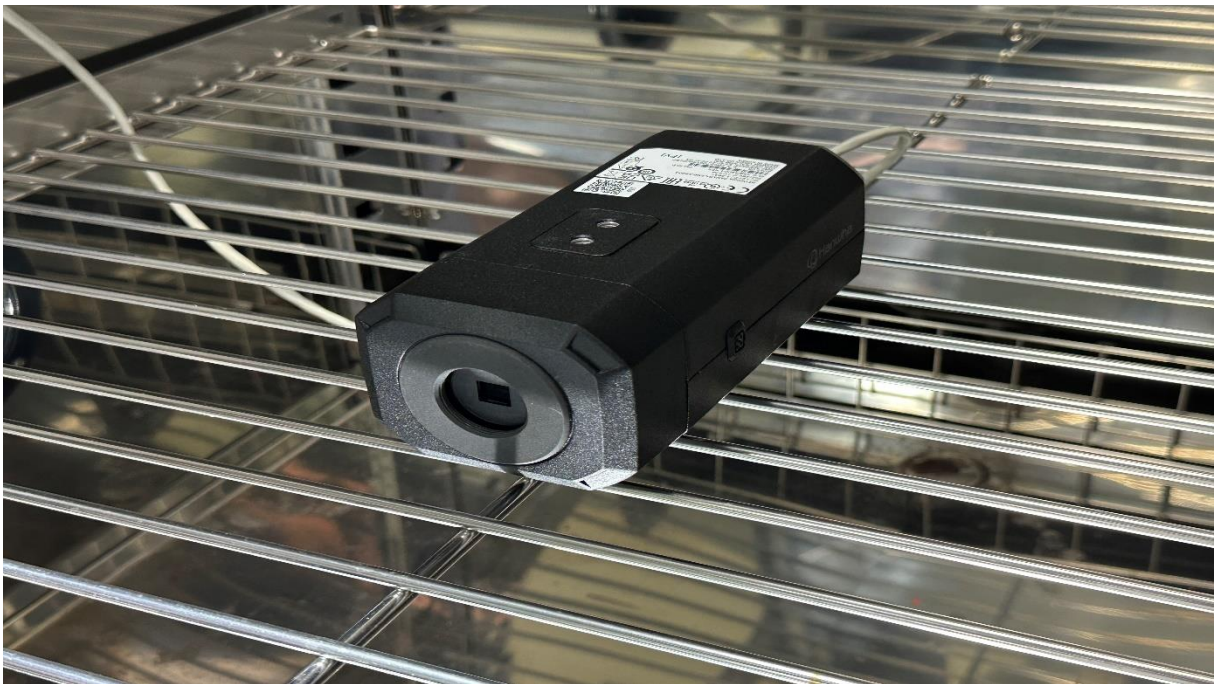
#### 8.3.1 Evidence of test setting

8.2.2 Test temperature:  $40 \pm 2$  °C

8.2.3 Test Humidity:  $93 \pm 3$  % R.H.

8.2.4 Test time: 240 h

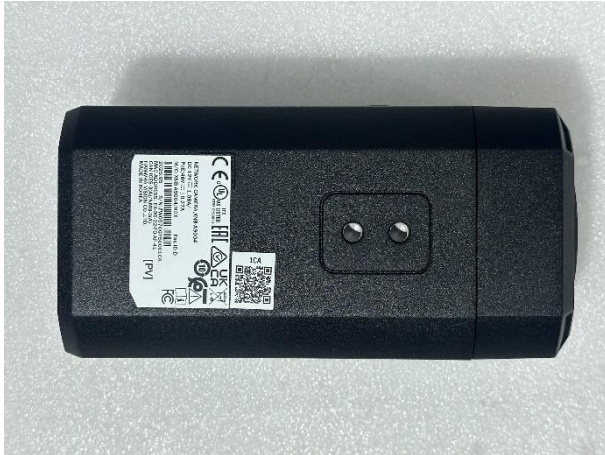
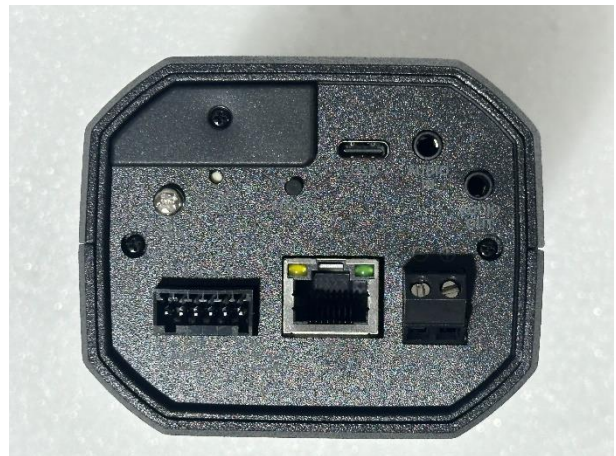
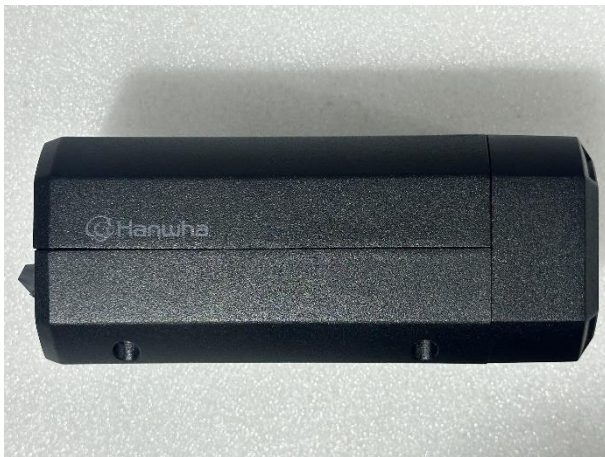
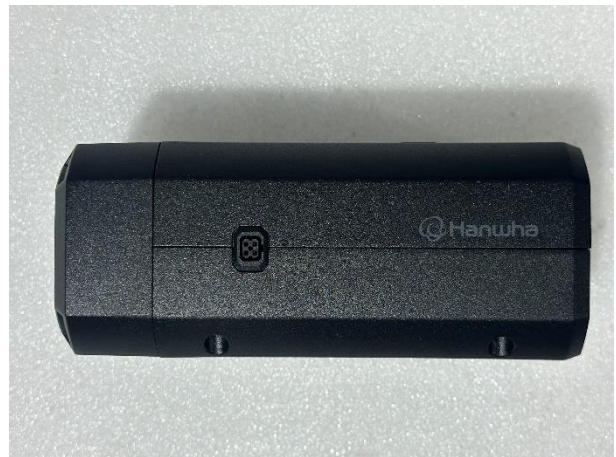
### 8.6.1 Test sample

| Evaluations Criteria | Test result | | 비고 |
|---|---|---|---|
| Sample | Visual Inspection | Normal | - |

## 8.6 Post-test product images
