# TEST REPORT

CTK-2025-02275

NETWORK CAMERA / XND-A9084RV

EN 60068-2-1, EN 60068-2-2, EN 60068-2-14, EN 60068-2-6  
EN 60068-2-27, EN 60068-2-78, IEC 60068-2-1, IEC 60068-2-2,  
IEC 60068-2-14, IEC 60068-2-6, IEC 60068-2-27, IEC 60068-2-78

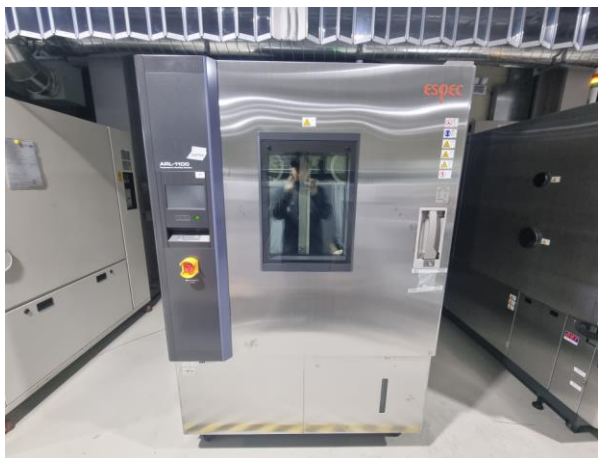
Temperature & Humidity Chamber

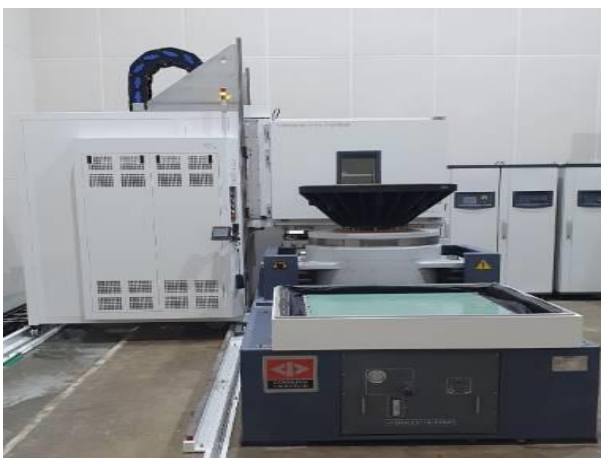
VIBRATION TESTING SYSTEM

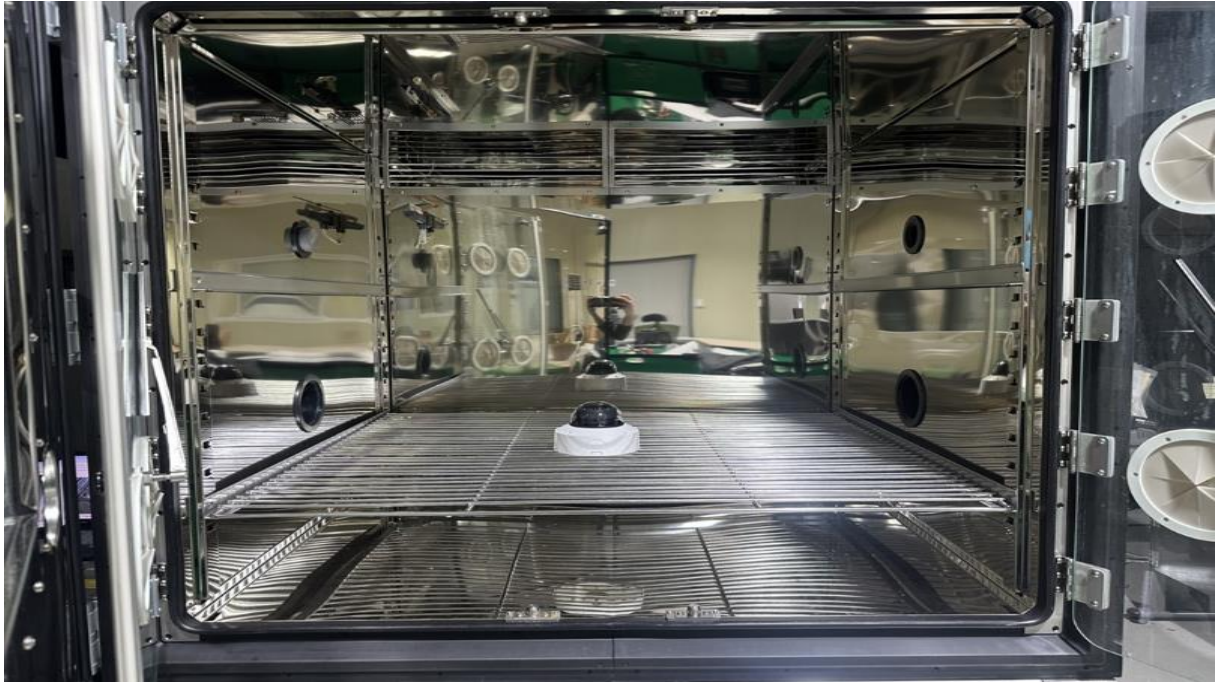
#### 3.3.1 Evidence of test setting

3.2.1 Sample status: Non-operation

3.2.2 Test temperature: -33

3.2.3 Test time: 16 h

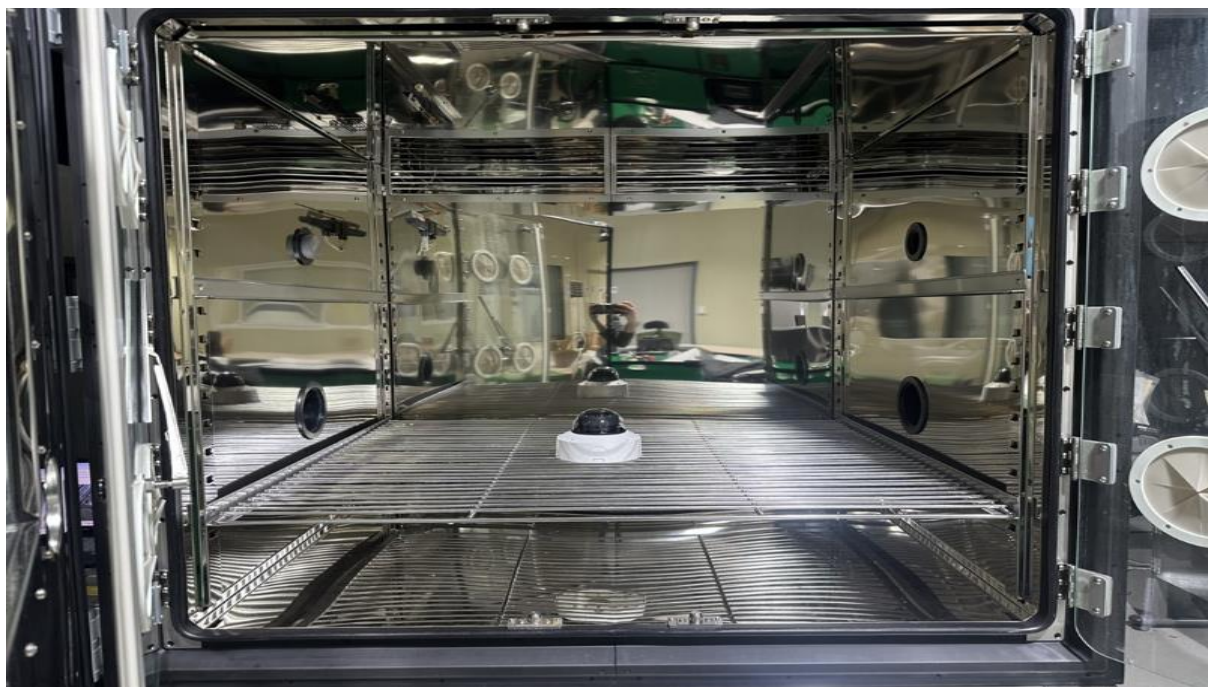
#### 4.3.1 Evidence of test setting

4.2.1 Sample status: Non-operation

4.2.2 Test temperature: 60 °C

4.2.3 Test time: 96 h

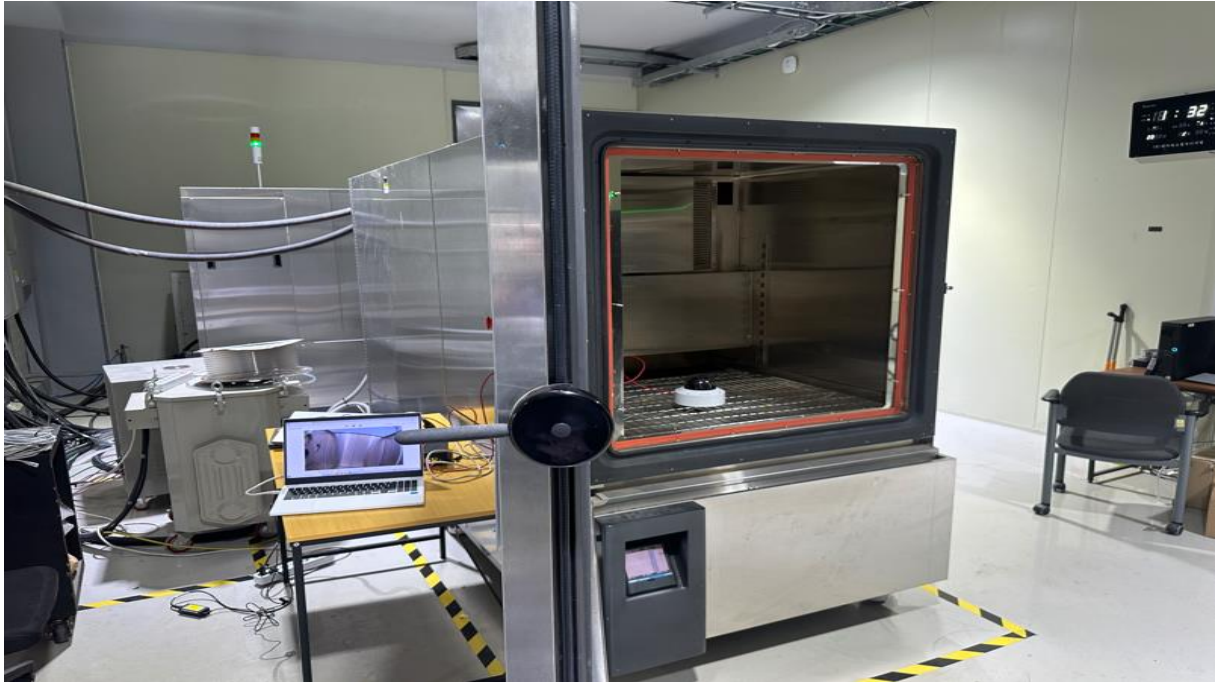
#### 5.3.1 Evidence of test setting

5.2.1 Sample status: operation

5.2.2 Test temperature: -40 °C, 50 °C

| T <sub>A</sub> (High)↵ | T <sub>B</sub> (Low)↵ | Temperature change rate(°C/min)↵ | t <sub>1</sub> (idle time)↵ | Cycles↵ |
| 50 °C ↵ | -↵ | 5 °C/min↵ | 3 h↵ | 3↵ |
| -↵ | -40 °C↵ | 1 °C/min↵ | 3 h↵ | 3↵ |

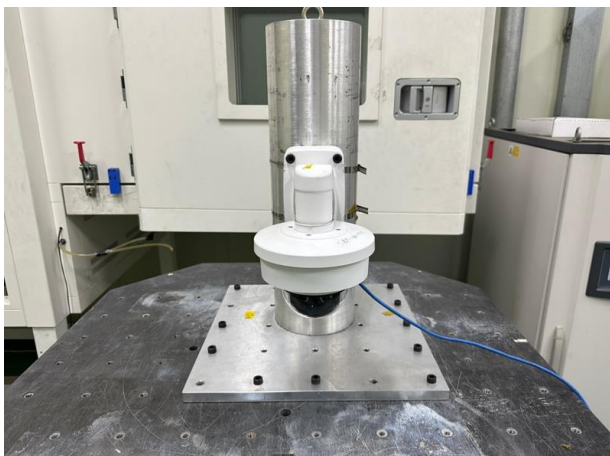
#### 7.3.1 Evidence of test setting

7.2.2 Acceleration(G): 10 G

7.2.3 Number of impacts: 10 per direction (total 60)

7.2.4 Test Axis: Z, X, Y

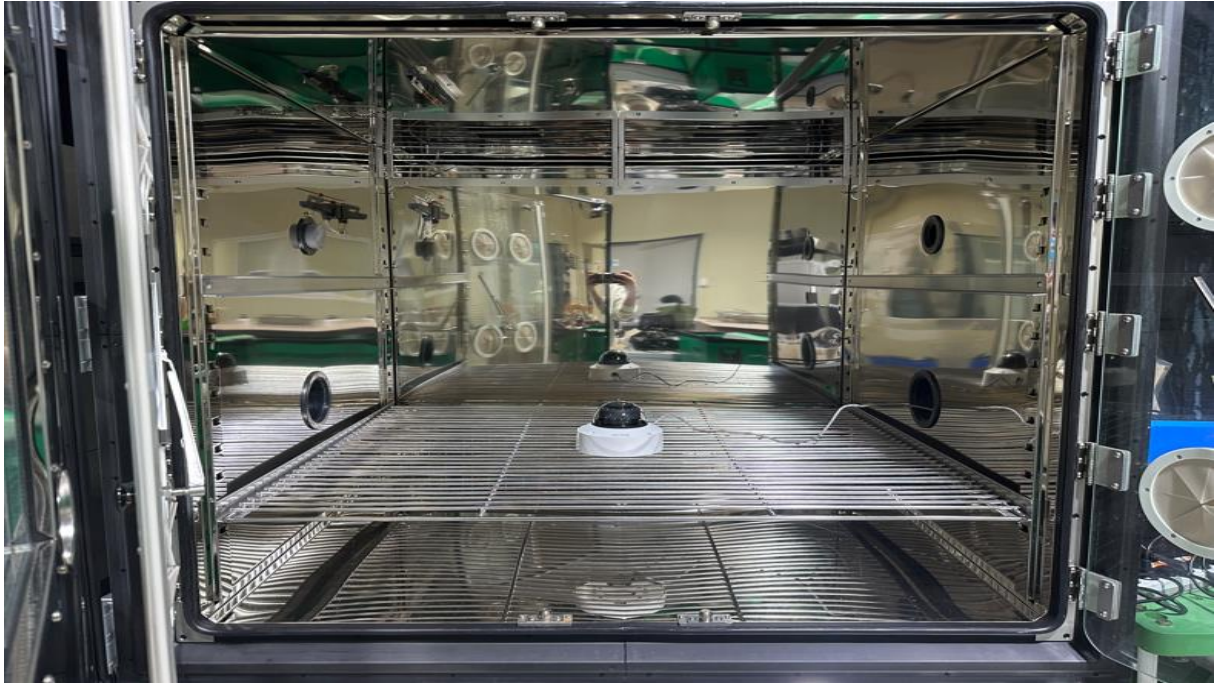
### 8.3.1 Evidence of test setting

8.2.2 Test temperature:  $40 \pm 2$  °C

8.2.3 Test Humidity:  $93 \pm 3$  % R.H.

8.2.4 Test time: 240 h

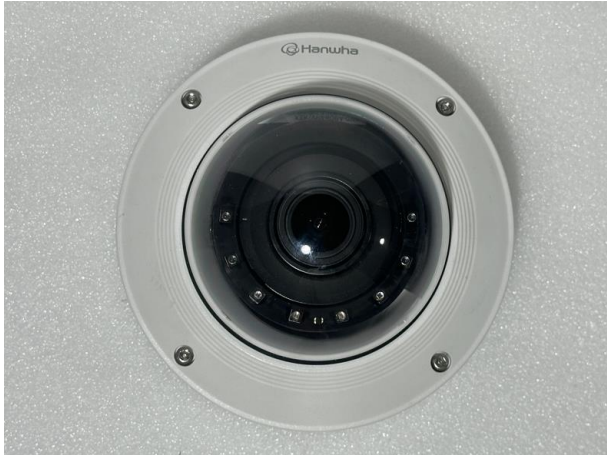
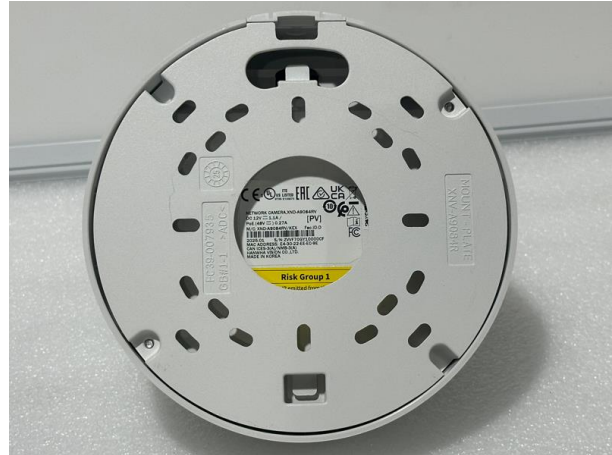
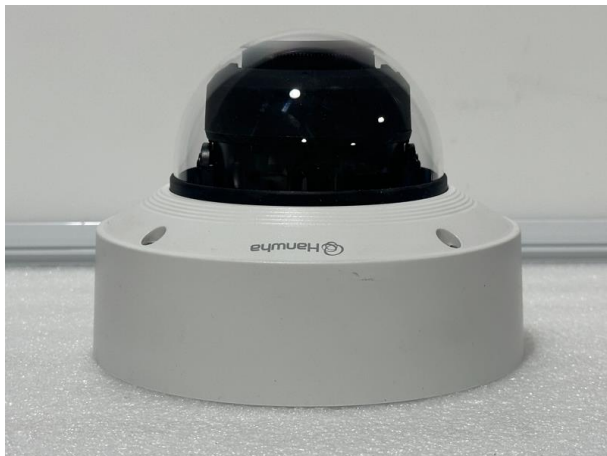
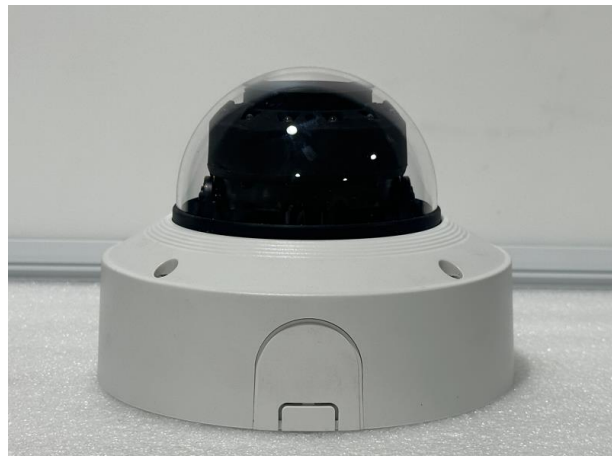
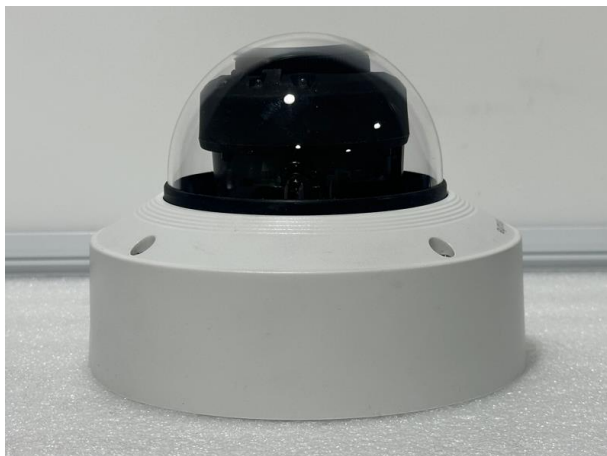
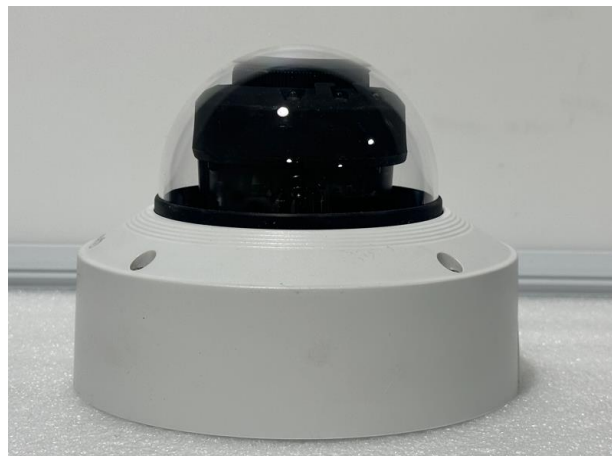
#### 8.6.1 Test sample

| Evaluations Criteria | Test result | | 비고 |
|---|---|---|---|
| | Visual Inspection | Normal | - |
| Sample | Operation and Function | Normal | - |
