# TEST REPORT

REPORT No.:  
CTK-2026-00744  
Page (1) / (13) pages

NETWORK CAMERA / XND-A9014R

IEC 60529:1989 +A1:1999+A2:2013

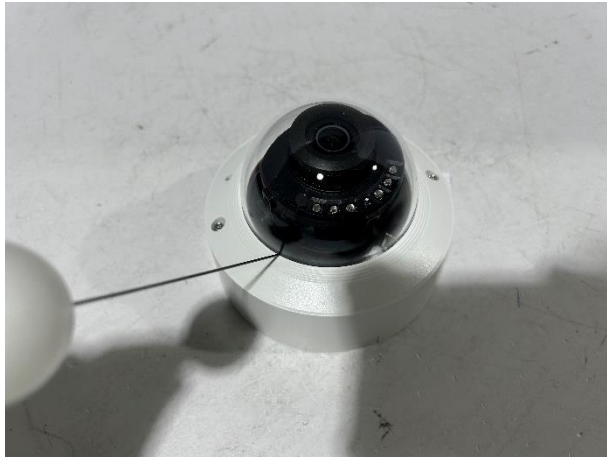
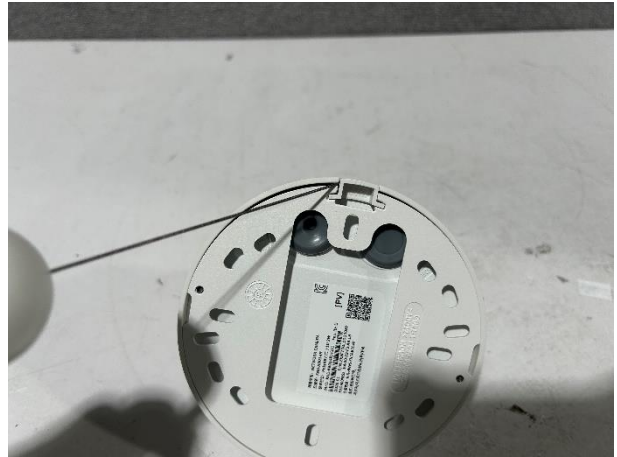
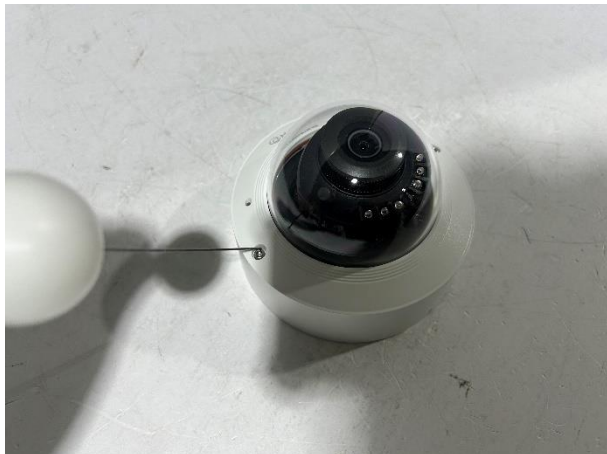
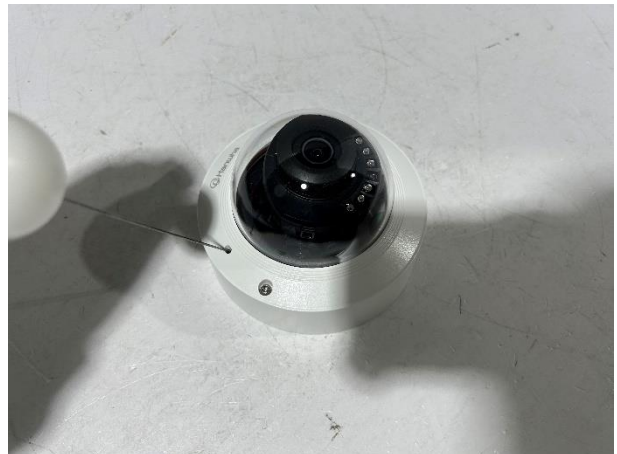
| First characteristic numeral | Degree of protection | Application |
|---|---|---|
| 5 | Protected against access to hazardous parts with a wire.<br>The access probe of 1.0 mmØ, shall not penetrate.<br>Test force: 1 N ± 10 % | <input checked="" type="checkbox"/> |

Prove test

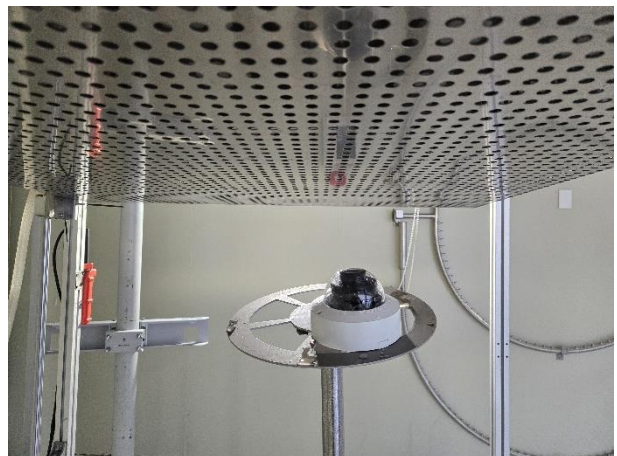
| Second characteristic numeral | Degrees of protection | Application |
|---|---|---|
| 2 | <p>When outskirts of the product have been tilted by 15° Water that drops verticality has to be harmless.</p> <p>Drip box Fig.3, Enclosure in 4 fixed positions of 15° tilt</p> <p>Water flow rate: 3 mm/min</p> <p>Duration of test: 2.5 min for each position of tilt</p> | ☒ |

Waterproof test

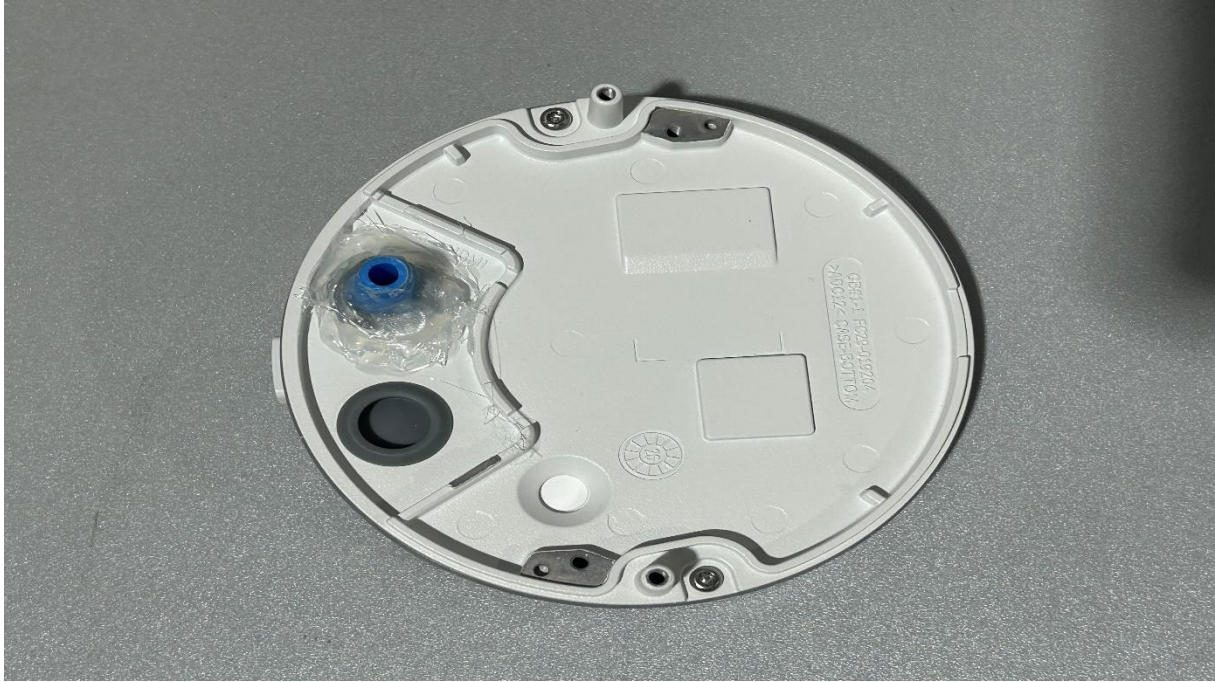
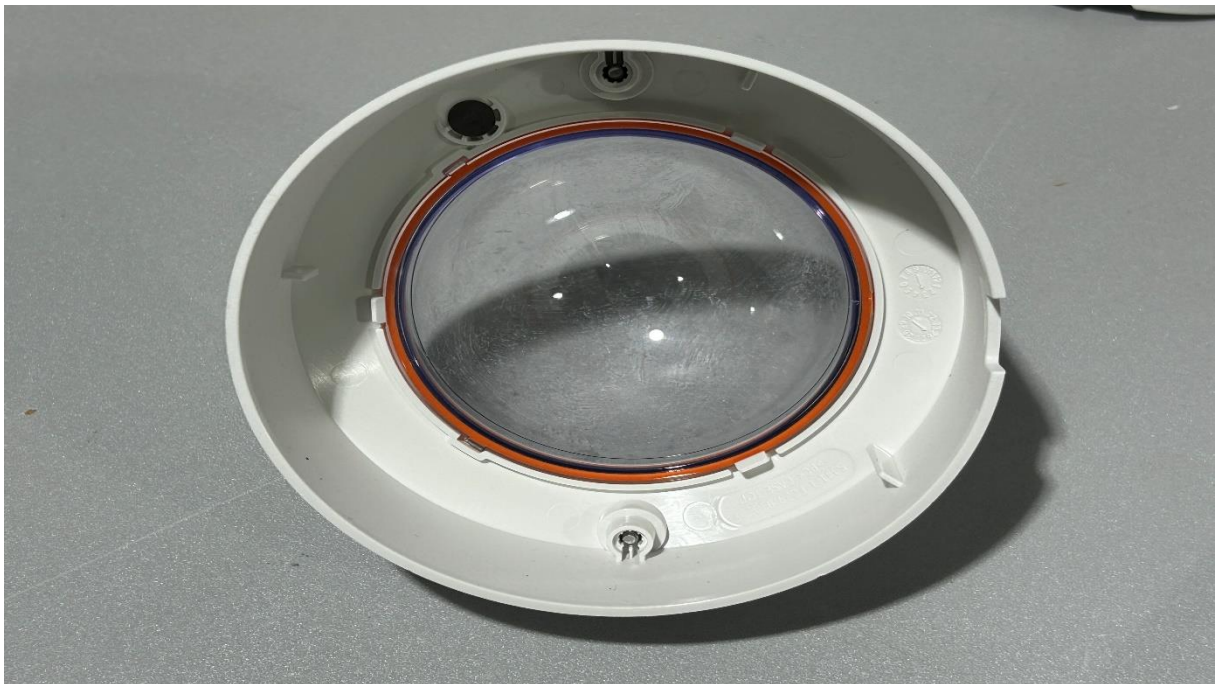
#### 3.5.1 Sample internal images after test [The first characteristic numeral test]

| IP code | Evaluation Criteria | Test Results | Remark |
|---|---|---|---|
| IP 5X | No ingress of Probe | Normal | - |
| | No ingress of dust | Normal | |

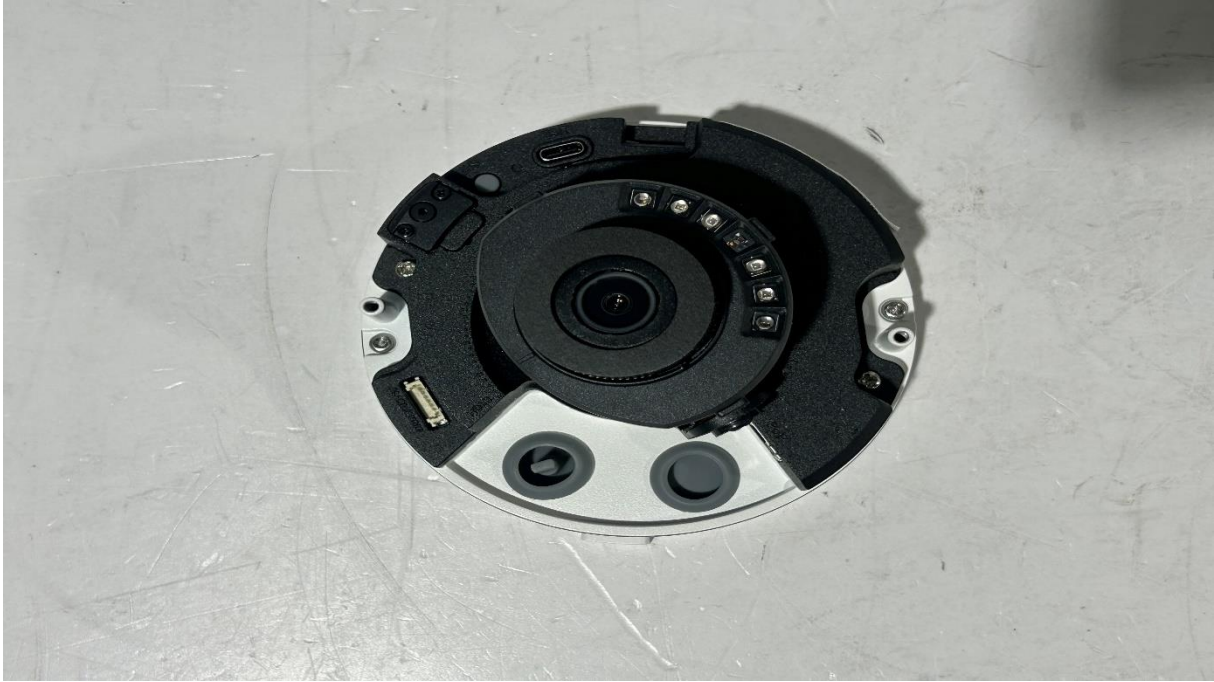
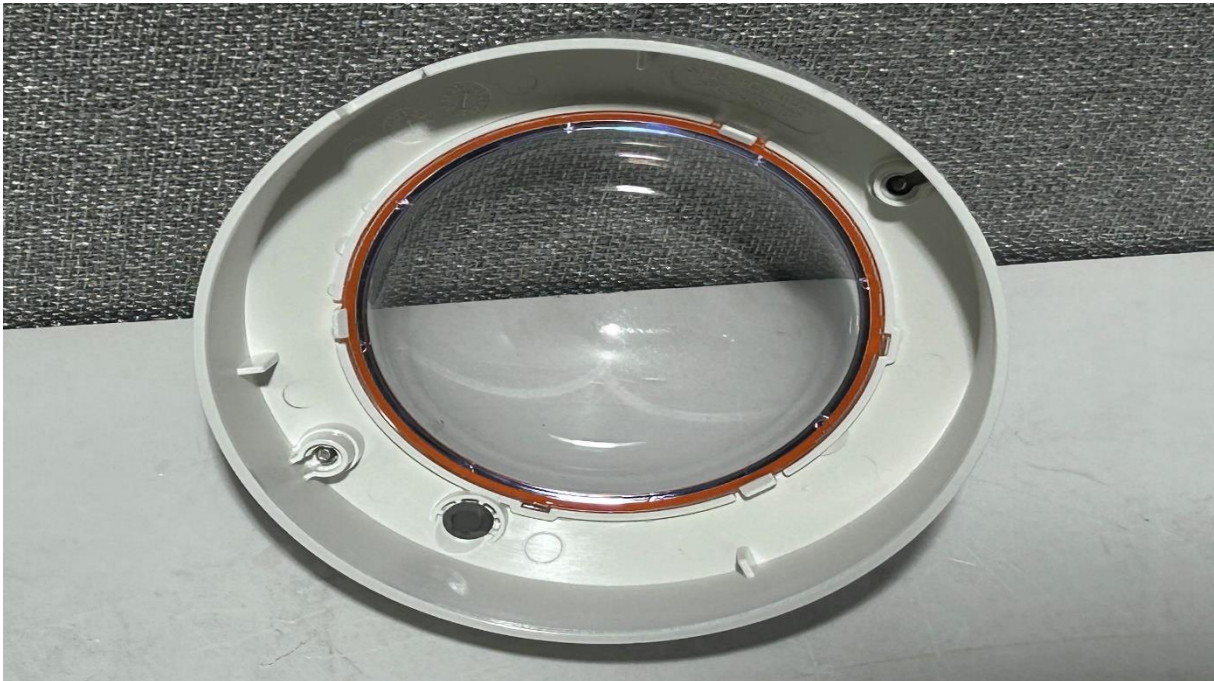
### 3.5.2 Sample internal images after test [The second characteristic numeral test]

| IP code | Evaluation Criteria | Test Results | Remark |
|---|---|---|---|
| IP X2 | No ingress of water | Normal | |
