# TEST REPORT

REPORT No.:  
CTK-2025-02845  
Page (1) / (12) pages

NETWORK CAMERA / XND-A9085RV

IEC 62262:2002+AMD1:2021

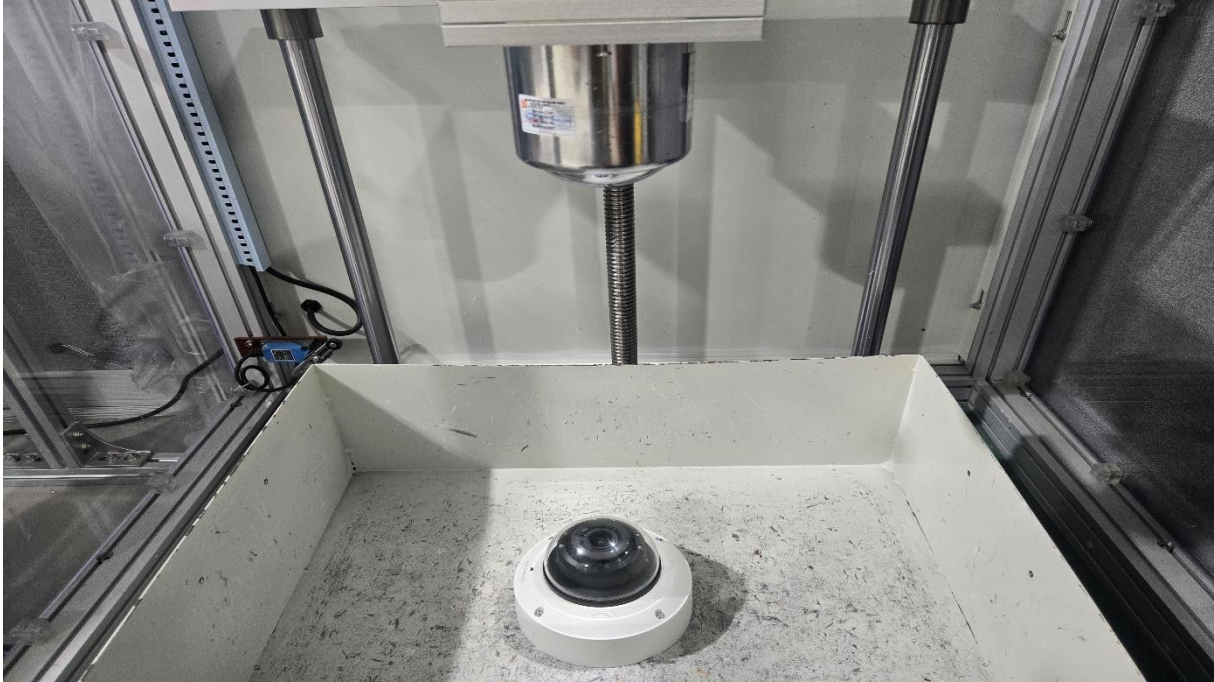
#### 3.3.1 Evidence of test setting (1)

| IK code | Impact Energy (J) | Equivalent mass (kg) | Drop height (mm ± 1%) | Application |
|---|---|---|---|---|
| 10 | 20.00 | 5.00 | 400 | <input checked="" type="checkbox"/> |
| Impact times: five times for each of the exposed surface. (Do not impact more than 3 times in the same spot) | | | | |

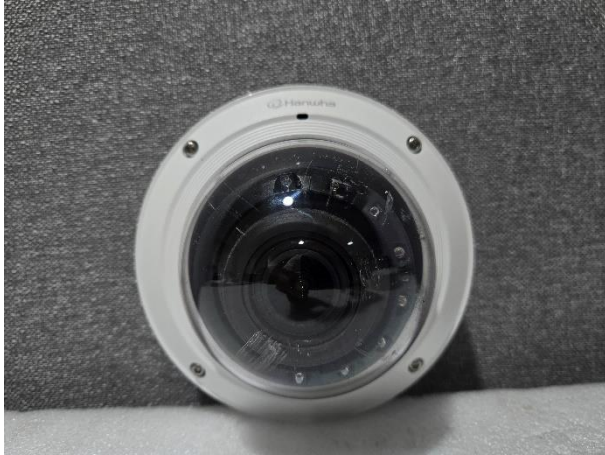
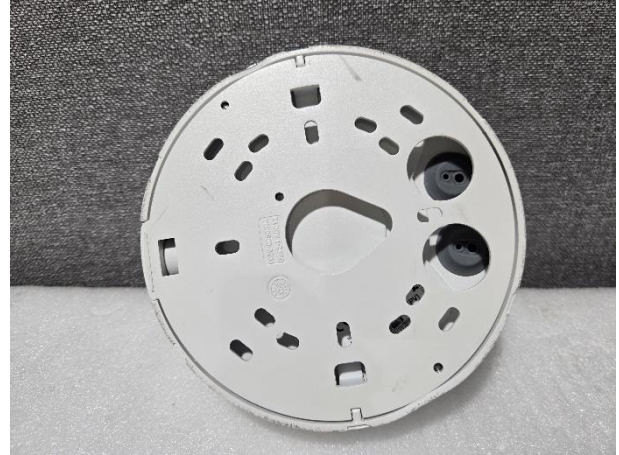
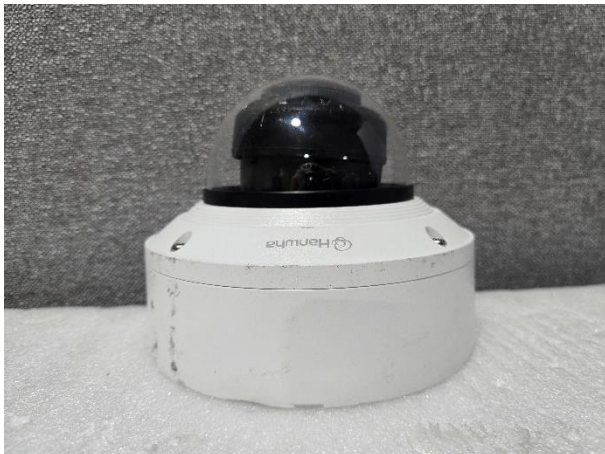
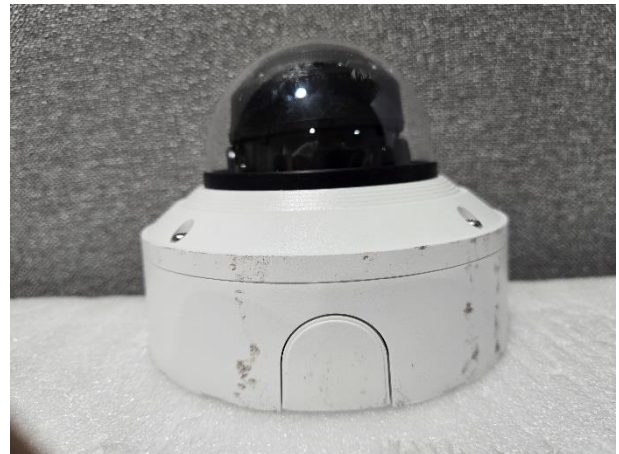
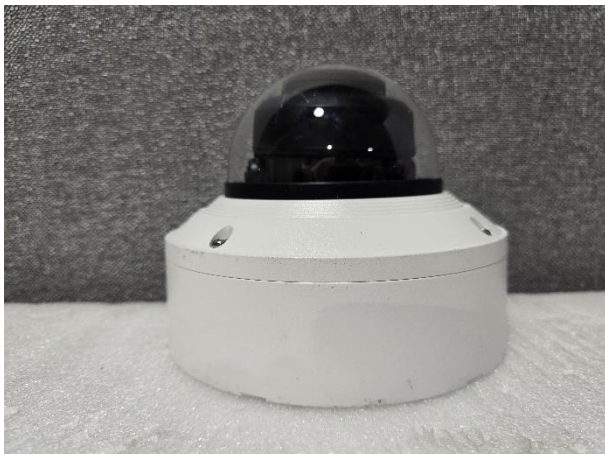
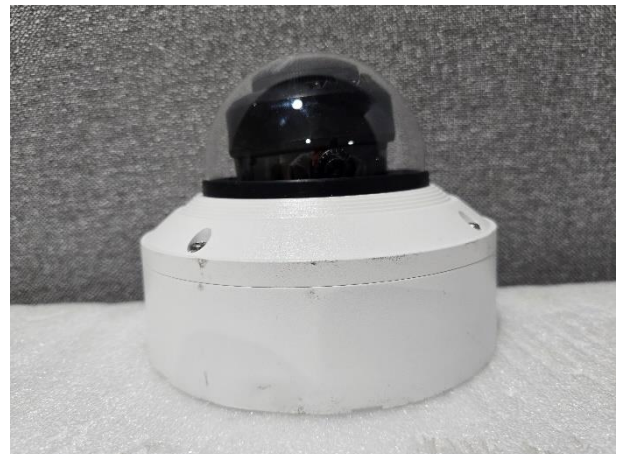
### 3.5.2 Post-test product images

| Evaluation Criteria | Test Results | Remark |
|---|---|---|
| Visual Inspection | Some scratches were generated on the outside of the product. | - |

※ Refer to the product photos after the completion of testing in section 3.5.2
