# TEST REPORT

REPORT No.:  
CTK-2025-02843  
Page (1) / (13) pages

NETWORK CAMERA / XND-A9085RV

IEC 60529:1989 +A1:1999+A2:2013

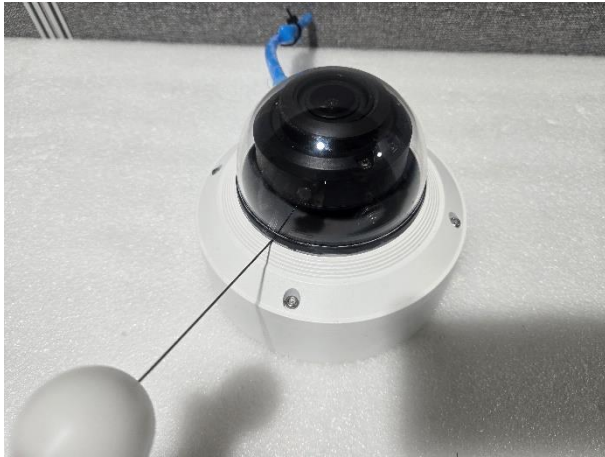
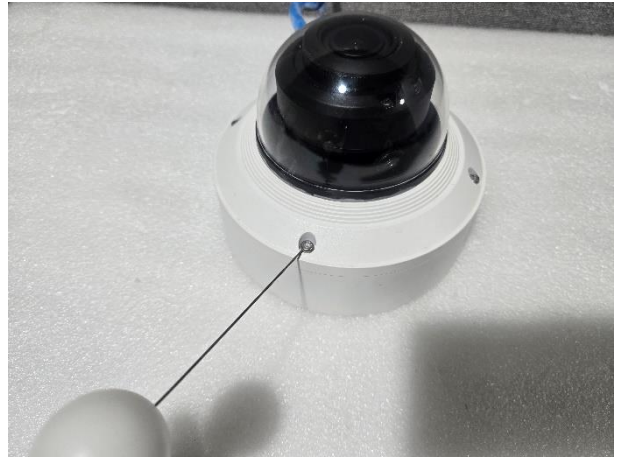
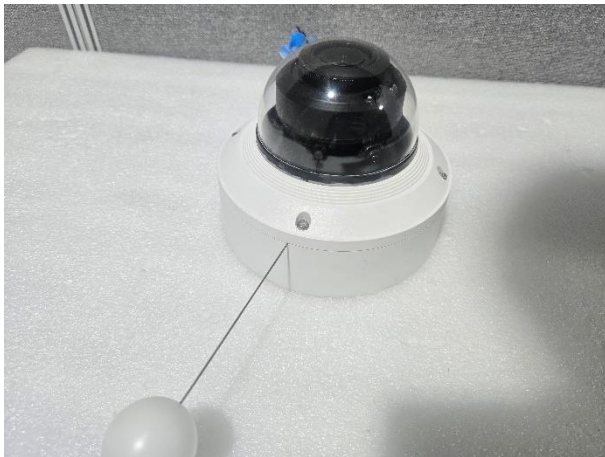
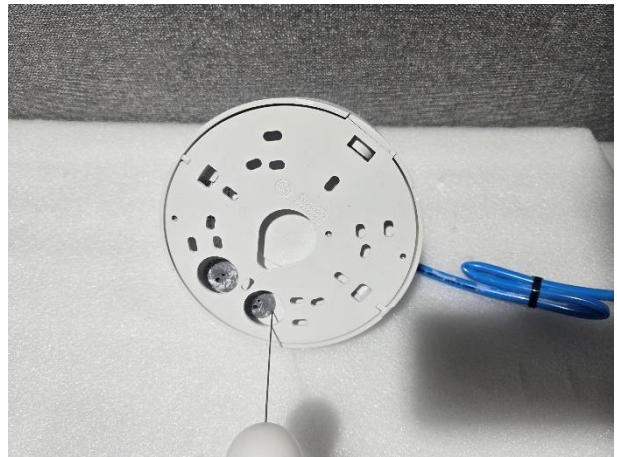
Probe test

| First characteristic numeral | Degree of protection | Application |
|---|---|---|
| 5 | Protected against access to hazardous parts with a wire.<br>The access probe of 1.0 mmØ, shall not penetrate.<br>Test force: 1 N ± 10 % | <input checked="" type="checkbox"/> |

| IP code | Evaluation Criteria | Test Results | Remark |
|---|---|---|---|
| IP 6X | No ingress of Probe | Normal | - |

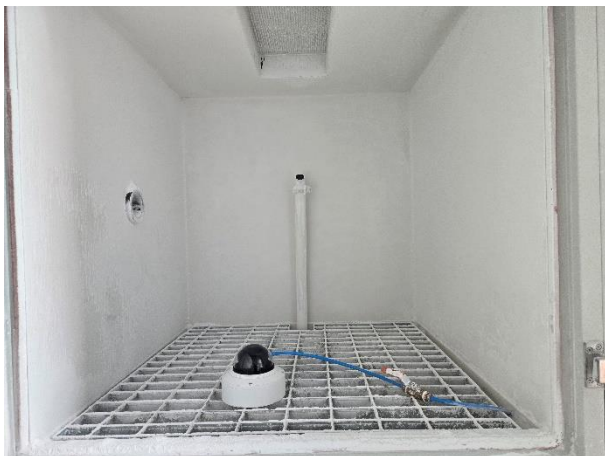
Dust test

| First characteristic numeral | Degree of protection | Application |
|---|---|---|
| | <p><b>Category 1:</b> Enclosures where the normal working cycle of the equipment causes reductions in air pressure within the enclosure below that of the surrounding air, for example, due to thermal cycling effects.</p> <p>Products in volume .....: <b>2 512 <math>\text{cm}^3 \rightarrow 2.512 \text{ L}</math></b></p> <p>Target intake volume (Products in volume 80) : <b>200.96 L</b></p> <p>Suction volume (Max product in volume 60) ..: <b>150.72 LPH <math>\rightarrow 2.512 \text{ LPM}</math></b></p> <p>Actual Suction volume .....: <b>2.502 L</b></p> <p>Suction pressure (Up to 2 kPa) .....: <b>2 kPa</b></p> <p>Test time (Up to 8 time) .....: <b>8 hr</b></p> | <input checked="" type="checkbox"/> |

| IP code | Evaluation Criteria | Test Results | Remark |
|---|---|---|---|
| | No ingress of dust | Normal | |

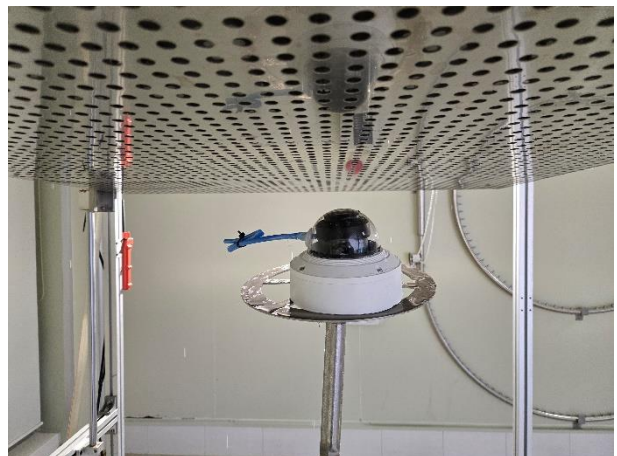
Water test

| Second characteristic numeral | Degrees of protection | Application |
|---|---|---|
| 2 | <p>When outskirts of the product have been tilted by 15° Water that drops verticality has to be harmless.</p> <p>Drip box Fig.3, Enclosure in 4 fixed positions of 15° tilt</p> <p>Water flow rate: 3 mm/min</p> <p>Duration of test: 2.5 min for each position of tilt</p> | ☒ |

| IP code | Evaluation Criteria | Test Results | Remark |
|---|---|---|---|
| IP X6 | No ingress of water | Normal | |

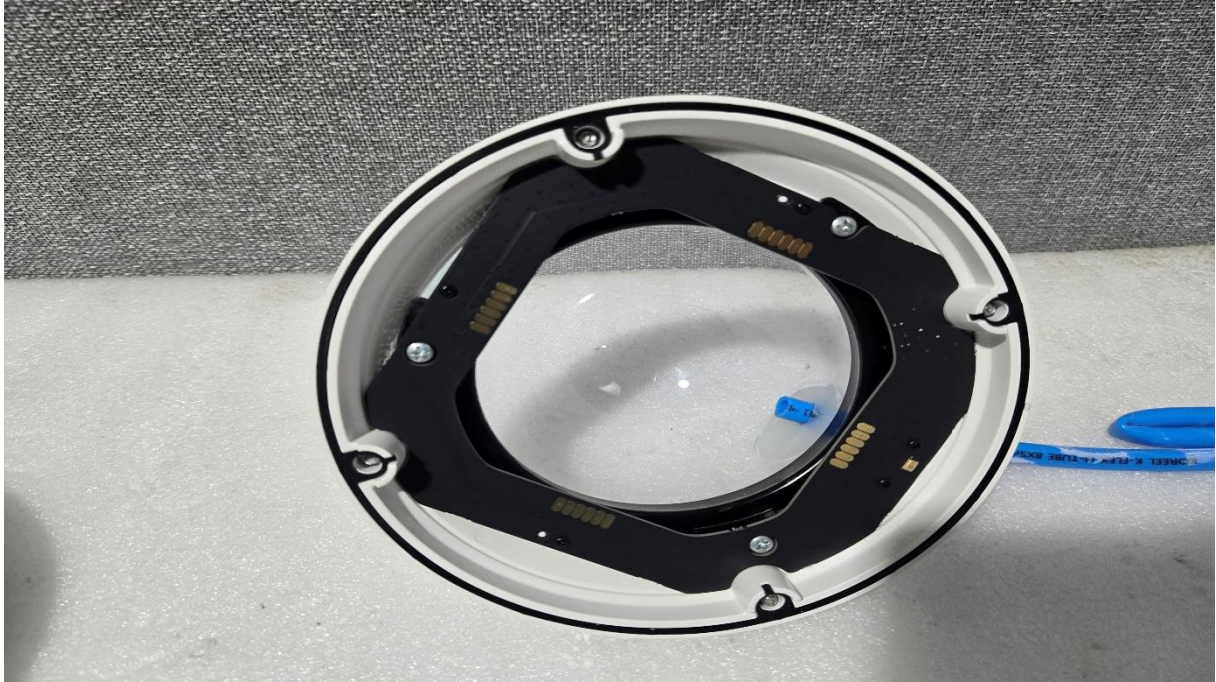
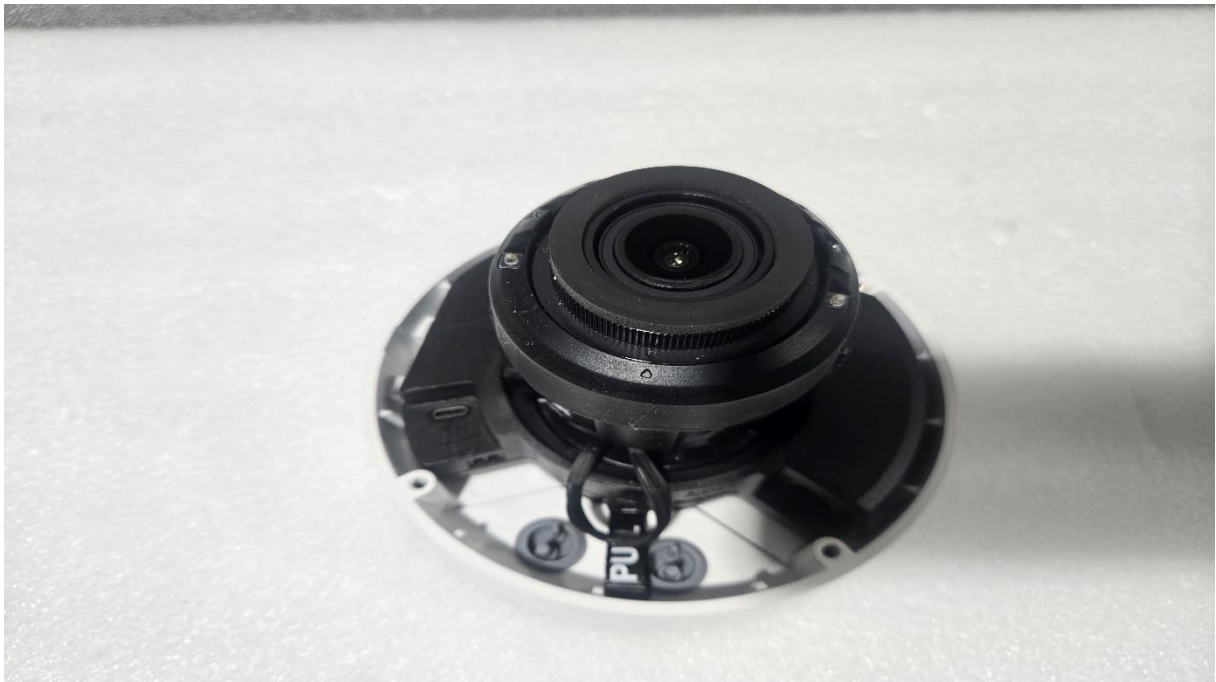
#### 3.5.1 Product internal images after test [The first and second characteristic numeral test]

※ Refer to the product photos after the completion of testing in section 3.5.
