# TEST REPORT

REPORT No.:  
CTK-2025-02846  
Page (1) / (37) pages

NETWORK CAMERA / XND-A9085RV

EN 60068-2-1, EN 60068-2-2, EN 60068-2-14, EN 60068-2-6, EN 60068-2-27, EN 60068-2-78, IEC 60068-2-1, IEC 60068-2-2, IEC 60068-2-14, IEC 60068-2-6, IEC 60068-2-27, IEC 60068-2-78

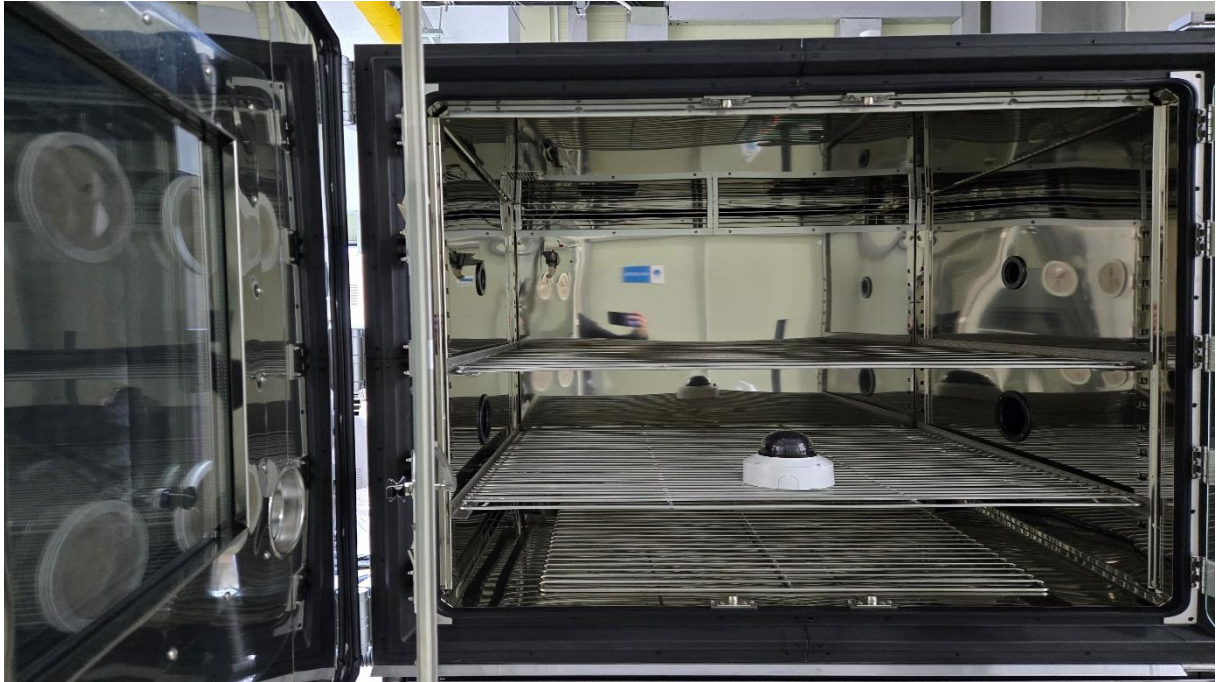
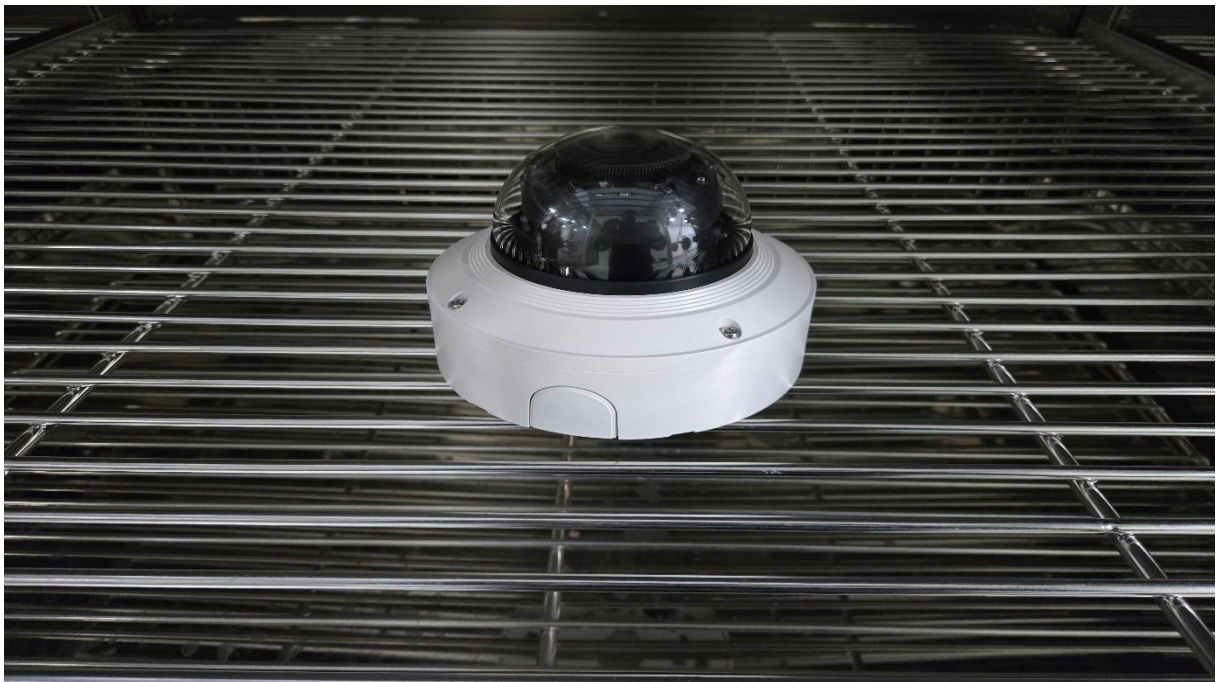
#### 3.3.1 Evidence of test setting

3.2.1 Sample status: Non-operation

3.2.2 Test temperature: -33 °C

3.2.3 Test time: 16 h

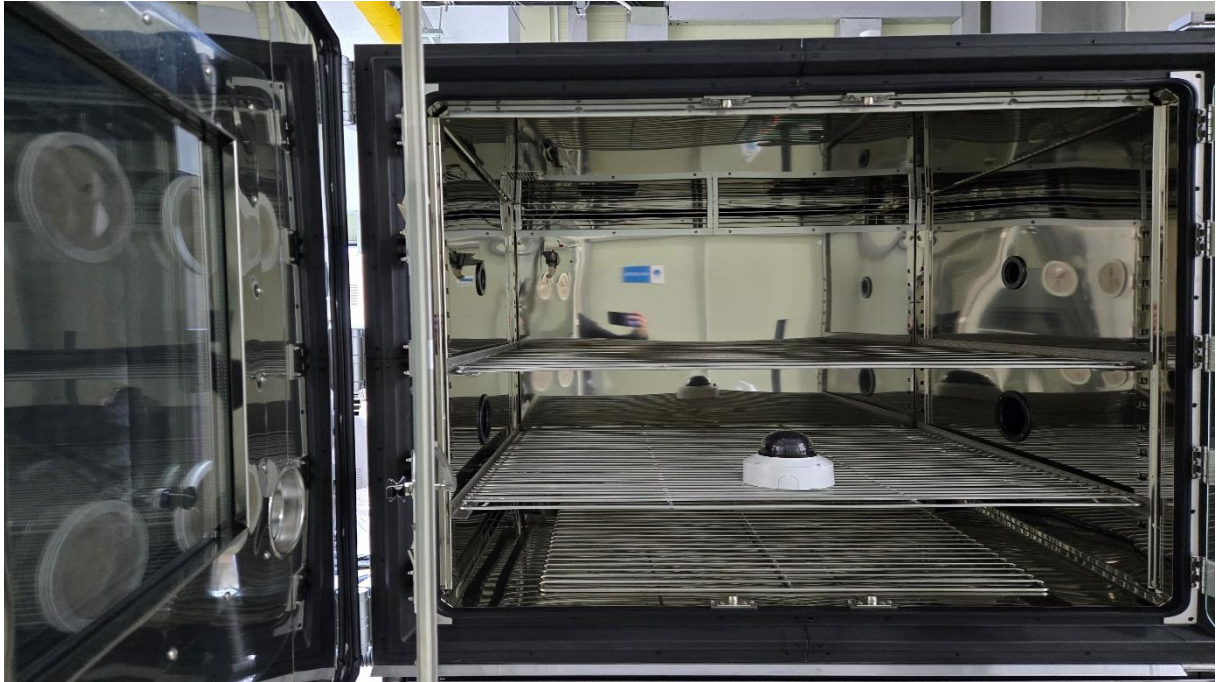
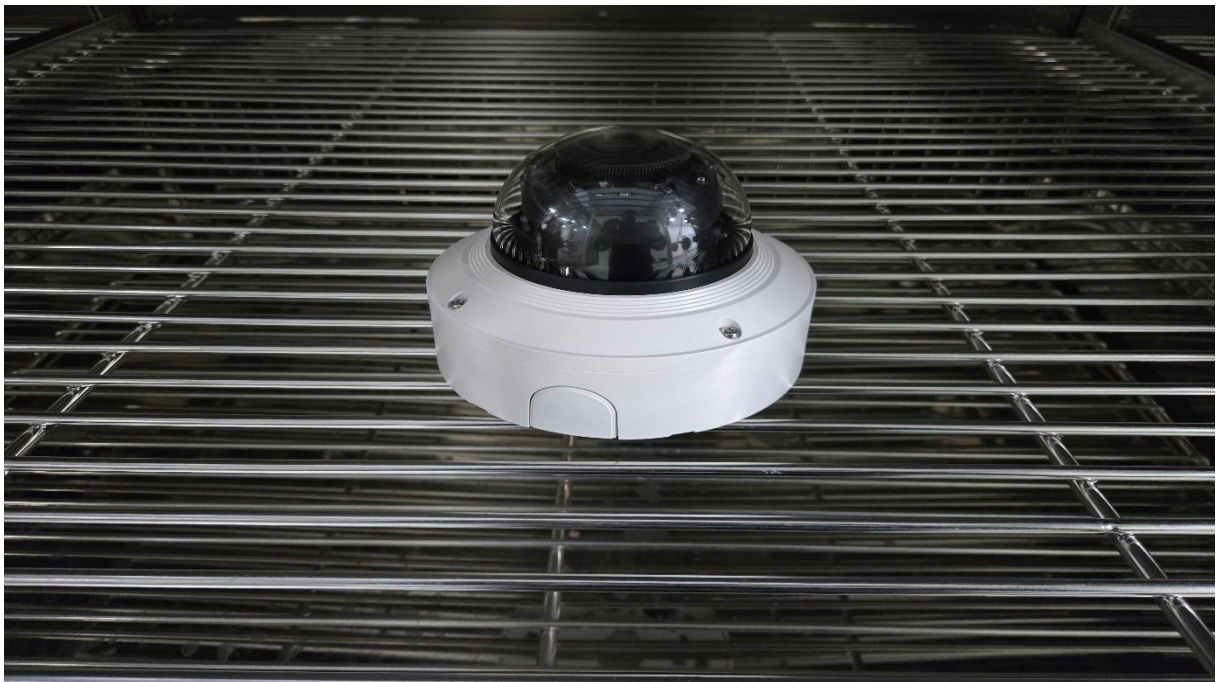
#### 4.3.1 Evidence of test setting

4.2.1 Sample status: Non-operation

4.2.2 Test temperature: 60 °C

4.2.3 Test time: 96 h

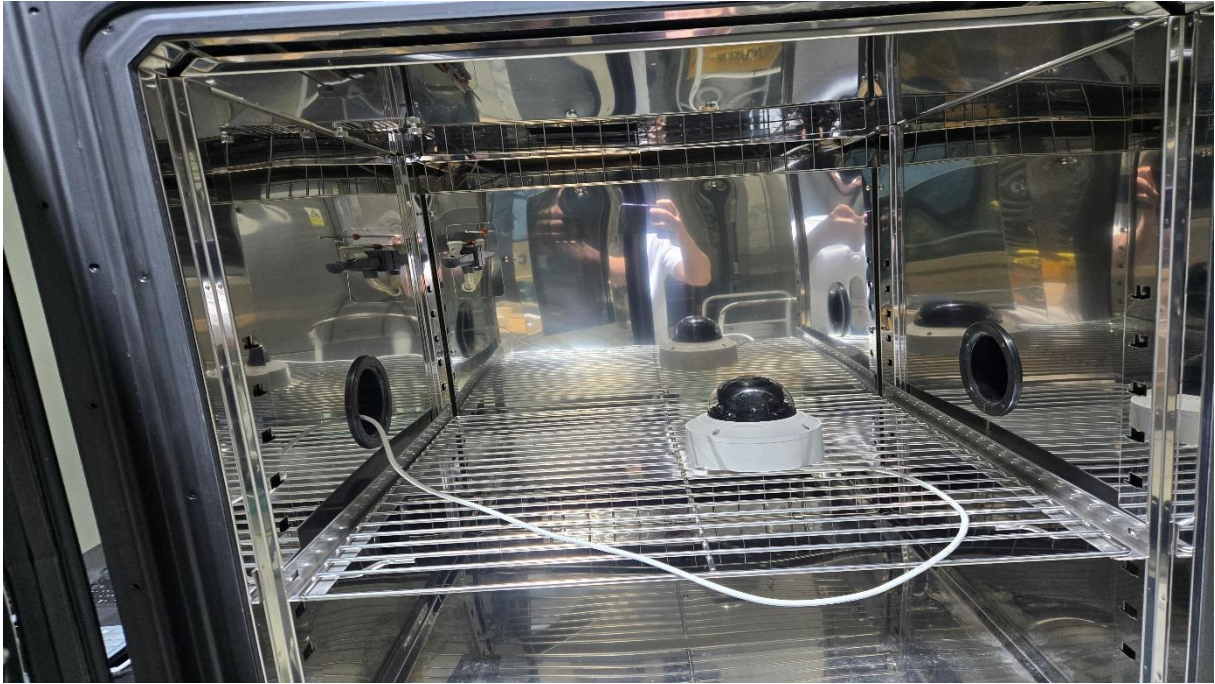
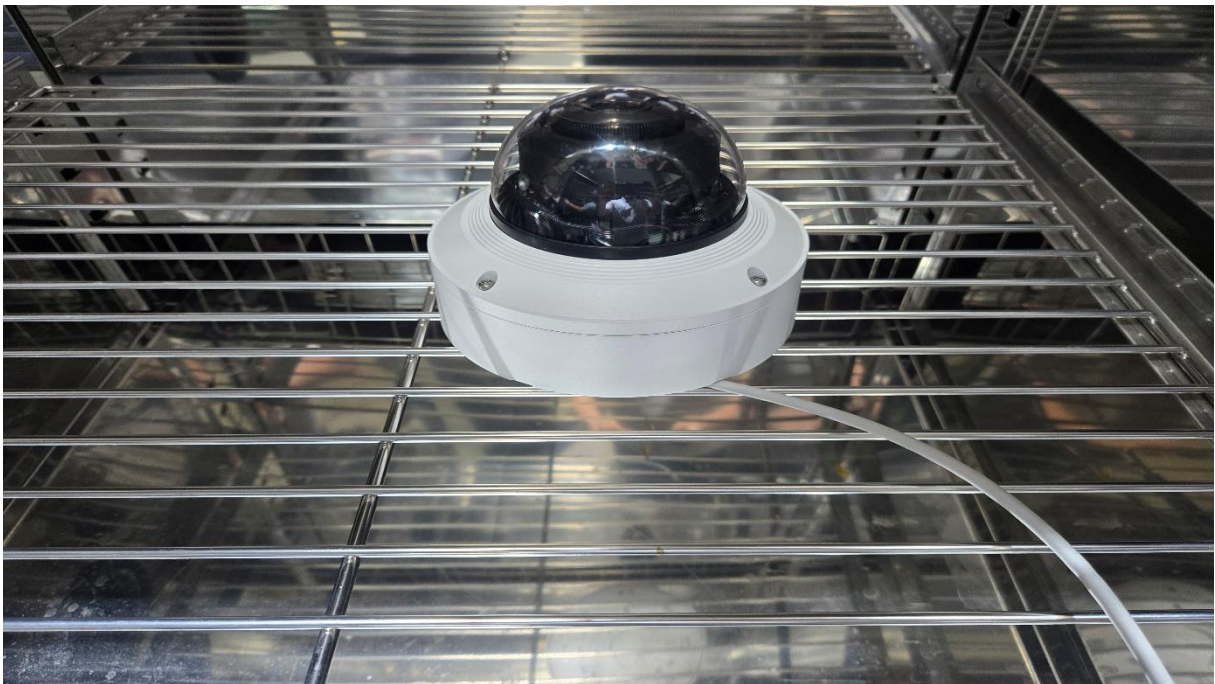
#### 5.3.1 Evidence of test setting

5.2.1 Sample status: operation

5.2.2 Test temperature: -33 °C, 55 °C

| Temp↵ | Temperature change rate(°C/min)↵ | t <sub>1</sub> (idle time)↵ | Cycles↵ |
| High↵ | 5 °C/min↵ | 3 h↵ | 3↵ |
| Low↵ | 1 °C/min↵ | 3 h↵ | 3↵ |

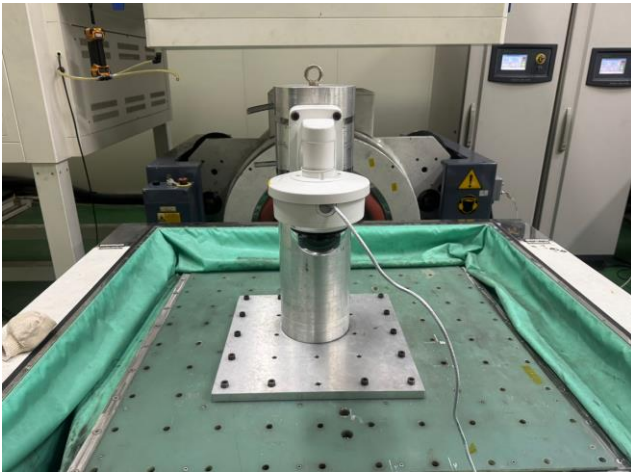
X axis

- Sample status: operation
- Frequency(Hz): 5 Hz ~ 200 Hz
- Acceleration(G): 1 G
- Sweep rate: 1 oct/min
- Test Axis: X, Y, Z
- Test time(h): Total 30 min (10 min. per each axis)

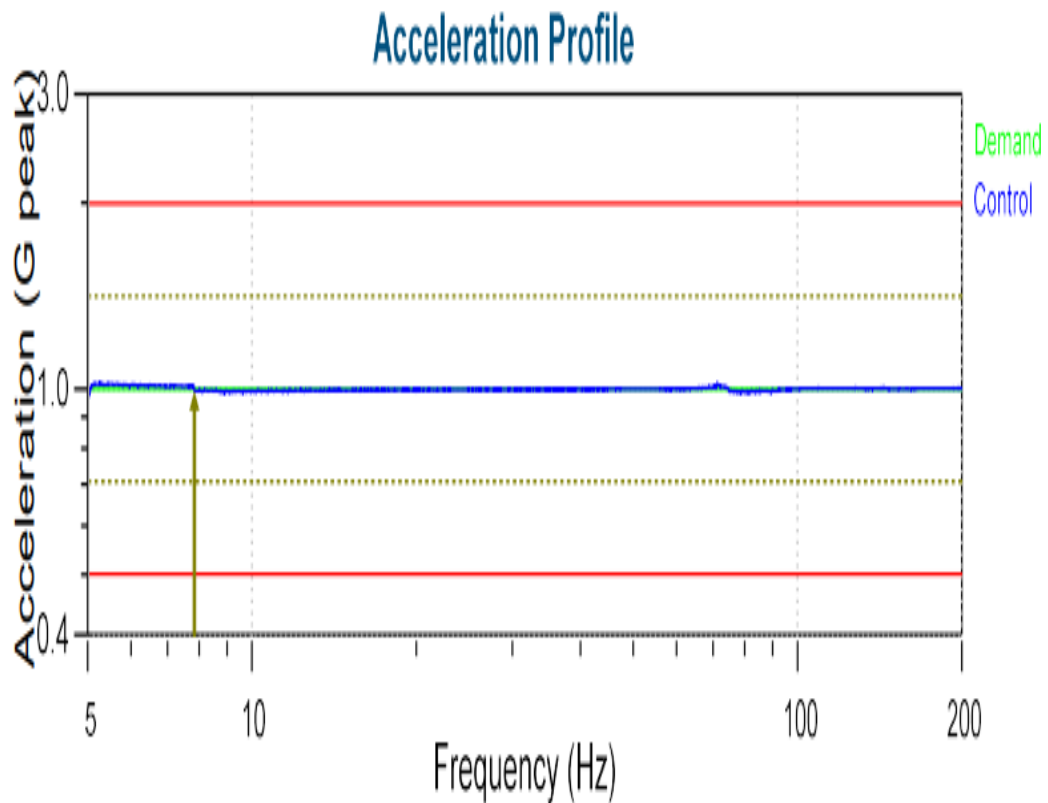
### 6.5.1 Test data and graph (Vibration Test X Axis)

Demand: 1 G Level Time: 0:10:0

Frequency: 7.841 Hz

Control: 0.001274 G Total Time: 0:10:1

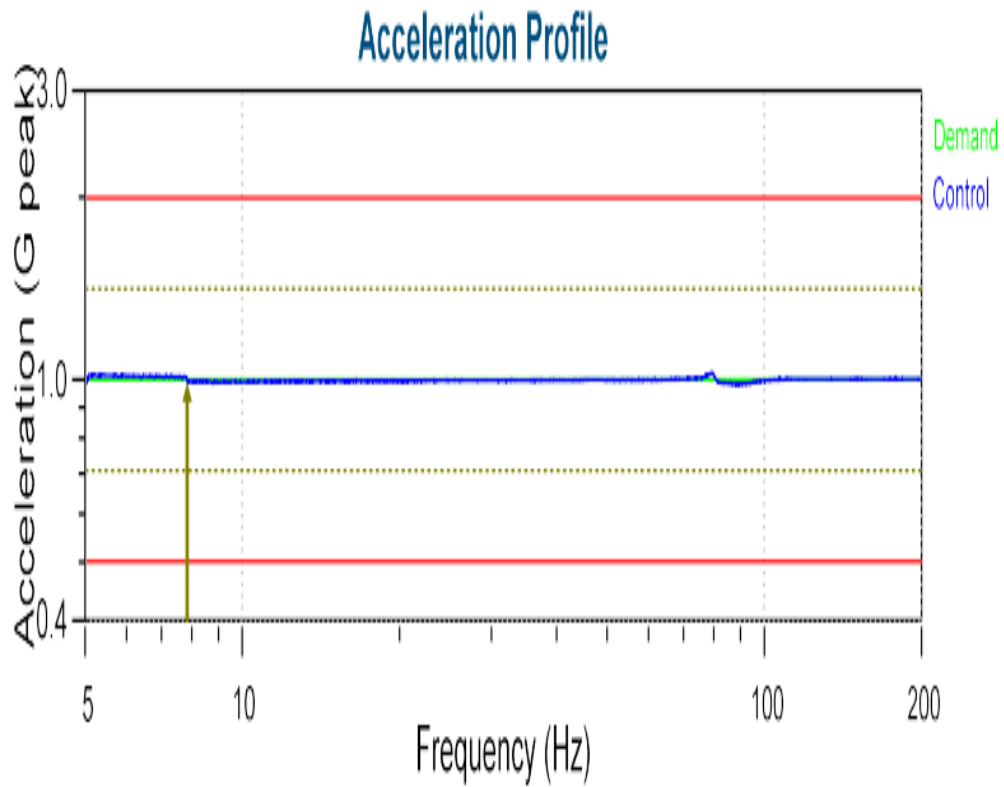
### 6.5.2 Test data and graph (Vibration Test Y Axis)

Demand: 1 G Level Time: 0:10:0

Frequency: 7.841 Hz

Control: 0.003047 G Total Time: 0:10:1

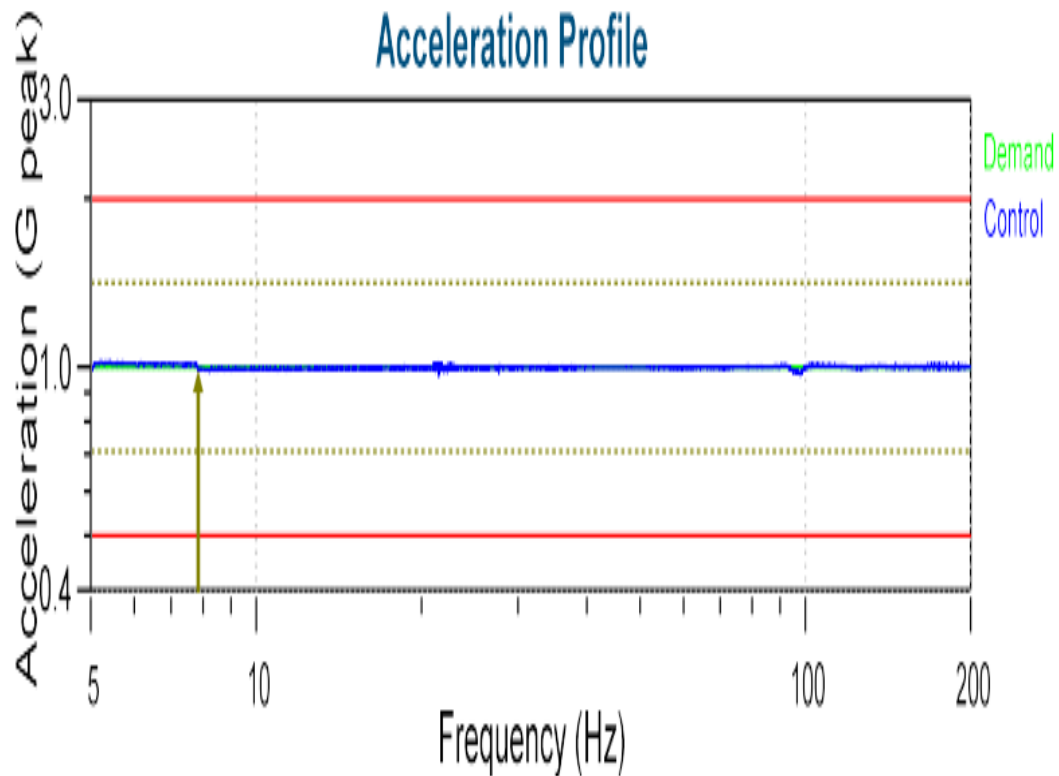
### 6.5.3 Test data and graph (Vibration Test Z Axis)

Demand: 1 G Level Time: 0:10:00 Frequency: 7.841 Hz

Control: 0.9895 G Total Time: 0:10:12 End of Timed Test

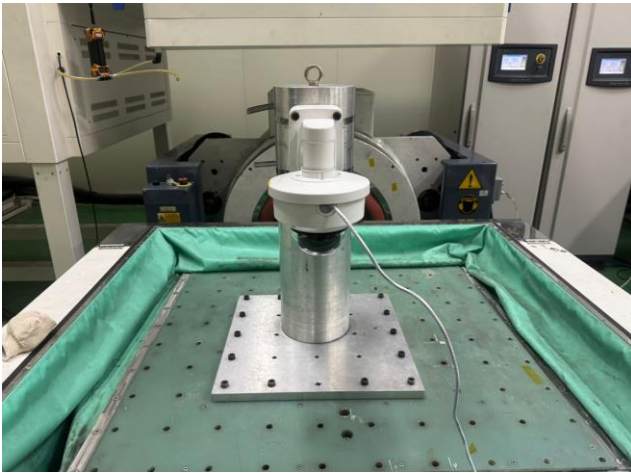
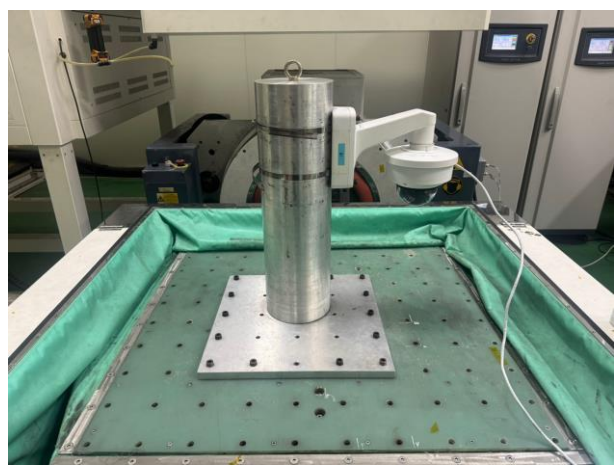
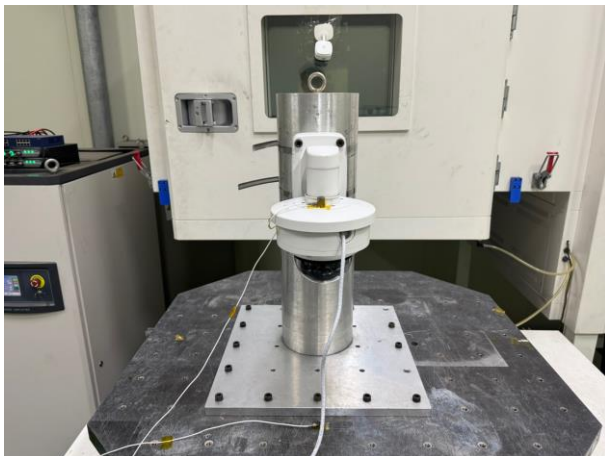
#### 7.3.1 Evidence of test setting

7.2.1 Sample status: Non-operation

7.2.2 Acceleration( $\text{m/s}^2$ ):  $150 \text{ m/s}^2$

7.2.3 Number of impacts: 10 per direction (total 60)

7.2.4 Test Axis: X, Y, Z

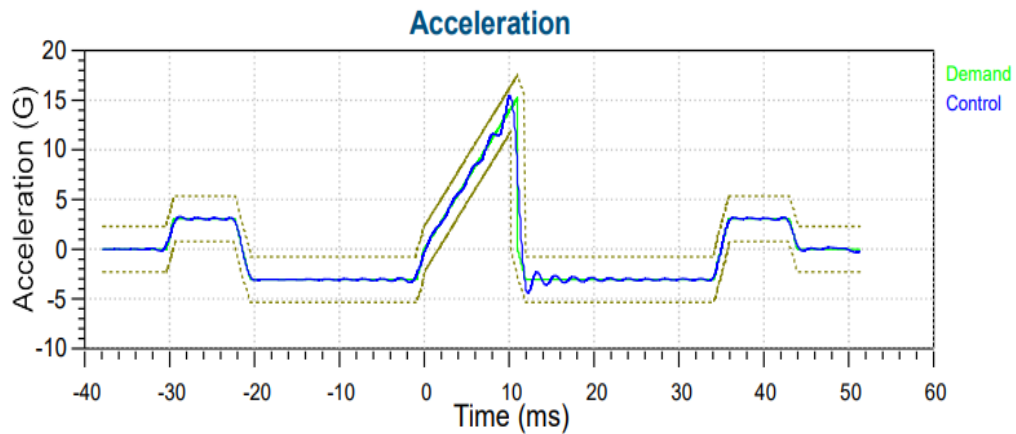
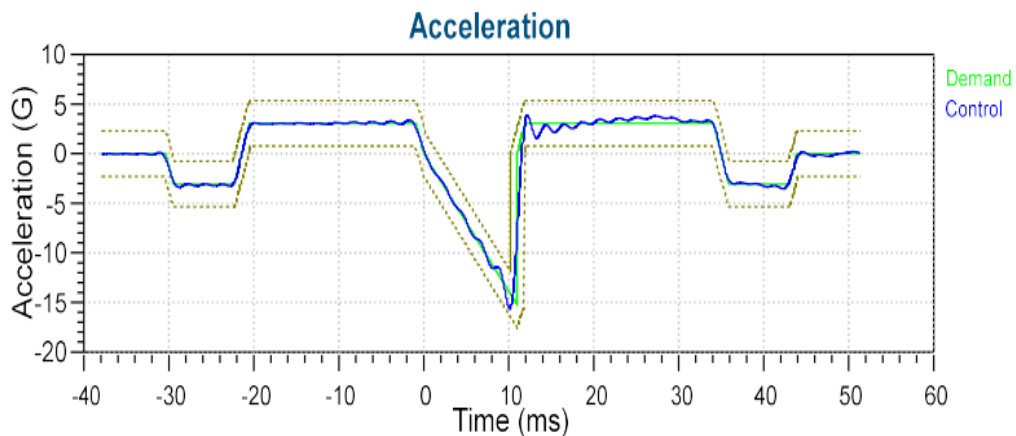
#### 7.5.1 Test data and graph (Shock Test X Axis)

10 20, 2025 14:38:31 Level 1) 100 %  
Demand: 15.3 G  
Control: 15.43 G Pulse: 10 of 10

10 20, 2025 14:39:01 Level 2) 100 %  
Demand: 15.3 G  
Control: 15.63 G Pulse: 10 of 10

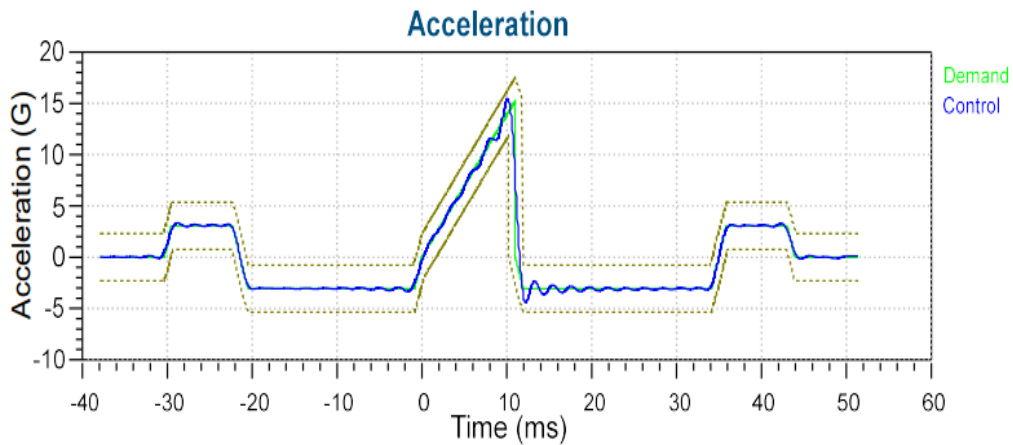
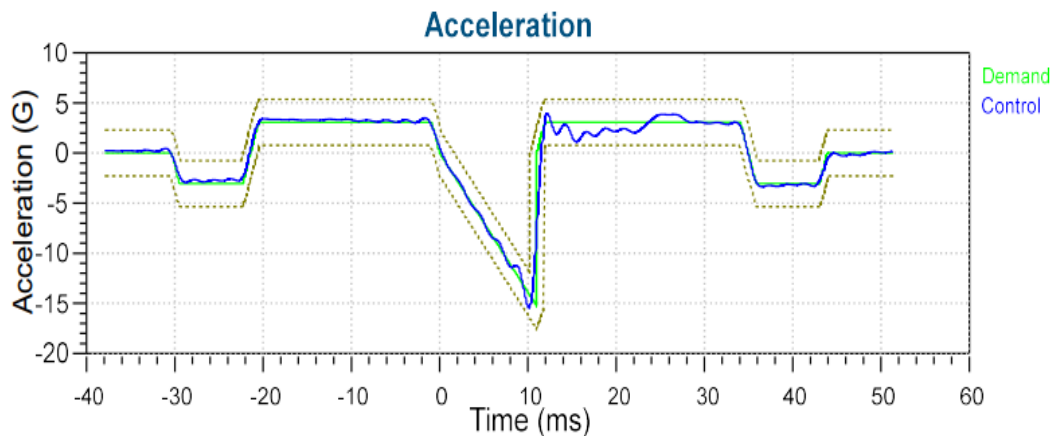
### 7.5.2 Test data and graph (Shock Test Y Axis)

10 20, 2025 14:56:0 Level 1) 100 %  
Demand: 15.3 G  
Control: 15.46 G Pulse: 10 of 10

10 20, 2025 14:56:3 Level 2) 100 %  
Demand: 15.3 G  
Control: 15.43 G Pulse: 10 of 10

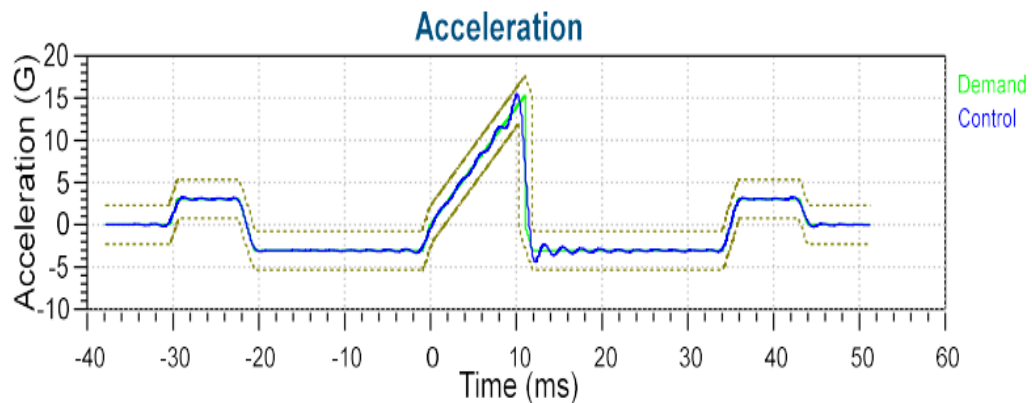
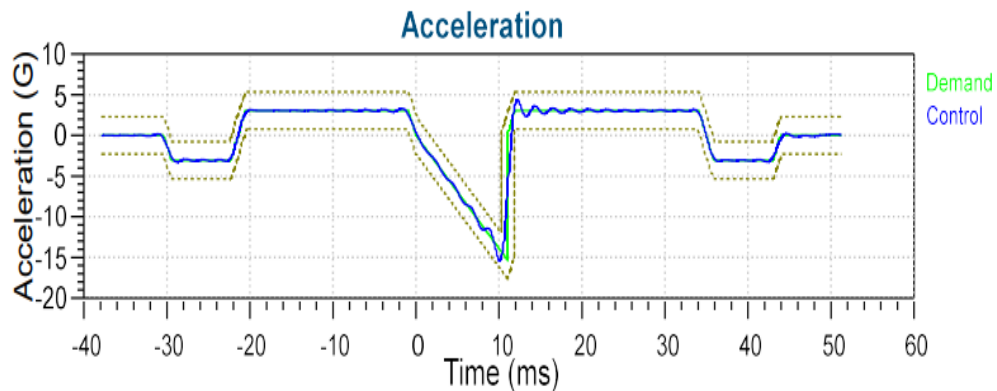
### 7.5.3 Test data and graph (Shock Test Z Axis)

10 21, 2025 19:19:45 Level 1) 100 % Output: 1.35 Volts peak 60068-2-27  
Demand: 15.3 G  
Control: 15.45 G Pulse: 10 of 10 Running

10 21, 2025 19:20:16 Level 2) 100 % Output: 1.406 Volts peak 60068-2-27  
Demand: 15.3 G  
Control: 15.43 G Pulse: 10 of 10 End of Test

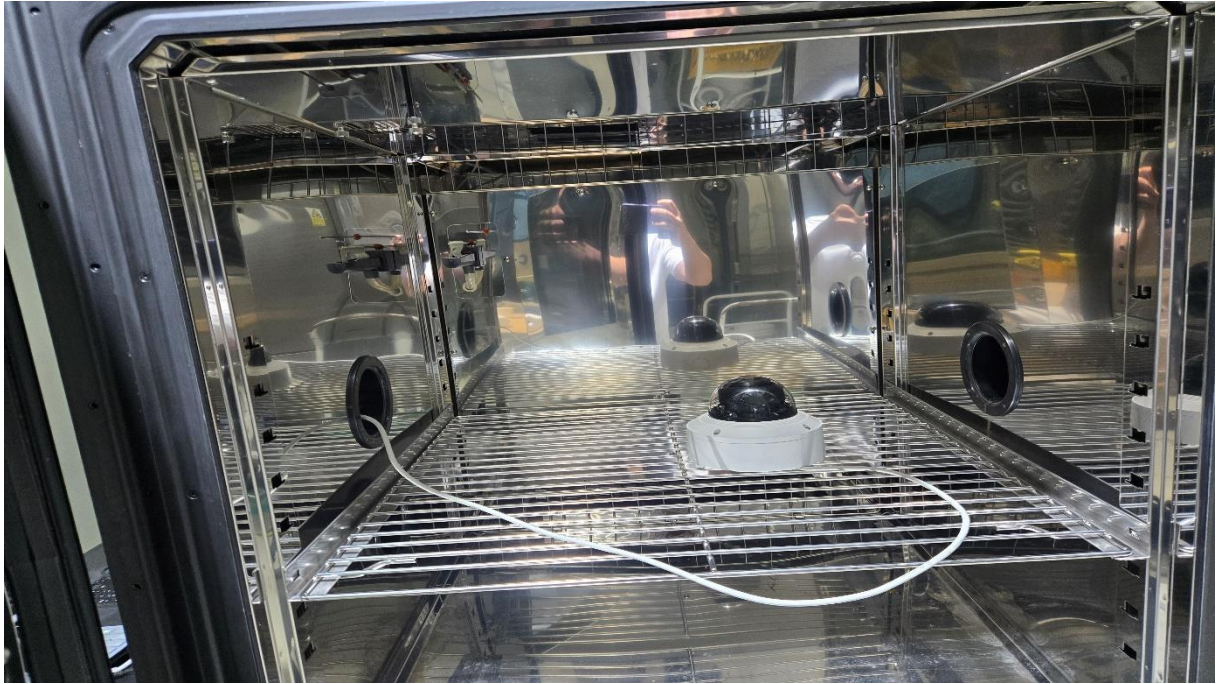
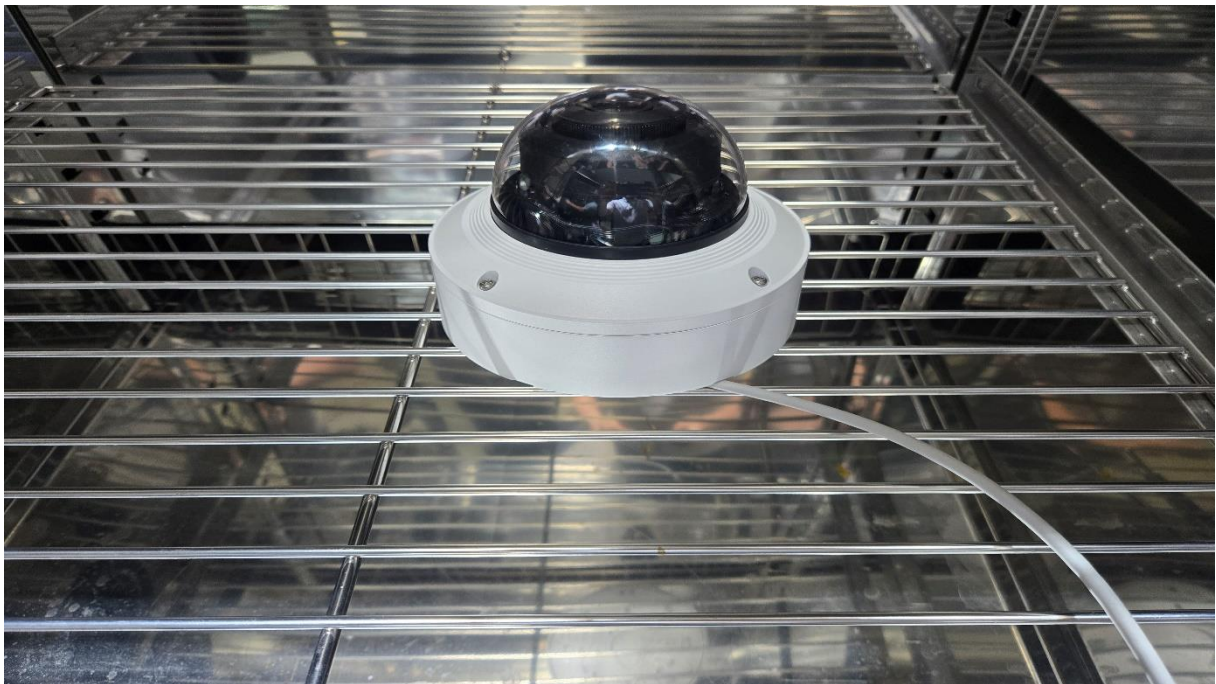
#### 8.3.1 Evidence of test setting

8.2.1 Sample status: operation

8.2.2 Test temperature:  $40 \pm 2$  °C

8.2.3 Test Humidity:  $93 \pm 3$  % R.H.

8.2.4 Test time: 240 h
