# TEST REPORT

REPORT No.:  
CTK-2025-03002  
Page (1) / (12) pages

NETWORK CAMERA / XNF-A9014RV

IEC 62262:2002+AMD1:2021

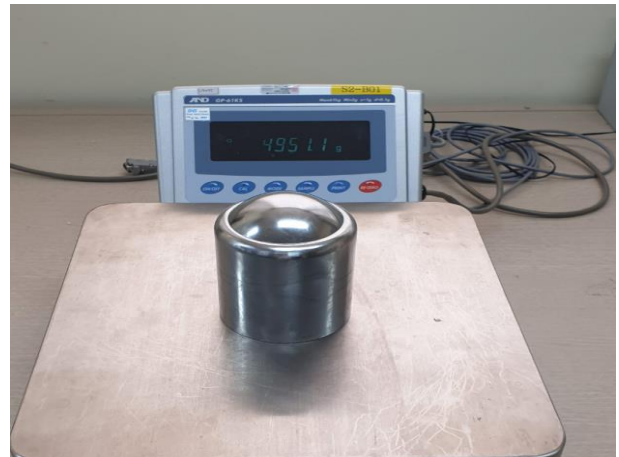
| Testing equipment | Model Name | Manufacturer | Manufacturing Number | Next Cal. Date |
|---|---|---|---|---|
| Vertical Hammer | 5000g | Kingpo | TX-029-20J | Jul. 08, 2026 |

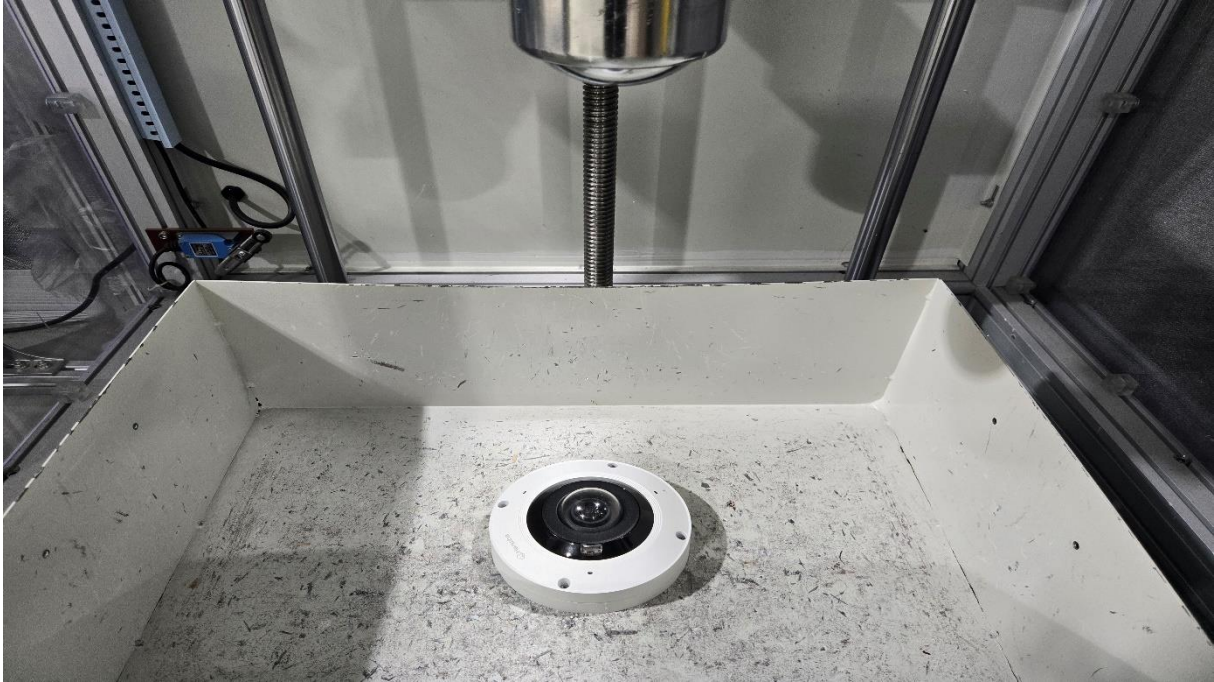
#### 3.3.1 Evidence of test setting (1)

| IK code | Impact Energy (J) | Equivalent mass (kg) | Drop height (mm ± 1%) | Application |
|---|---|---|---|---|
| 10 | 20.00 | 5.00 | 400 | <input checked="" type="checkbox"/> |
| Impact times: five times for each of the exposed surface. (Do not impact more than 3 times in the same spot) | | | | |

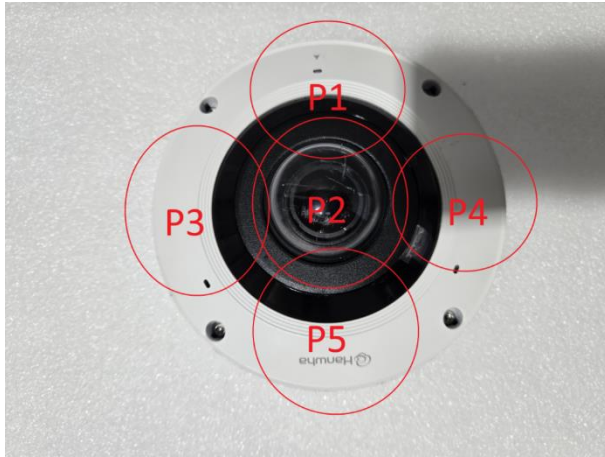
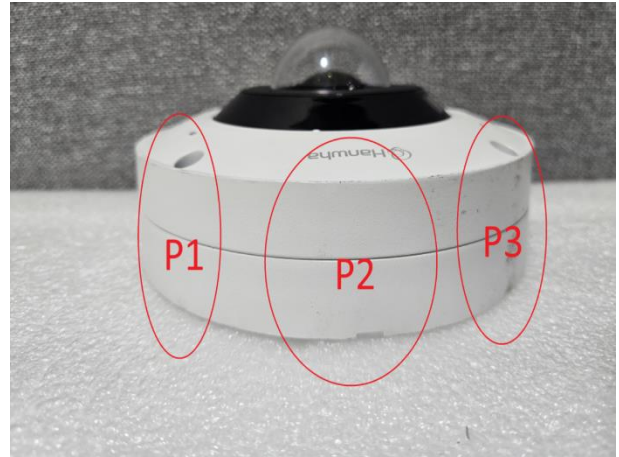
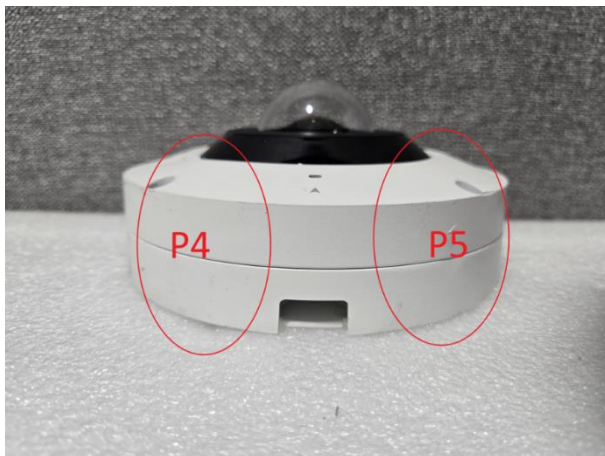
#### 3.5.1 Check the hit area during the test

Check the hit area the test\_1

Check the hit area the test\_2

Check the hit area the test\_3

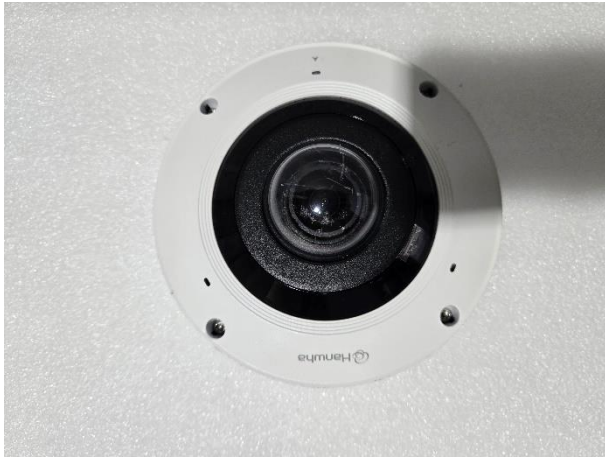
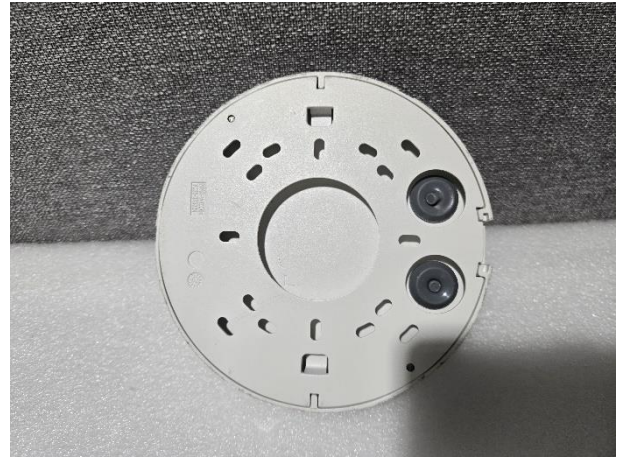
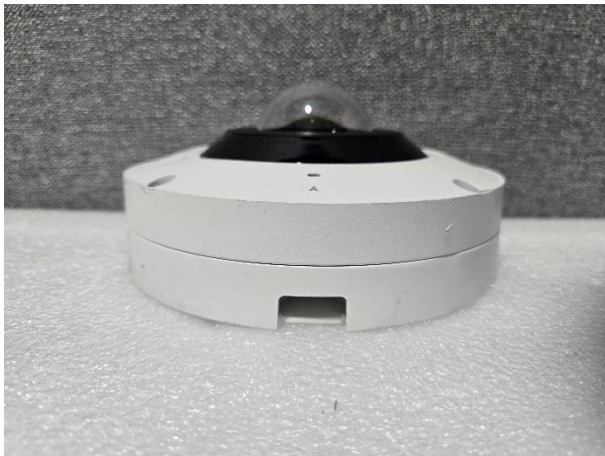
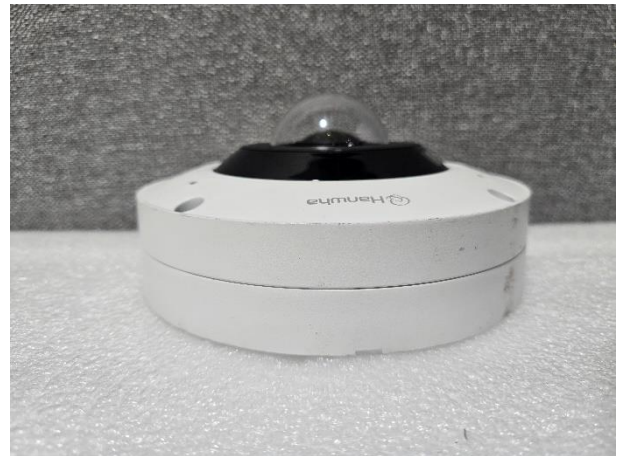
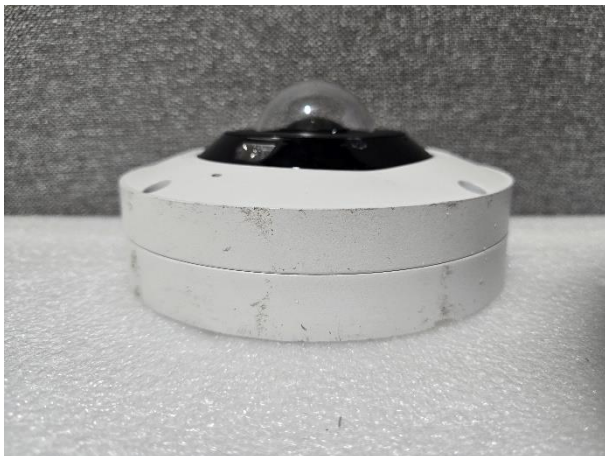
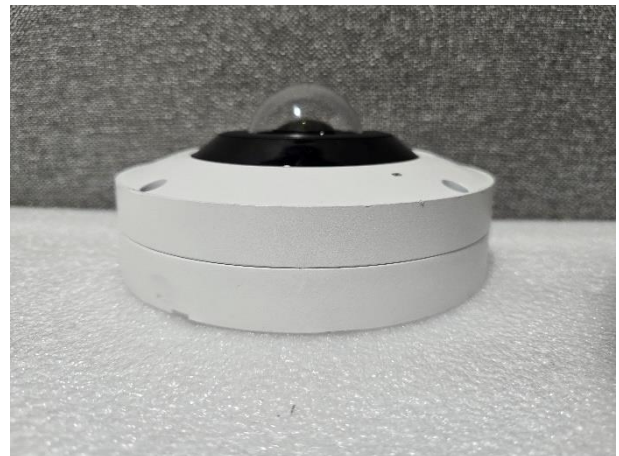
### 3.5.2 Post-test product images

| Evaluation Criteria | Test Results | Remark |
|---|---|---|
| Visual Inspection | Some scratches were generated on the outside of the product. | - |

※ Refer to the product photos after the completion of testing in section 3.5.2
