# TEST REPORT

REPORT No.:  
CTK-2025-03066  
Page (1) / (37) pages

NETWORK CAMERA / XNF-A9014RV

EN 60068-2-1, EN 60068-2-2, EN 60068-2-14, EN 60068-2-6, EN 60068-2-27, EN 60068-2-78, IEC 60068-2-1, IEC 60068-2-2, IEC 60068-2-14, IEC 60068-2-6, IEC 60068-2-27, IEC 60068-2-78

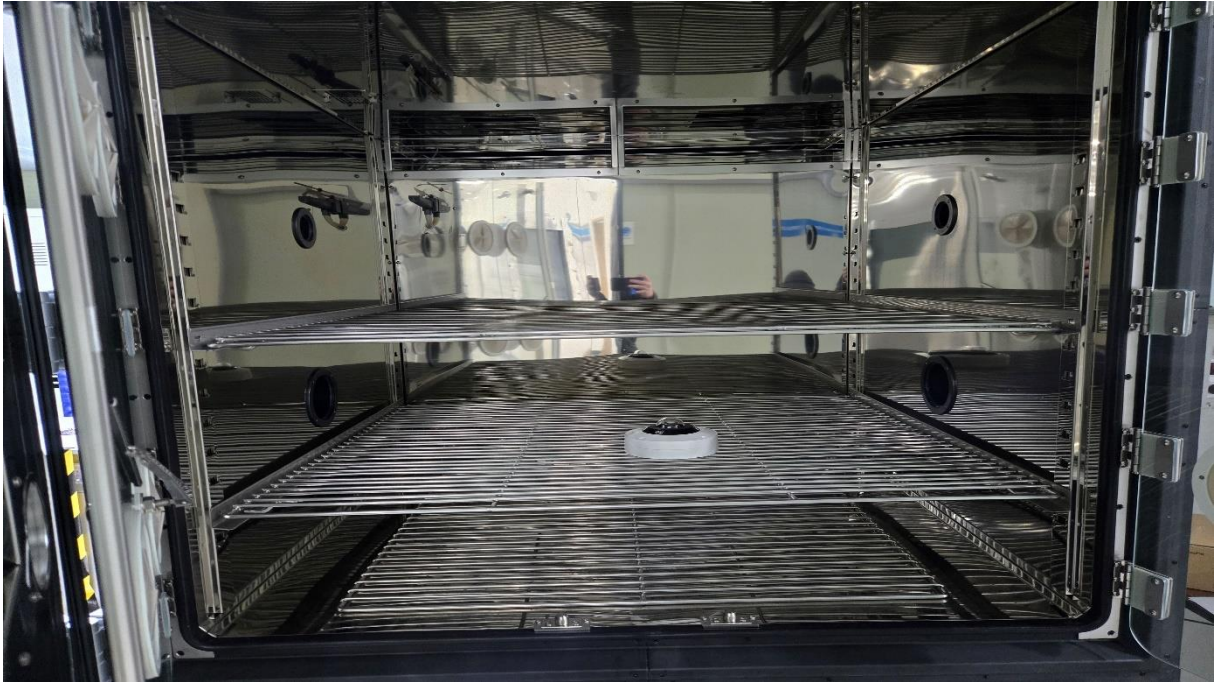
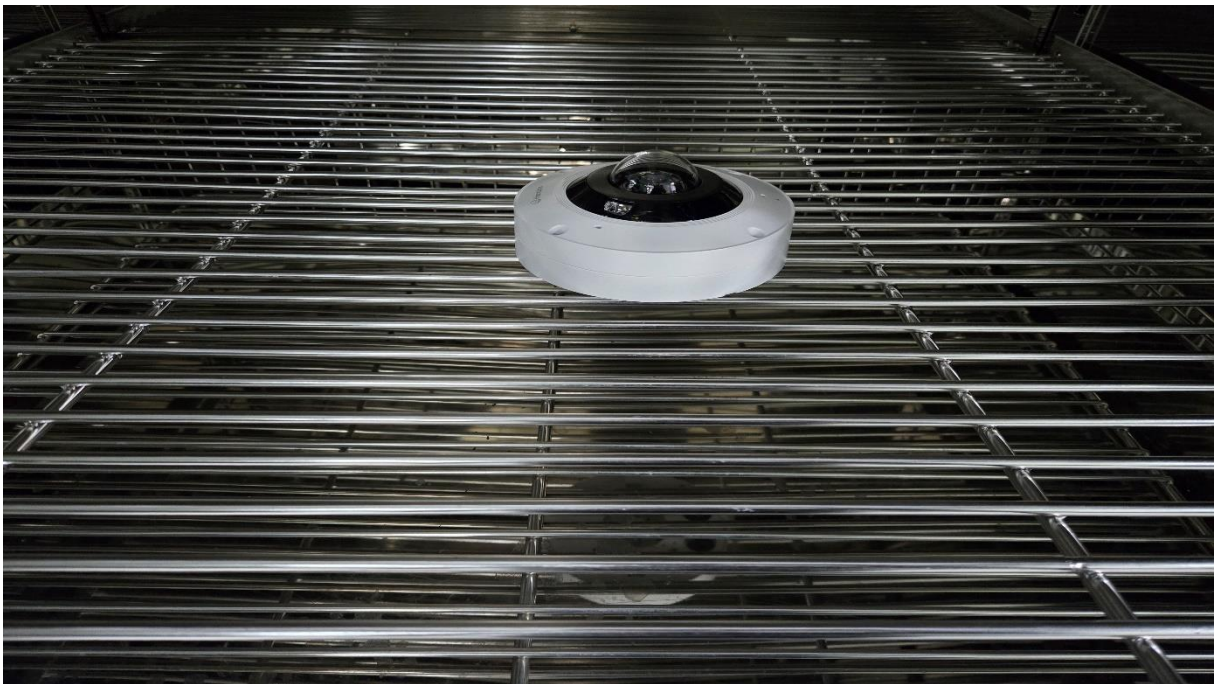
#### 3.3.1 Evidence of test setting

3.2.1 Sample status: Non-operation

3.2.2 Test temperature: -40 °C

3.2.3 Test time: 16 h

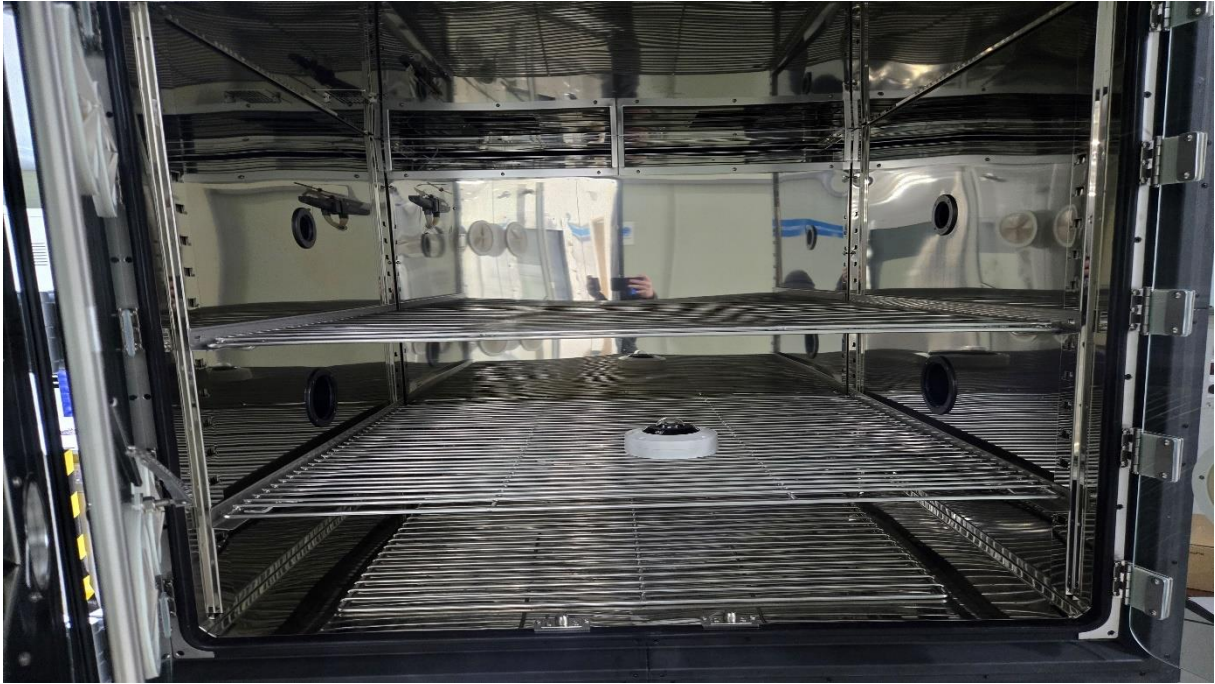
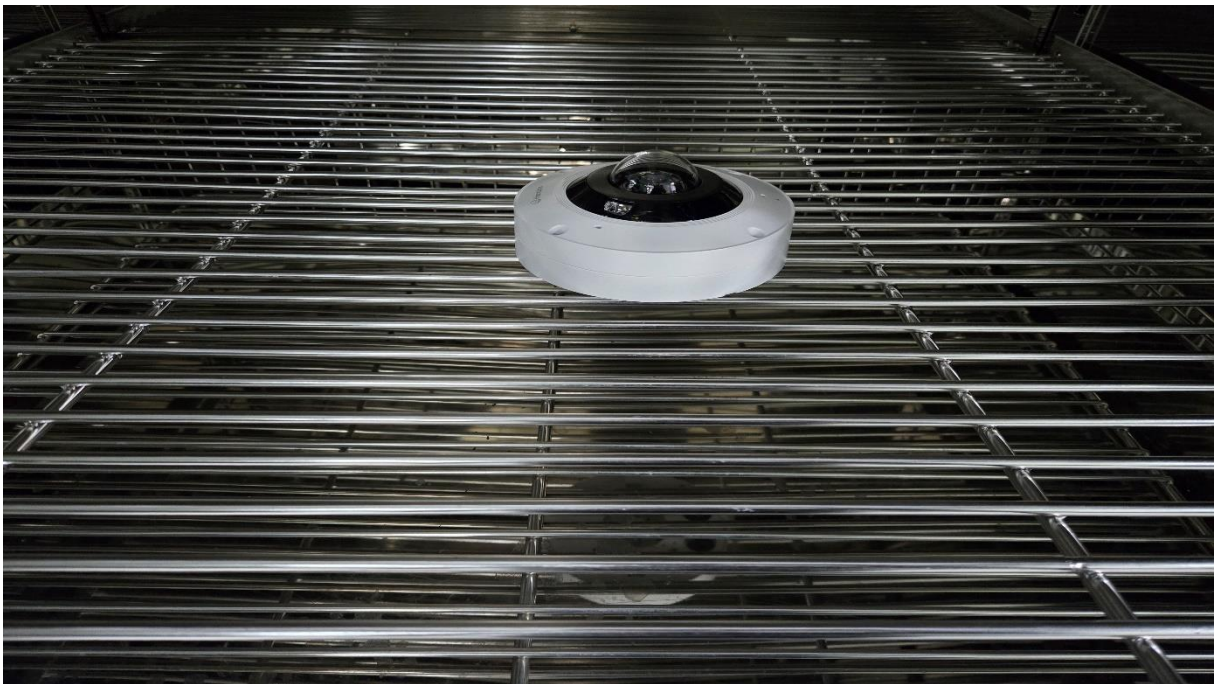
#### 4.3.1 Evidence of test setting

4.2.1 Sample status: Non-operation

4.2.2 Test temperature: 65 °C

4.2.3 Test time: 96 h

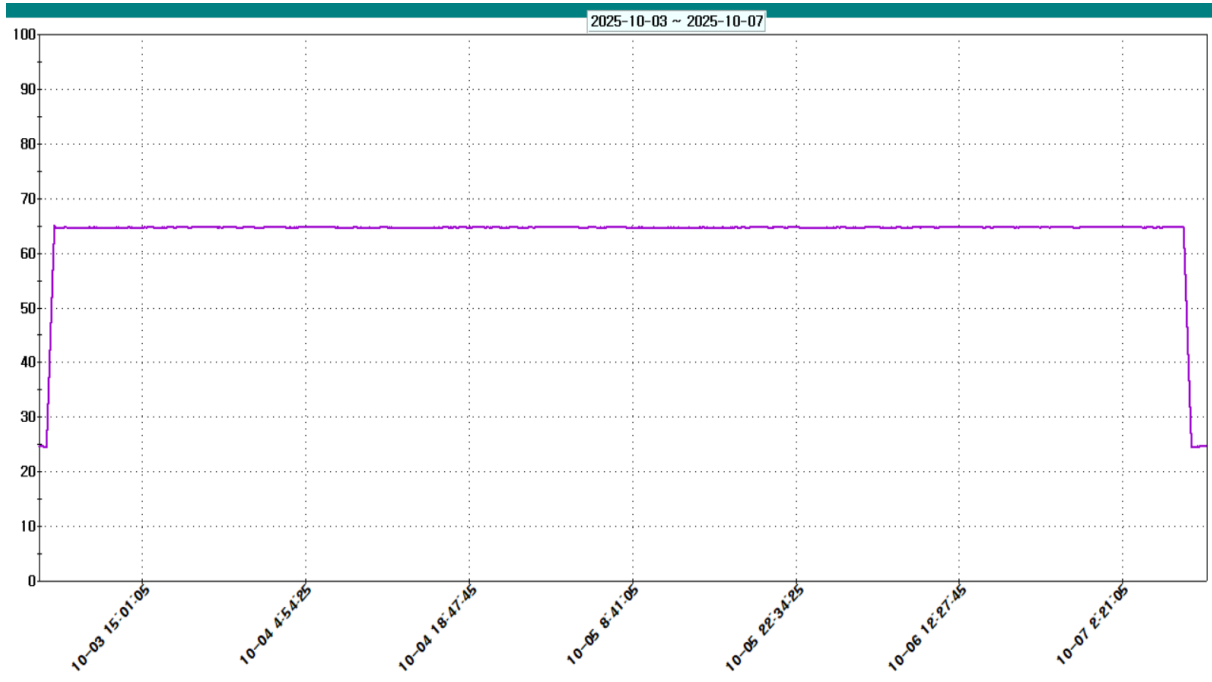
#### 4.5.1 Test data and graph

Temperature Data

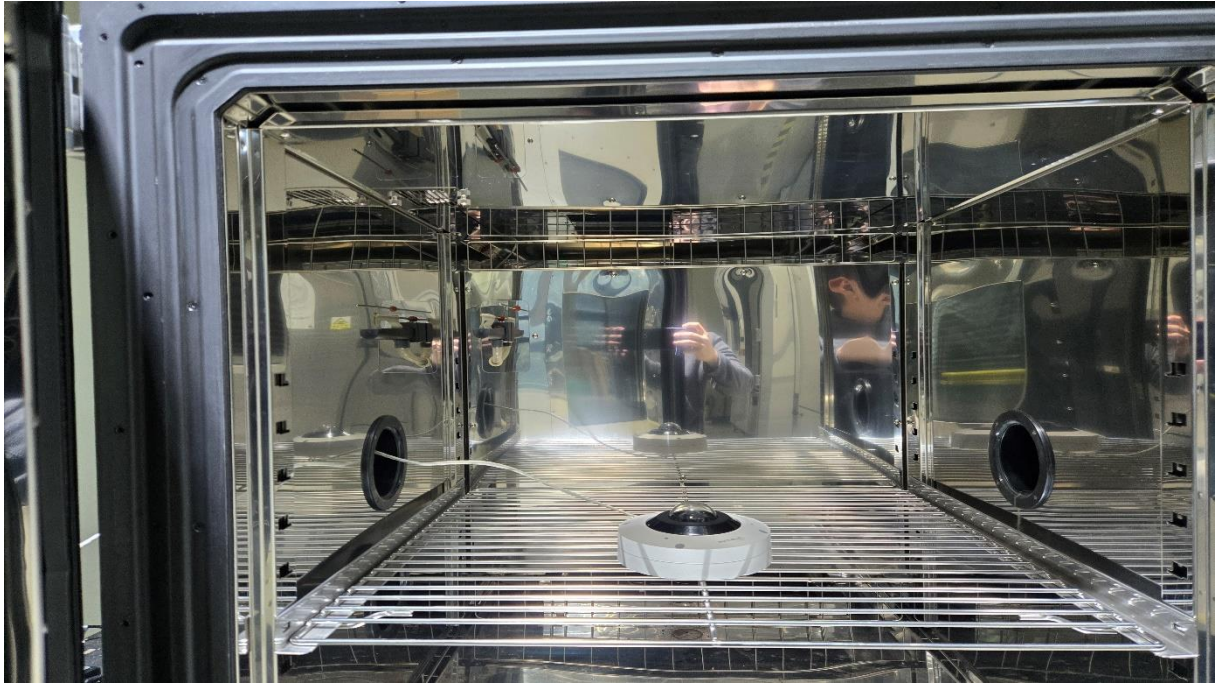
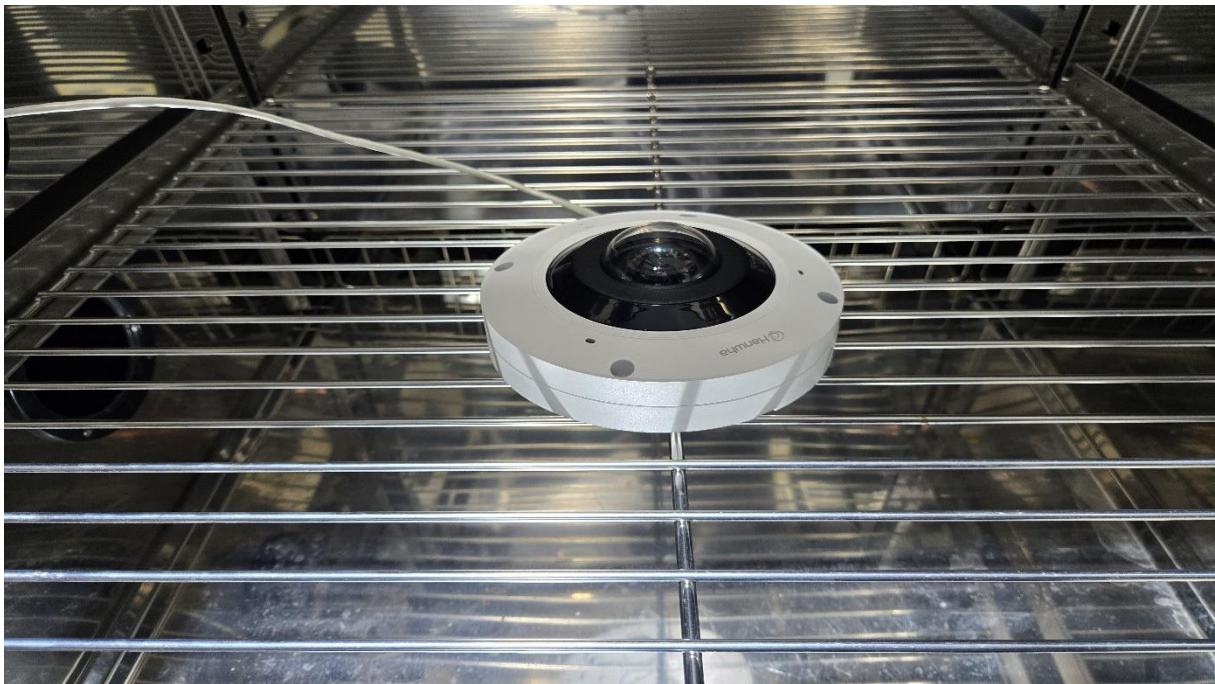
#### 5.3.1 Evidence of test setting

5.2.1 Sample status: operation

5.2.2 Test temperature: -40 °C, 65 °C

| Temp↵ | Temperature change rate(°C/min)↵ | t <sub>1</sub> (idle time)↵ | Cycles↵ |
| High↵ | 5 °C/min↵ | 3 h↵ | 3↵ |
| Low↵ | 1 °C/min↵ | 3 h↵ | 3↵ |

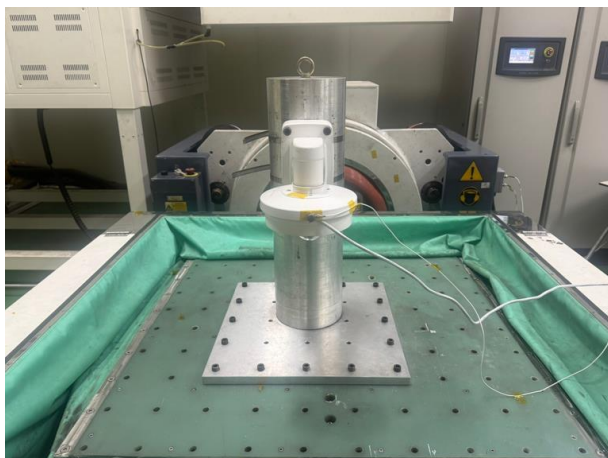
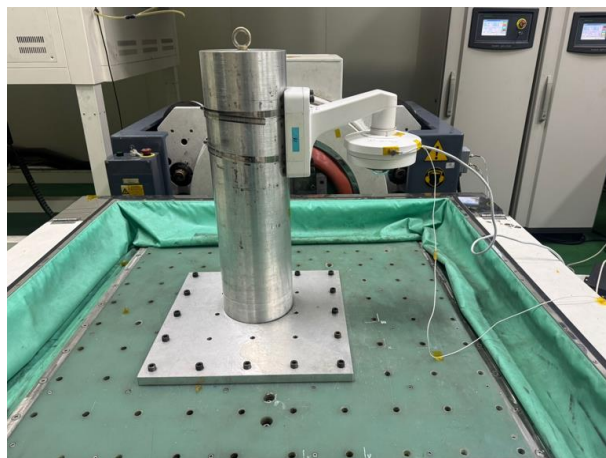
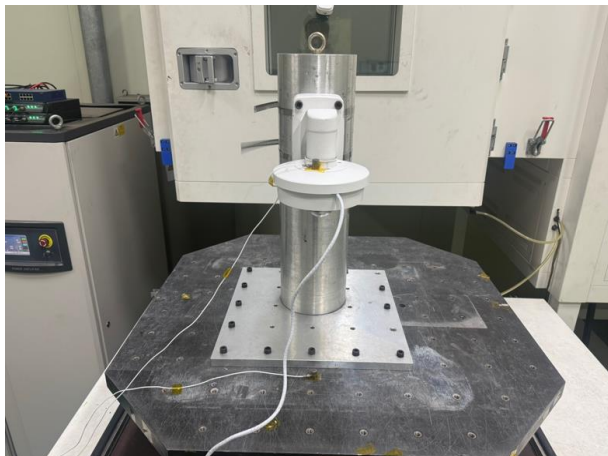
#### 6.3.1 Evidence of test setting

- Sample status: operation
- Frequency(Hz): 5 Hz ~ 200 Hz
- Acceleration(G): 1 G
- Sweep rate: 1 oct/min
- Test Axis: X, Y, Z
- Test time(h): Total 30 min (10 min. per each axis)

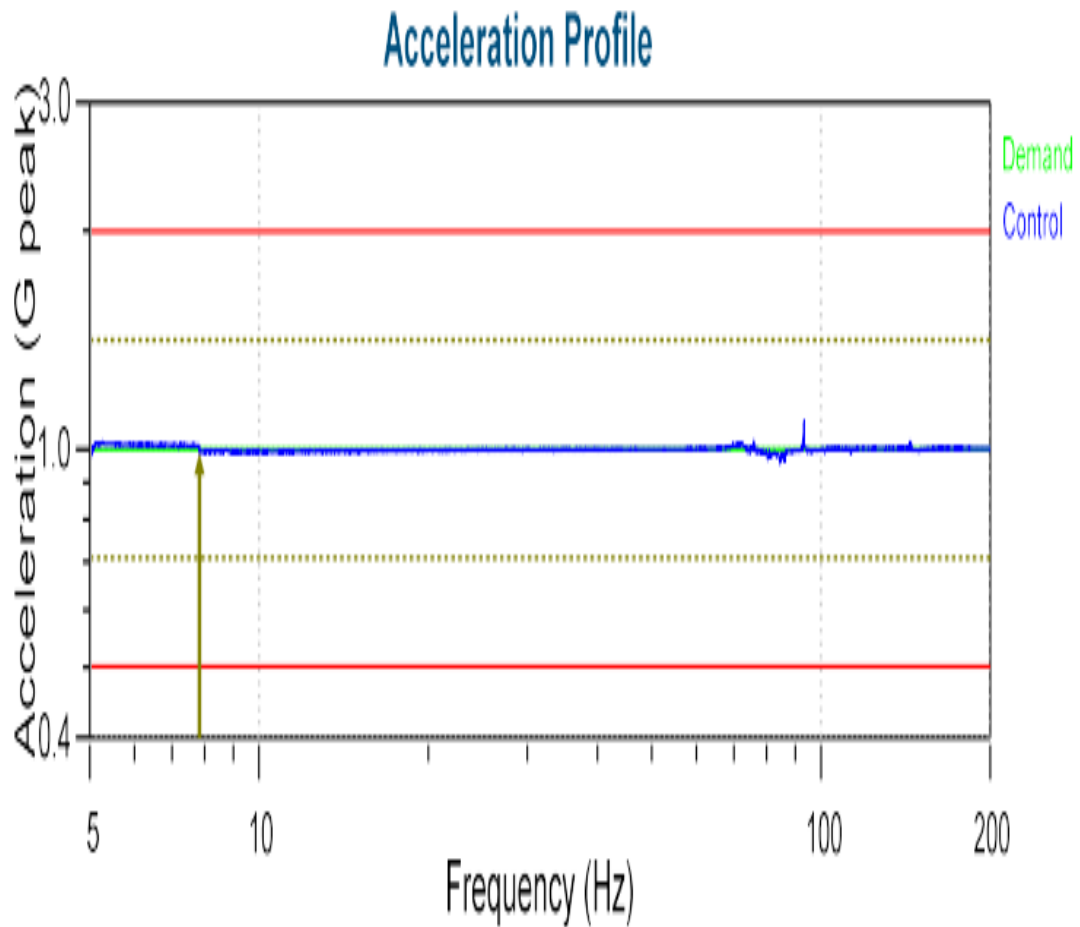
#### 6.5.1 Test data and graph (Vibration Test X Axis)

10 30, 2025 10:20:3' Level 1) 100 %

Output: 0 Volts peak

Demand: 1 G Level Time: 0:10:0

Frequency: 7.835 Hz

Control: 0.0003256 ( Total Time: 0:10:1

End of Timed Test

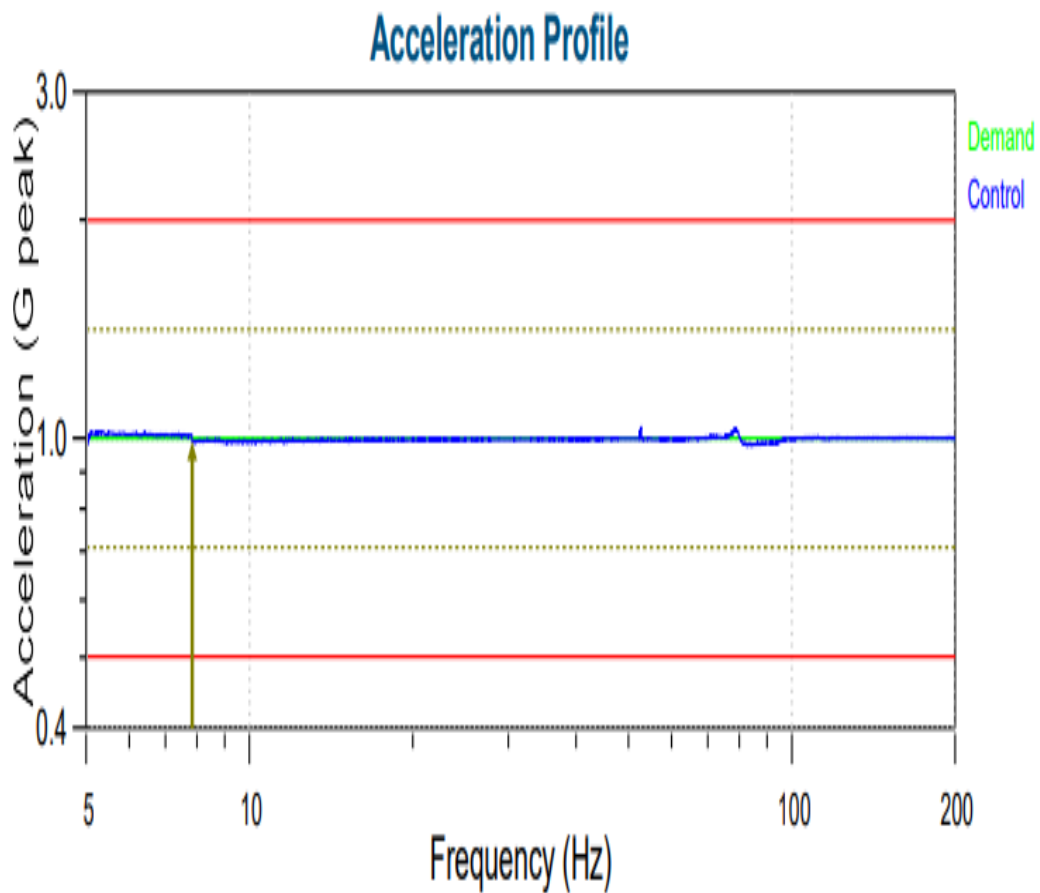
### 6.5.2 Test data and graph (Vibration Test Y Axis)

10 30, 2025 10:36:5 Level 1) 100 %

Output: 0 Volts peak

Demand: 1 G Level Time: 0:10:0

Frequency: 7.841 Hz

Control: 0.0005306 G Total Time: 0:10:1

End of Timed Test

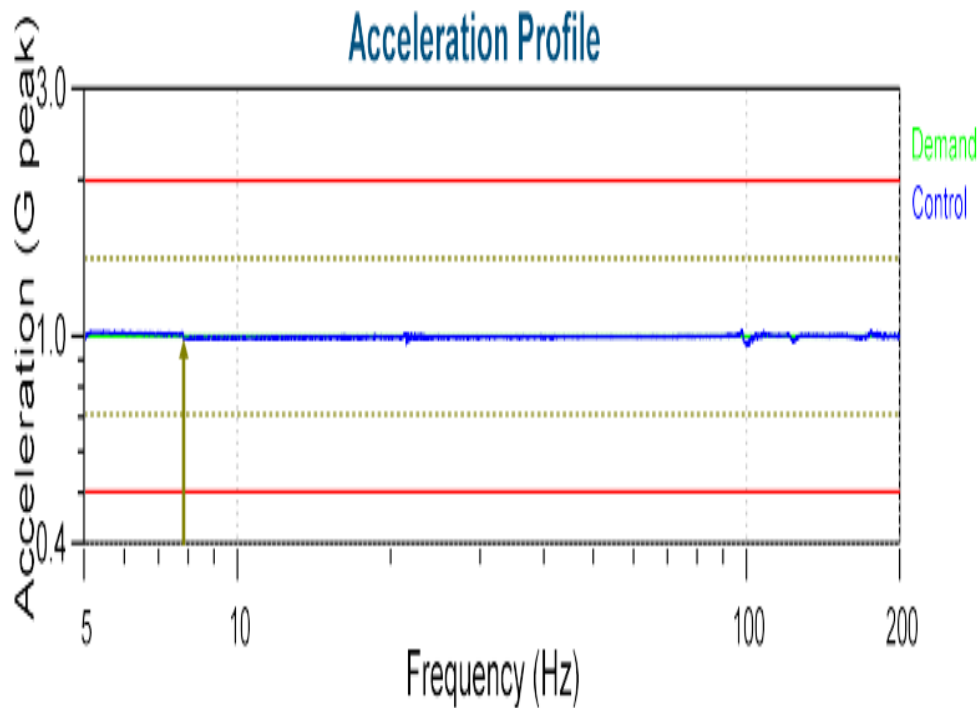
### 6.5.3 Test data and graph (Vibration Test Z Axis)

10 22, 2025 17:14:10 Level 1) 100 % Output: 0 Volts peak 60068-2-6  
Demand: 1 G Level Time: 0:10:00 Frequency: 7.846 Hz  
Control: 0.001056 G Total Time: 0:10:12 End of Timed Test

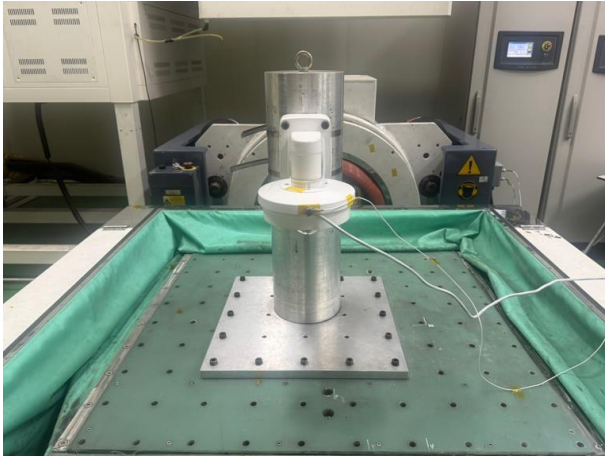
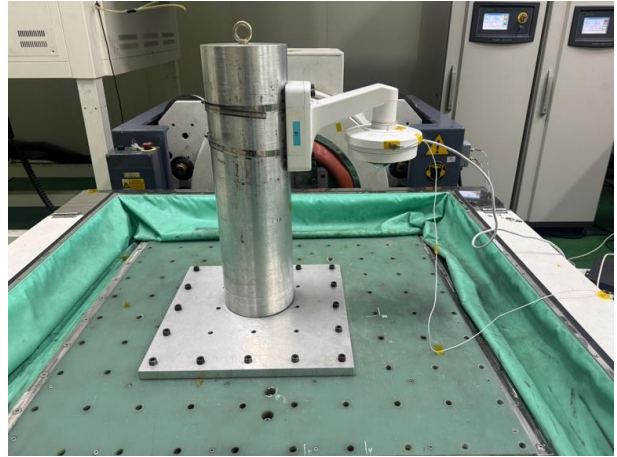
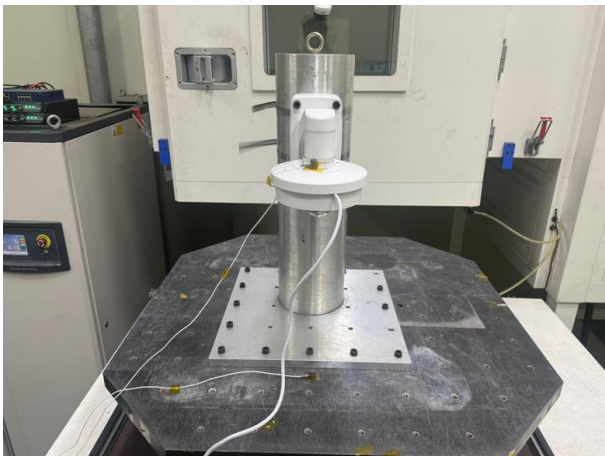
### 7.3.1 Evidence of test setting

7.2.1 Sample status: Non-operation

7.2.2 Acceleration( $m/s^2$ ):  $150 m/s^2$

7.2.3 Number of impacts: 10 per direction (total 60)

7.2.4 Test Axis: X, Y, Z

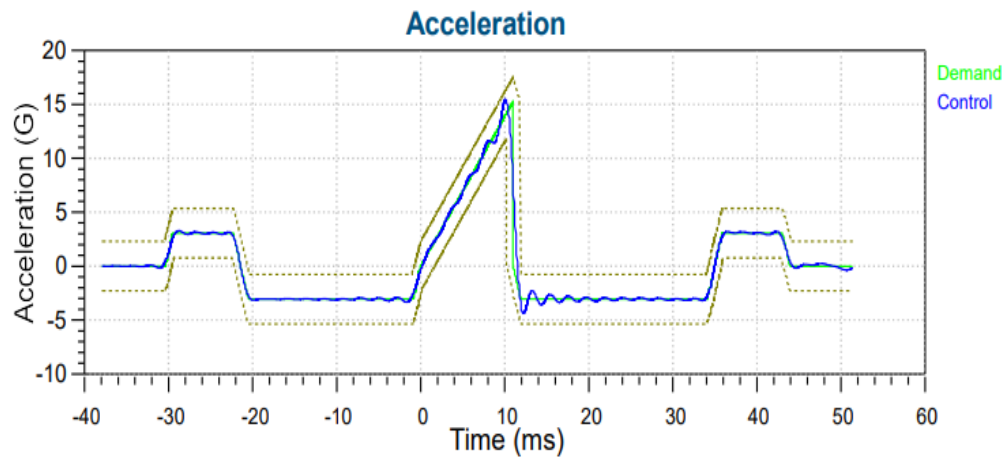
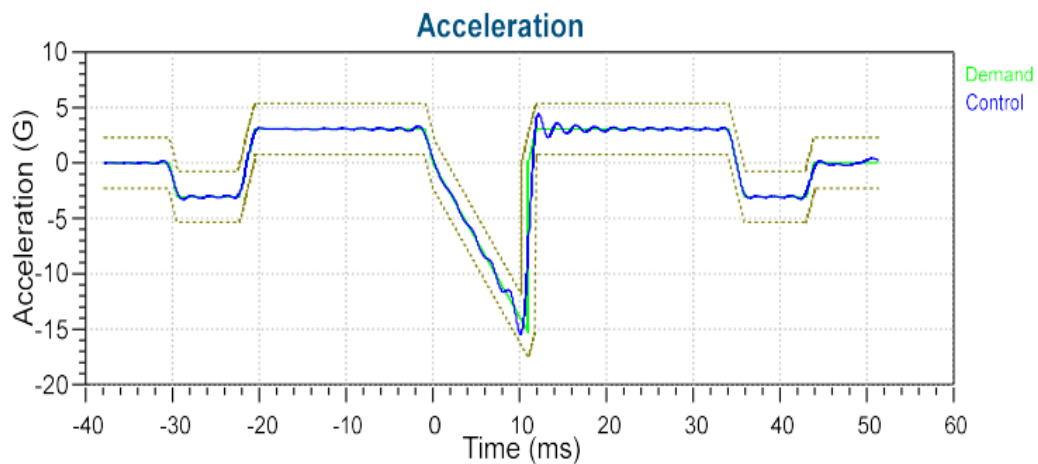
#### 7.5.1 Test data and graph (Shock Test X Axis)

10 30, 2025 10:21:4: Level 1) 100 %  
Demand: 15.3 G  
Control: 15.43 G

Output: 1.263 Volts peak 한화비전 60068-2  
Running

10 30, 2025 10:22:1: Level 2) 100 %  
Demand: 15.3 G  
Control: 15.44 G

Output: 1.254 Volts peak 한화비전 60068-2  
End of Test

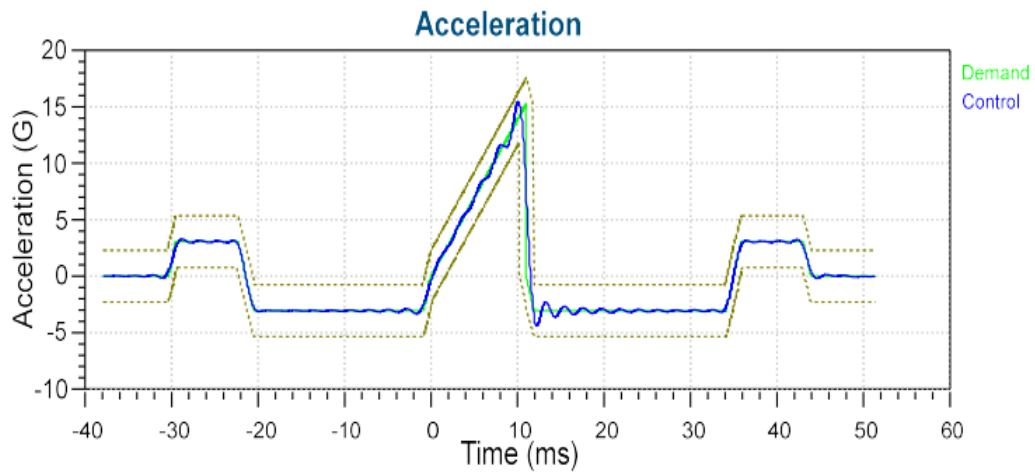
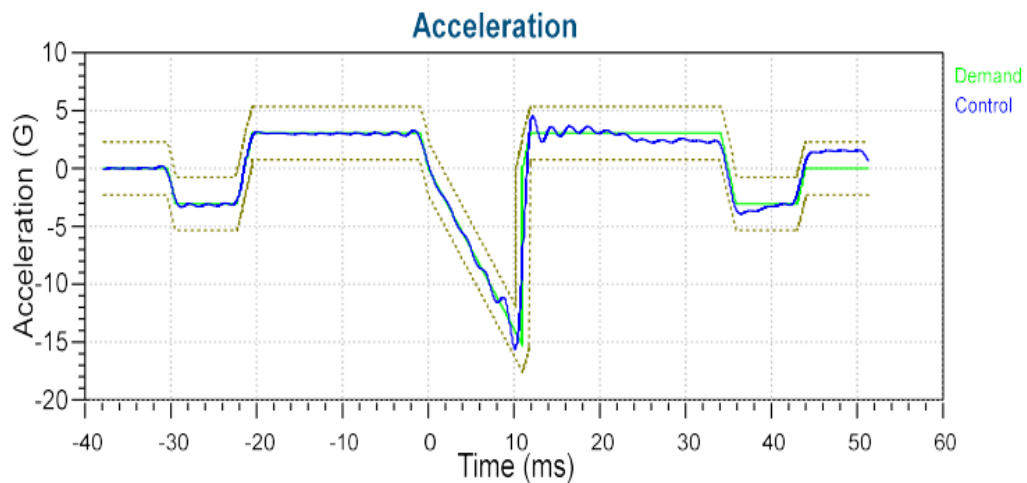
### 7.5.2 Test data and graph (Shock Test Y Axis)

10 30, 2025 10:37:4 Level 1) 100 %  
Demand: 15.3 C  
Control: 15.44 C Pulse: 10 of 10

Output: 1.253 Volts peak 한화비전 60068-2  
Running

10 30, 2025 10:38:1 Level 2) 100 %  
Demand: 15.3 C  
Control: 15.58 C Pulse: 10 of 10

Output: 1.295 Volts peak 한화비전 60068-2  
End of Test

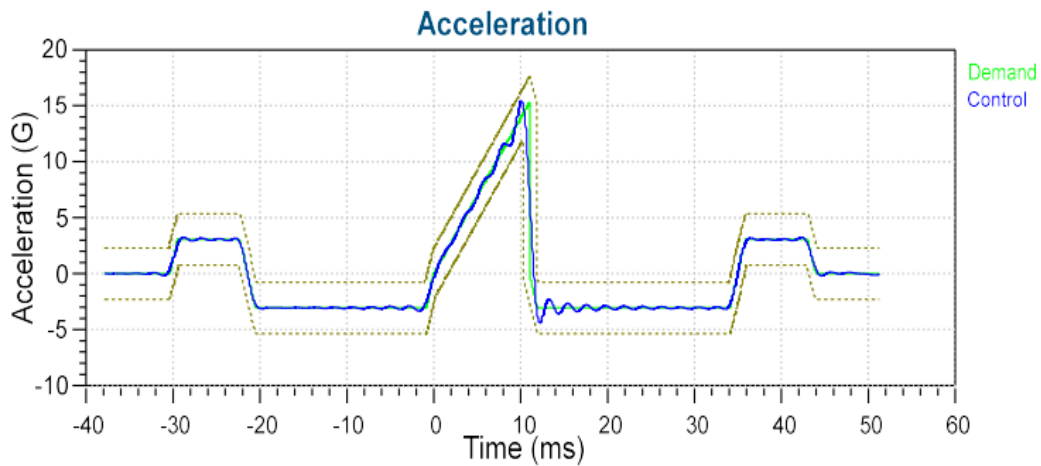
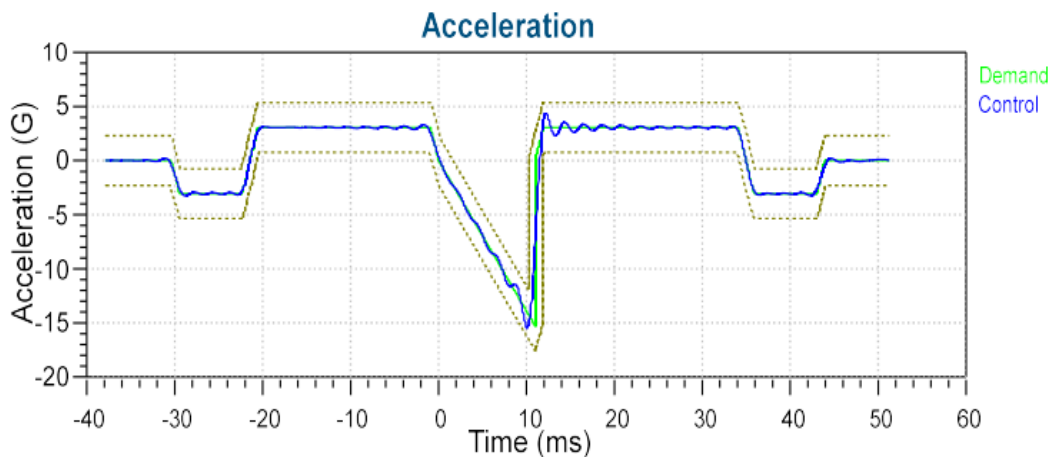
### 7.5.3 Test data and graph (Shock Test Z Axis)

10 22, 2025 17:15:17 Level 1) 100 % Output: 1.353 Volts peak 60068-2-27

Demand: 15.3 G

Control: 15.44 G Pulse: 10 of 10

10 22, 2025 17:15:47 Level 2) 100 % Output: 1.416 Volts peak 60068-2-27

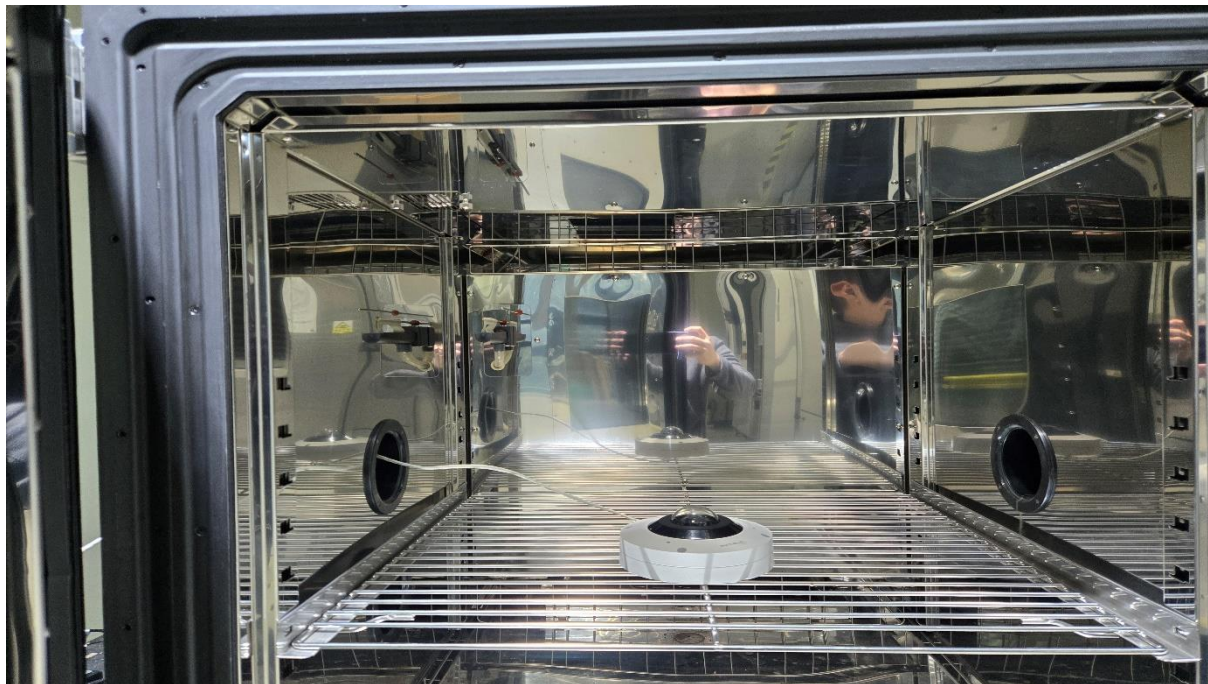
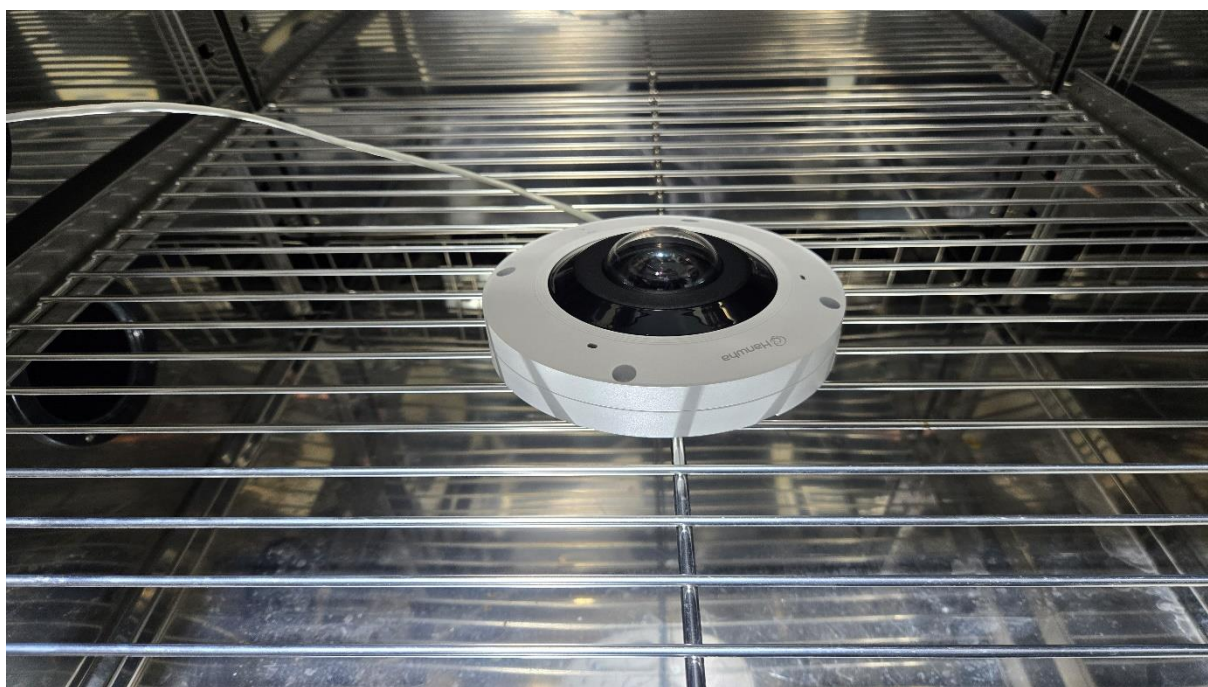
#### 8.3.1 Evidence of test setting

8.2.1 Sample status: operation

8.2.2 Test temperature:  $40 \pm 2$  °C

8.2.3 Test Humidity:  $93 \pm 3$  % R.H.

8.2.4 Test time: 240 h

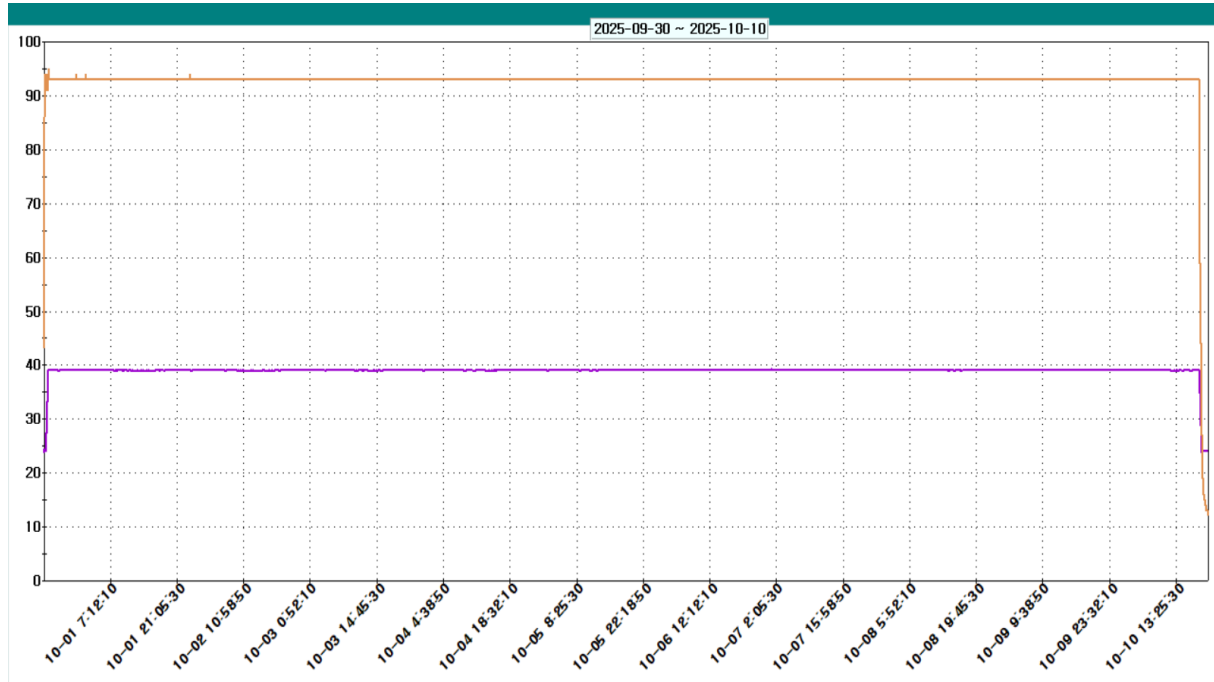
### 8.5.1 Test data and graph

Temperature Data
