# TEST REPORT

REPORT No.:  
CTK-2026-00742  
Page (1) / (31) pages

NETWORK CAMERA / XNO-A6014R

NEMA TS-2:2021 2.2.7.3 Test C ~ 2.2.7.8 Test H,  
NEMA TS-2 2.2.8, NEMA TS-2 2.2.9

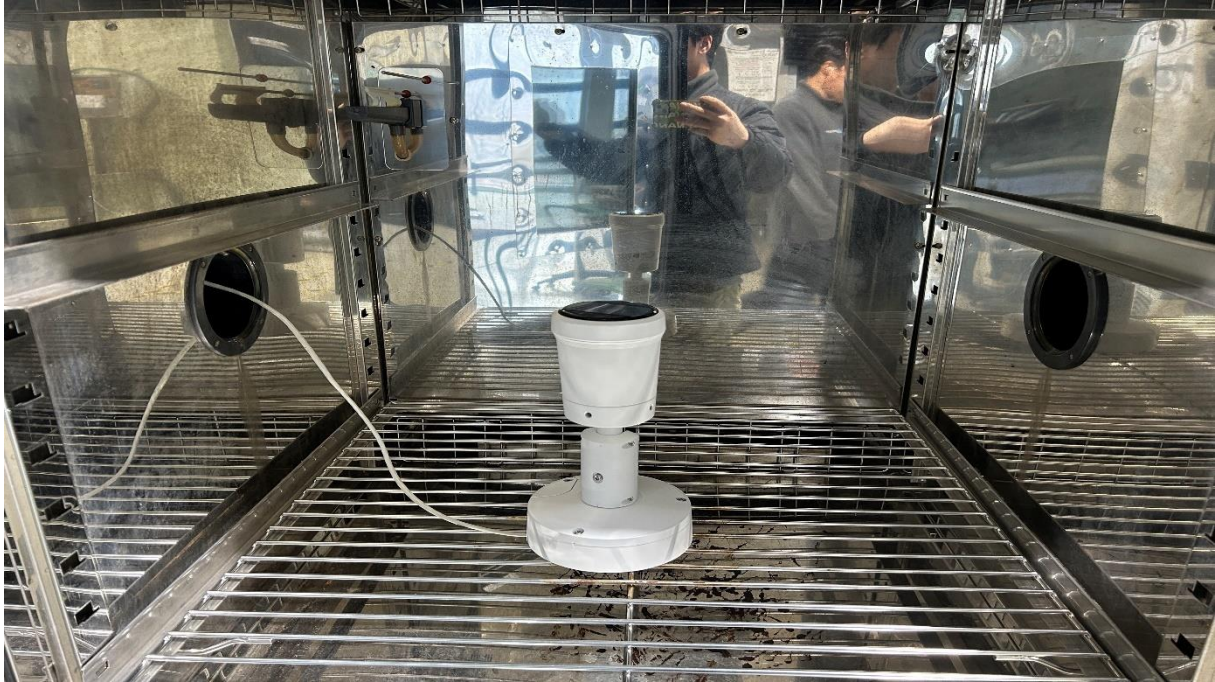
#### 3.9.1 Evidence of test setting
