# TEST REPORT

REPORT No.:  
CTK-2025-02269  
Page (1) / (26) pages

NETWORK CAMERA / XNO-A6084R

NEMA TS 2-2013 2.2.7.3 Test C ~ 2.2.7.8 Test H,  
NEMA TS 2.2.8, NEMA TS 2.2.9

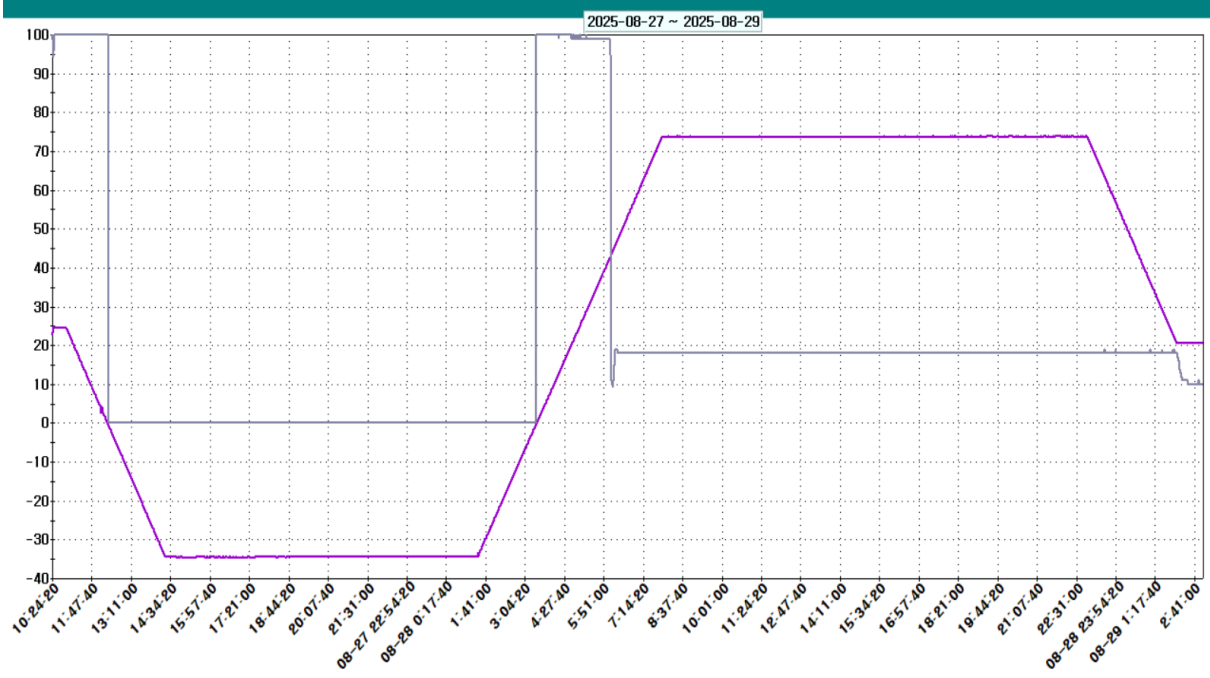
Temperature Data

#### 3.5.1 Test data and graph

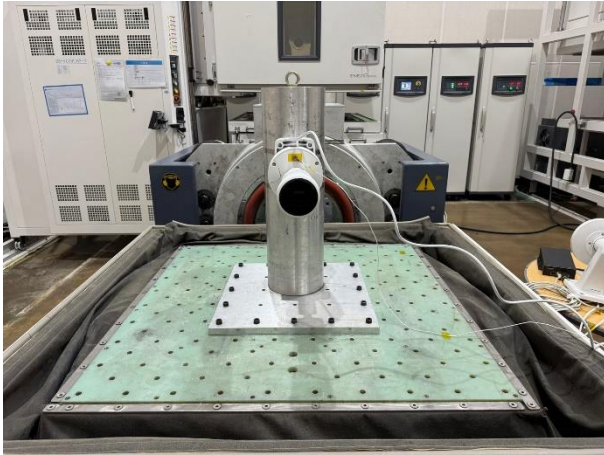
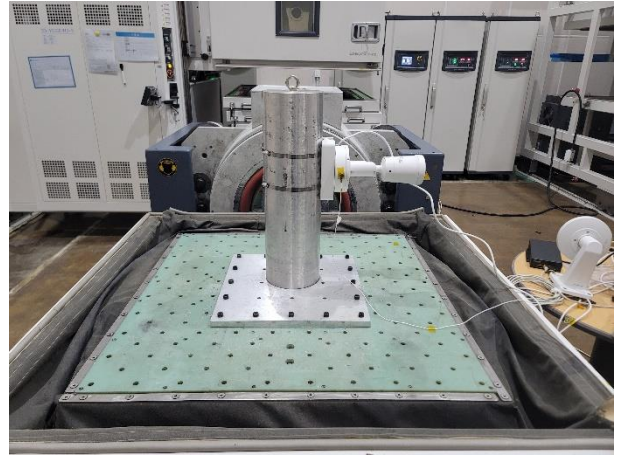
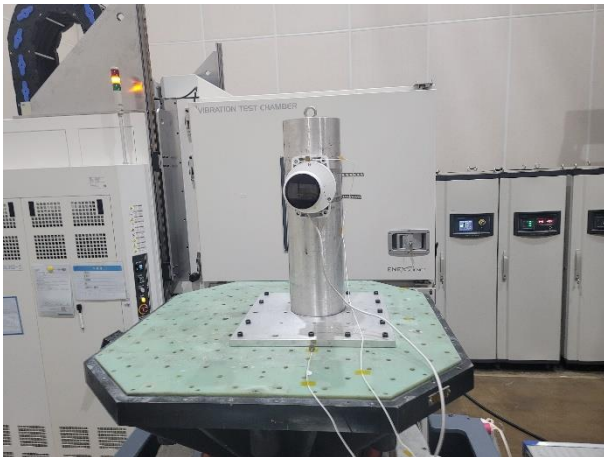
#### 4.3.1 Evidence of test setting (NEMA TS 2-2013 2.2.8)

- Sample status : unpackaged / not in operation
- Applied waveform : Sine
- Frequency(Hz) : 5 ~ 30
- Double amplitude displacement (inch) : 0.015
- Sweep rate(Sweep/min) : 12.5

- Applicable axis : X, Y, Z
- Test time(h) : 12.5
- Evaluation items
  - Check for mechanical damage before and after testing
- Test methods
  - With the test unit securely fastened to the test table, set the test table for a double amplitude displacement of 0.015 inch.

- Cycle the test table over a search range from 5 to 30 Hz and back within a period of 12.5 minutes.
  - Conduct the resonant frequency search in each of the three mutually perpendicular planes.

- Sample status : unpackaged / not in operation
- Applied waveform : Sine
- Frequency(Hz) : 30 or 3.2.2 Test results
- Acceleration(G) : 0.5
- Applicable axis : X, Y, Z
- Test time(h) : All 3(Each axis 1)
- Evaluation items
  - Check for mechanical damage before and after testing
- Test methods
  - Vibrate the test unit in each plane at its resonant frequency for a period of 1 hour at an amplitude resulting in 0.5 g acceleration. (test profile)
  - When more than one resonant frequency has been recorded in accordance with Section 1.2 Item 4, the test period of 1 hour shall be divided equally between the resonant frequencies.
  - The total time of the endurance test shall be limited to 3 hours, 1 hour in each of three mutually perpendicular planes.

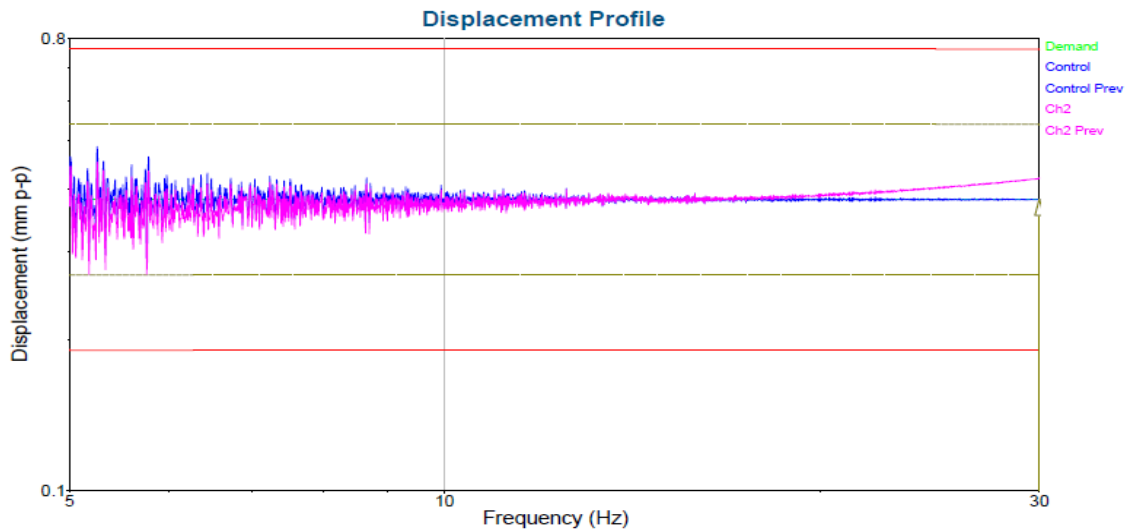
#### Resonant search Test

| 9 16, 2025 11:56:15 | Level 1) 100 % | Output: 0.04817 Volts peak | NEMA TS-2 2.2.8 |
| Demand: 0.381 mm | Level Time: 0:12:30 | Frequency: 30 Hz | |
| Control: 0.3818 mm | Total Time: 0:12:36 | End of Sweep Test | |

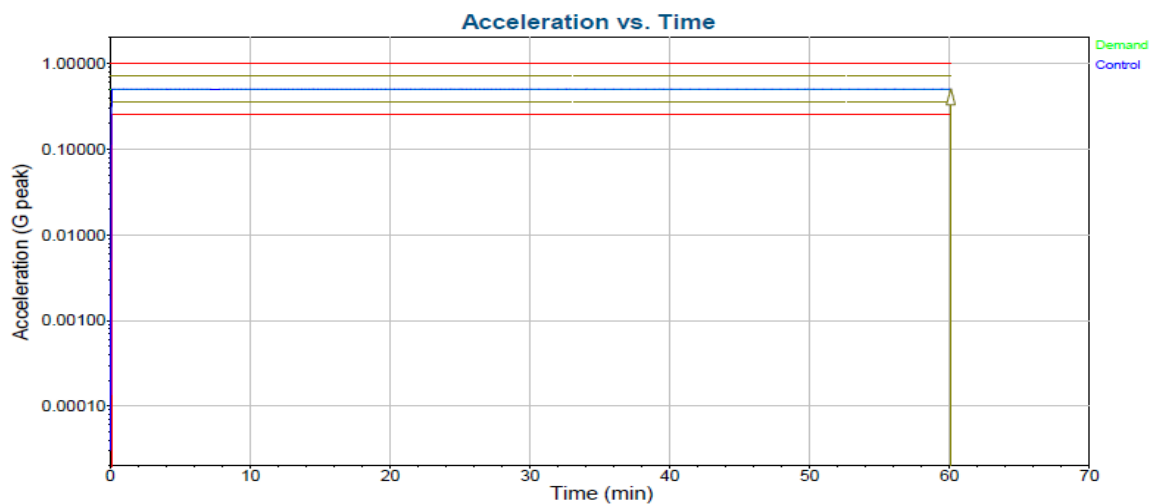
#### Endurance Test

| 9 16, 2025 12:56:55 | Level 1) 100 % | Output: 0.03529 Volts peak | NEMA TS-2 2.2.8 내구 |
| Demand: 0.5 G | Level Time: 1:00:00 | Frequency: 30 Hz | |
| Control: 0.4999 G | Total Time: 1:00:07 | End of Timed Test | |

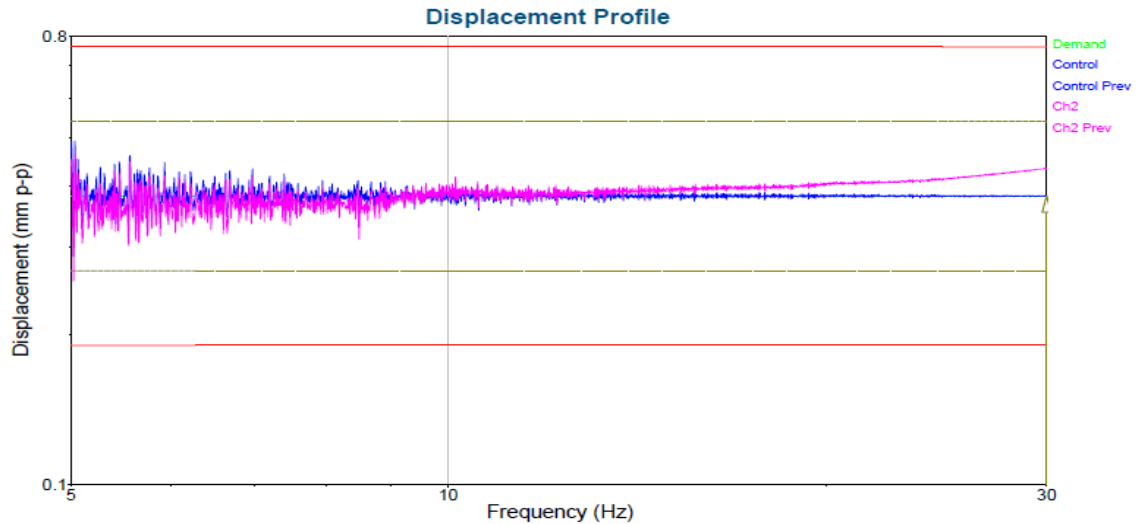
### Resonant search Test

9 16, 2025 13:22:19    Level 1) 100 %    Output: 0.04839 Volts peak    NEMA TS-2 2.2.8  
Demand: 0.381 mm    Level Time: 0:12:30    Frequency: 30 Hz  
Control: 0.381 mm    Total Time: 0:12:36    End of Sweep Test

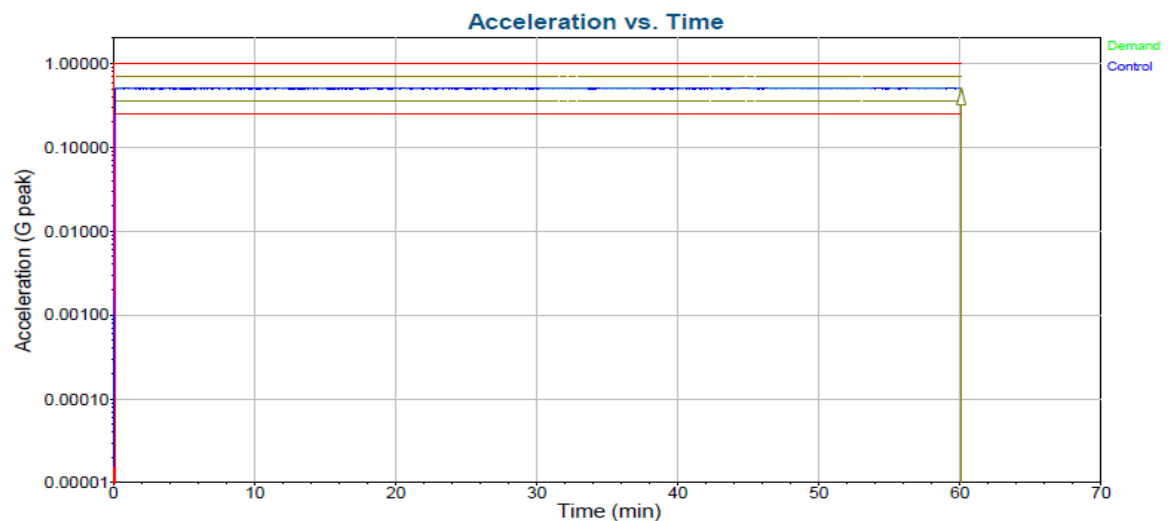
### Endurance Test

9 16, 2025 14:28:09    Level 1) 100 %    Output: 0.03516 Volts peak    NEMA TS-2 2.2.8 내구  
Demand: 0.5 G    Level Time: 1:00:00    Frequency: 30 Hz  
Control: 0.5003 G    Total Time: 1:00:06    End of Timed Test

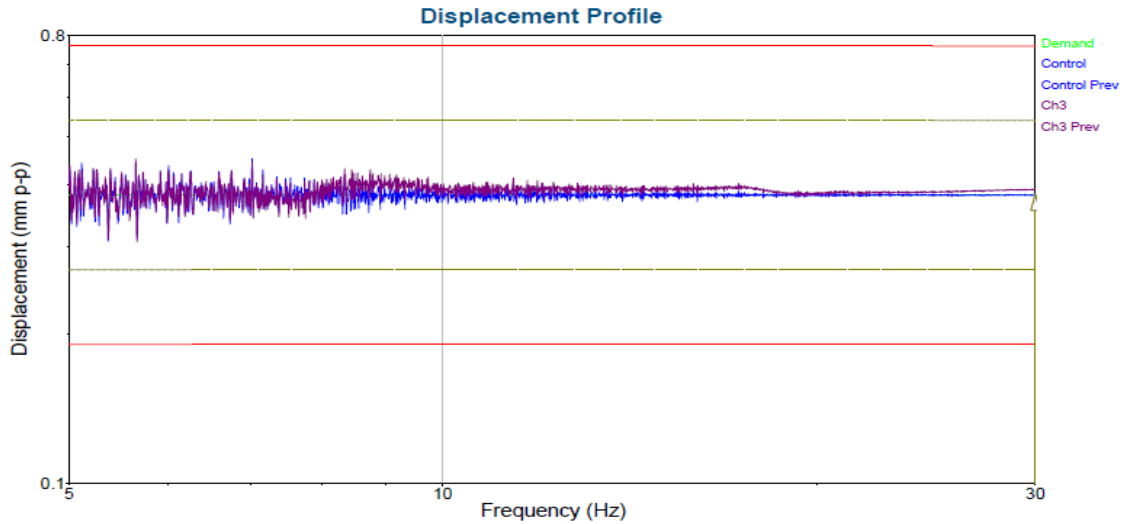
### Resonant search Test

9 17, 2025 09:47:16    Level 1) 100 %    Output: 0.04818 Volts peak    NEMA TS-2 2.2.8  
Demand: 0.381 mm    Level Time: 0:12:30    Frequency: 30 Hz  
Control: 0.3824 mm    Total Time: 0:12:37    End of Sweep Test

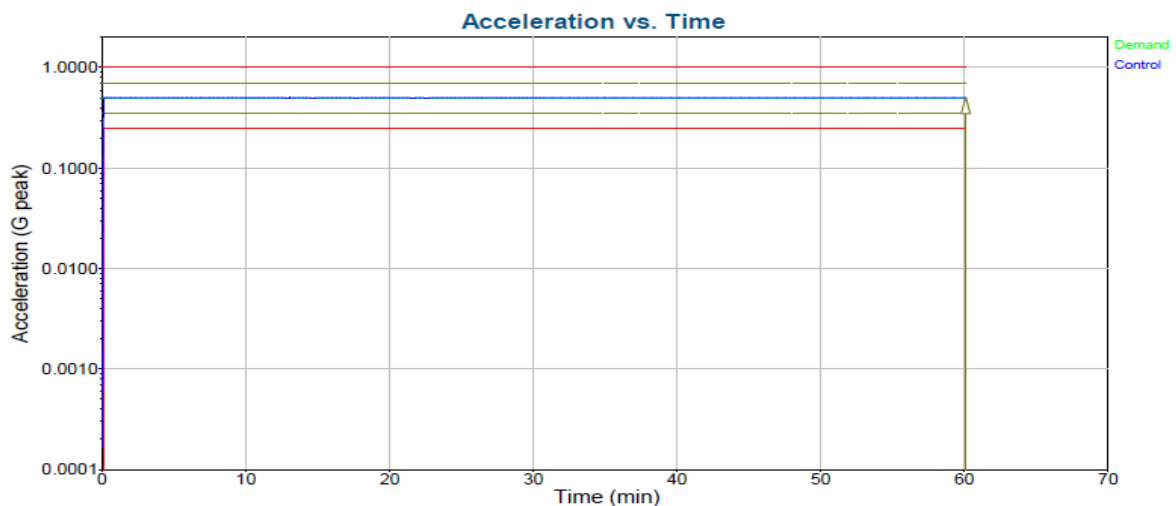
### Endurance Test

9 17, 2025 10:49:06    Level 1) 100 %    Output: 0.03496 Volts peak    NEMA TS-2 2.2.8 내구  
Demand: 0.5 G    Level Time: 1:00:00    Frequency: 30 Hz  
Control: 0.5007 G    Total Time: 1:00:07    End of Timed Test

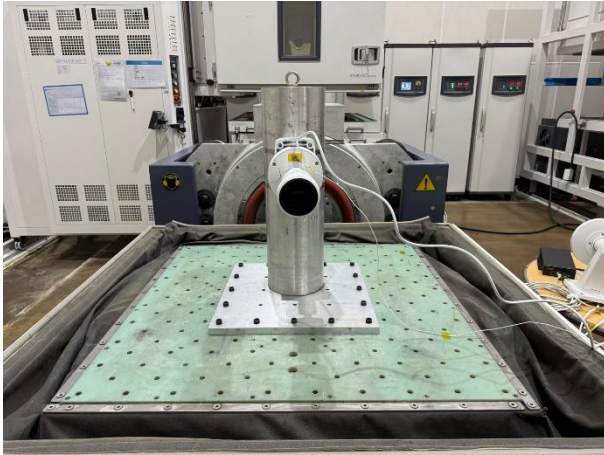
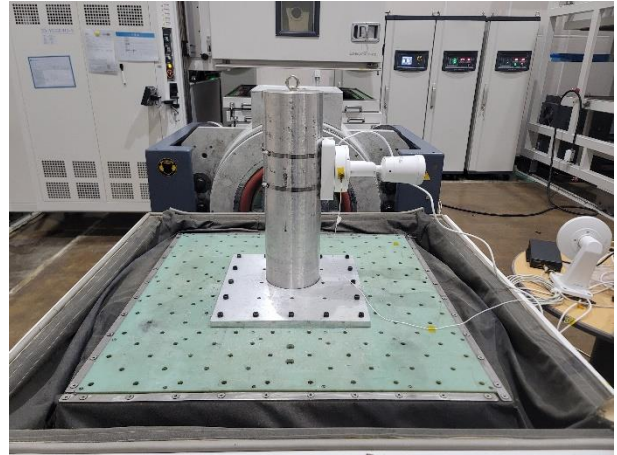
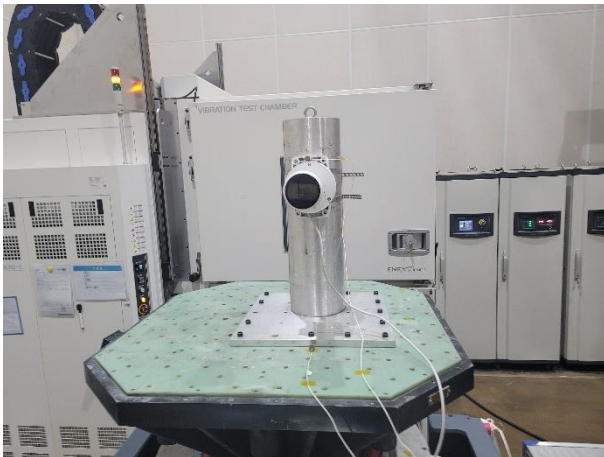
#### 5.3.1 Evidence of test setting (NEMA TS 2-2013 2.2.9)

5.2.2 Applied waveform: Half sine

5.2.3 Acceleration(G): 10 G

5.2.4 Nominal duration (ms): 11

5.2.6 Number of impacts: 1 per direction (total 6)

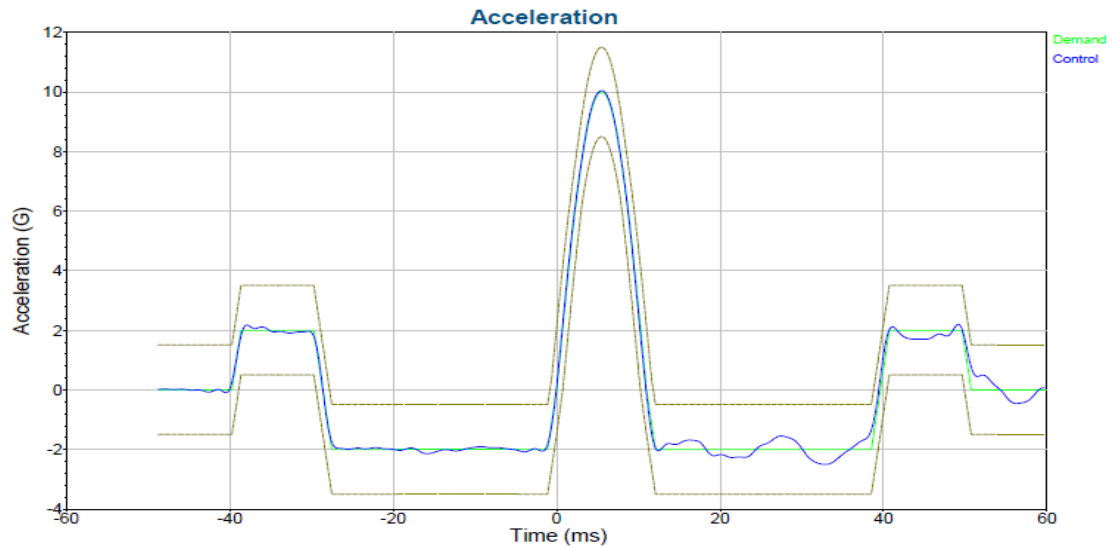
### 5.5.1 Test Data X Axis

Output: 0.5181 Volts peak

Demand: 10 G

Control: 10.04 G

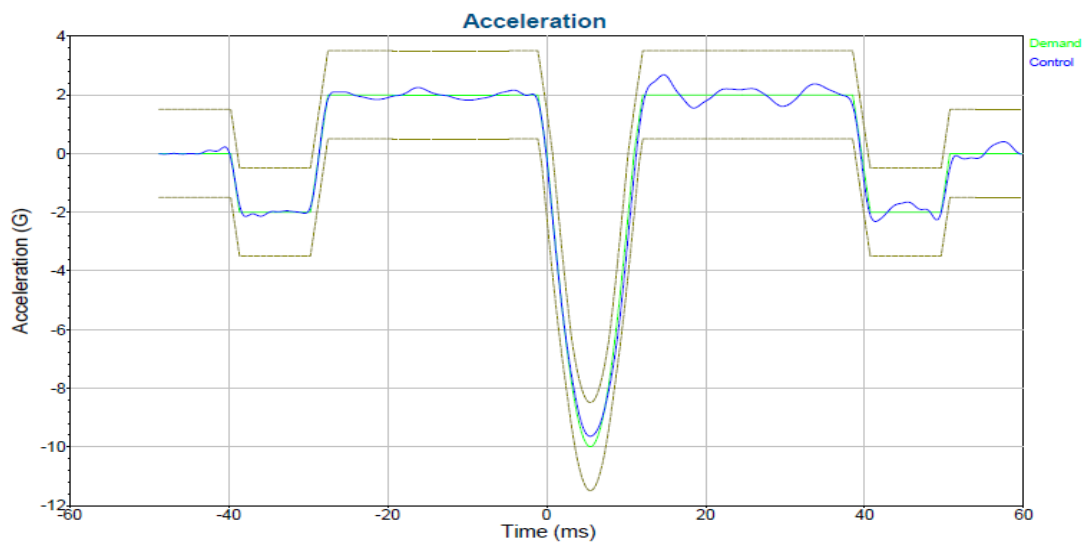
Output: 0.5164 Volts peak

Demand: 10 G

Control: 9.647 G

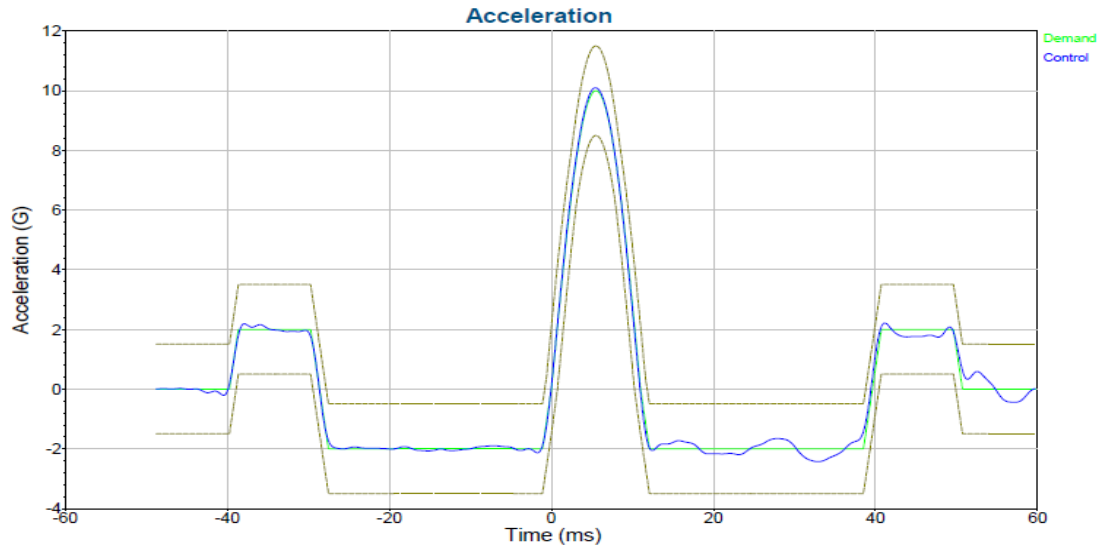
### 5.5.1 Test Data Y Axis

Output: 0.5177 Volts peak

Demand: 10 G

Control: 10.1 G

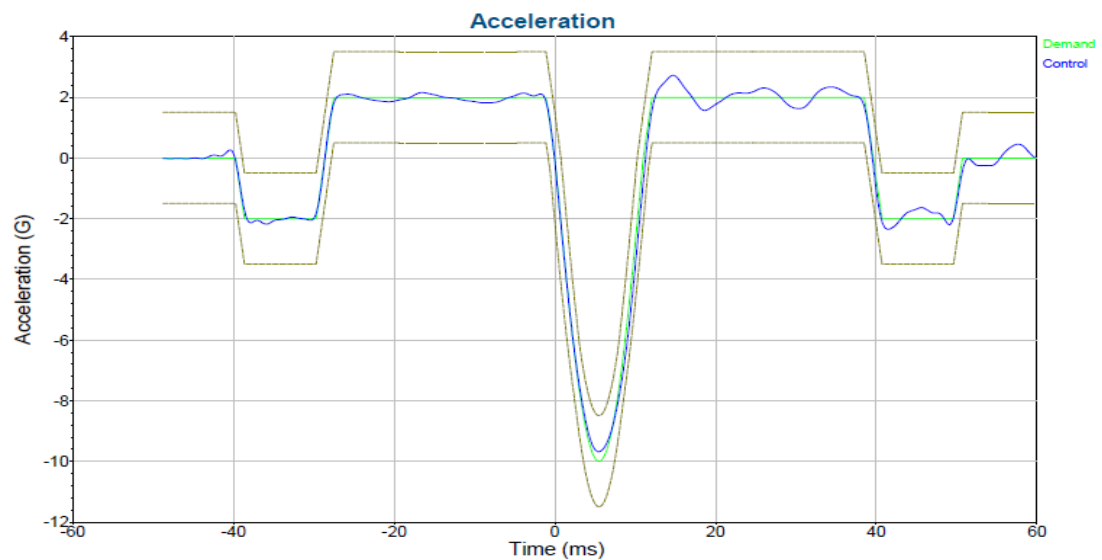
Output: 0.5209 Volts peak

Demand: 10 G

Control: 9.685 G

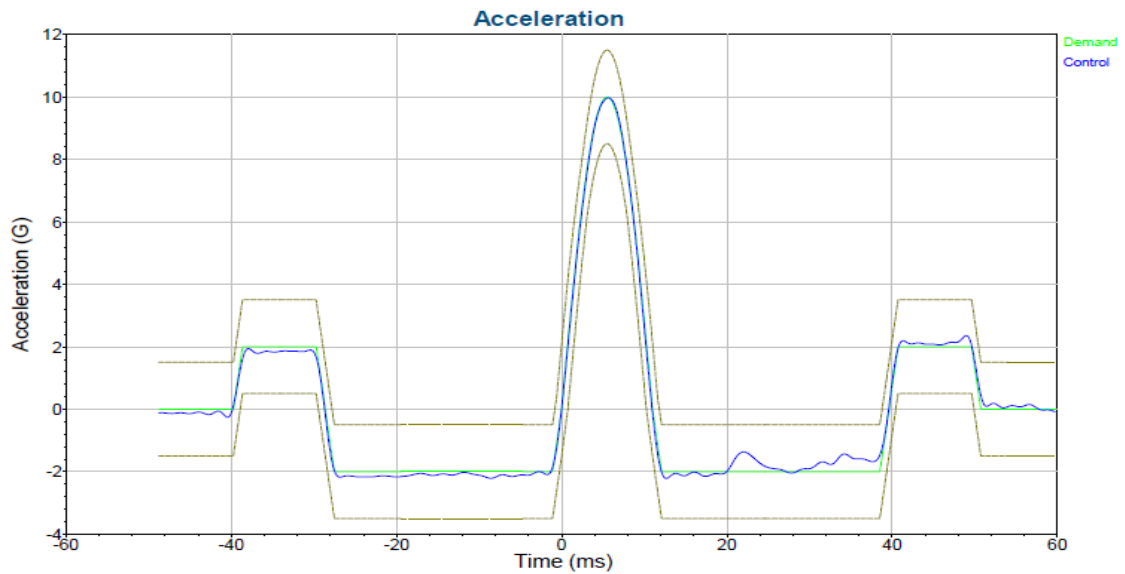
### 5.5.2 Test Data Z Axis

9 17, 2025 10:55:31    Level 1) 100 %  
Demand: 10 G  
Control: 9.971 G    Pulse: 1 of 1

Output: 0.5054 Volts peak    NEMA TS-2 2.2.9  
Running

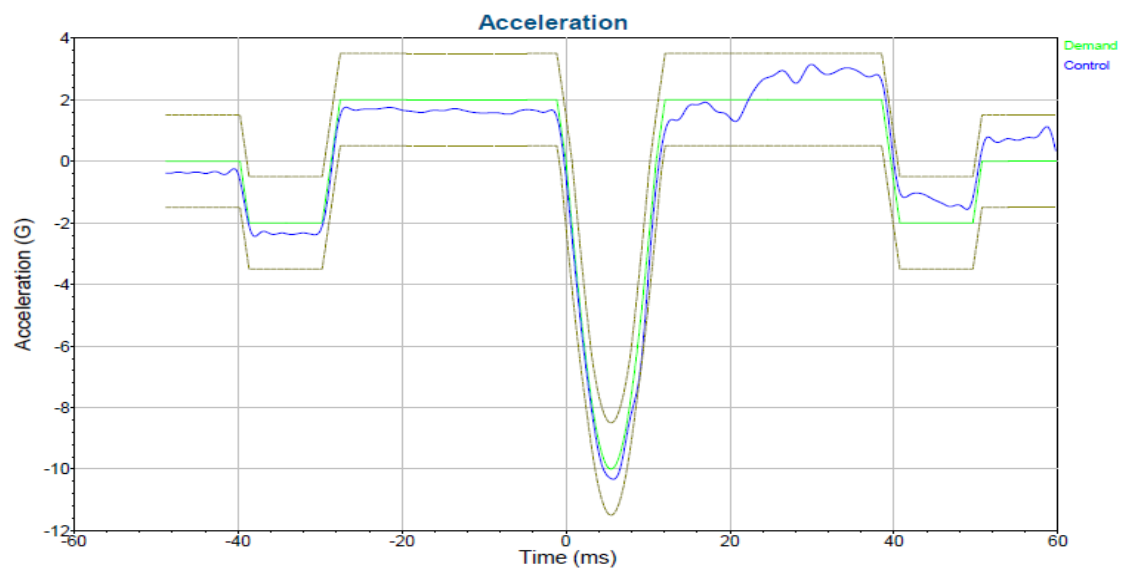
9 17, 2025 10:55:34    Level 2) 100 %  
Demand: 10 G  
Control: 10.33 G    Pulse: 1 of 1

Output: 0.5087 Volts peak    NEMA TS-2 2.2.9  
End of Test
