# TEST REPORT

REPORT No.:  
CTK-2026-00741  
Page (1) / (31) pages

NETWORK CAMERA / XNO-A8014R

NEMA TS-2:2021 2.2.7.3 Test C ~ 2.2.7.8 Test H,  
NEMA TS-2 2.2.8, NEMA TS-2 2.2.9

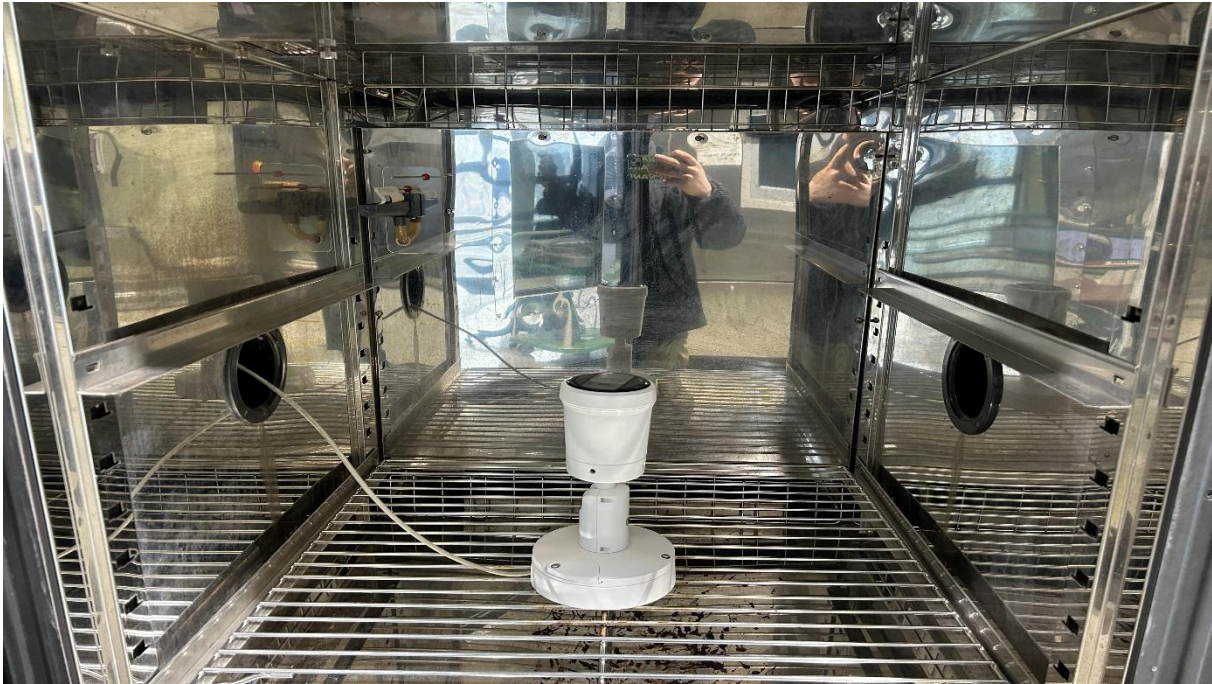
#### 3.9.1 Evidence of test setting

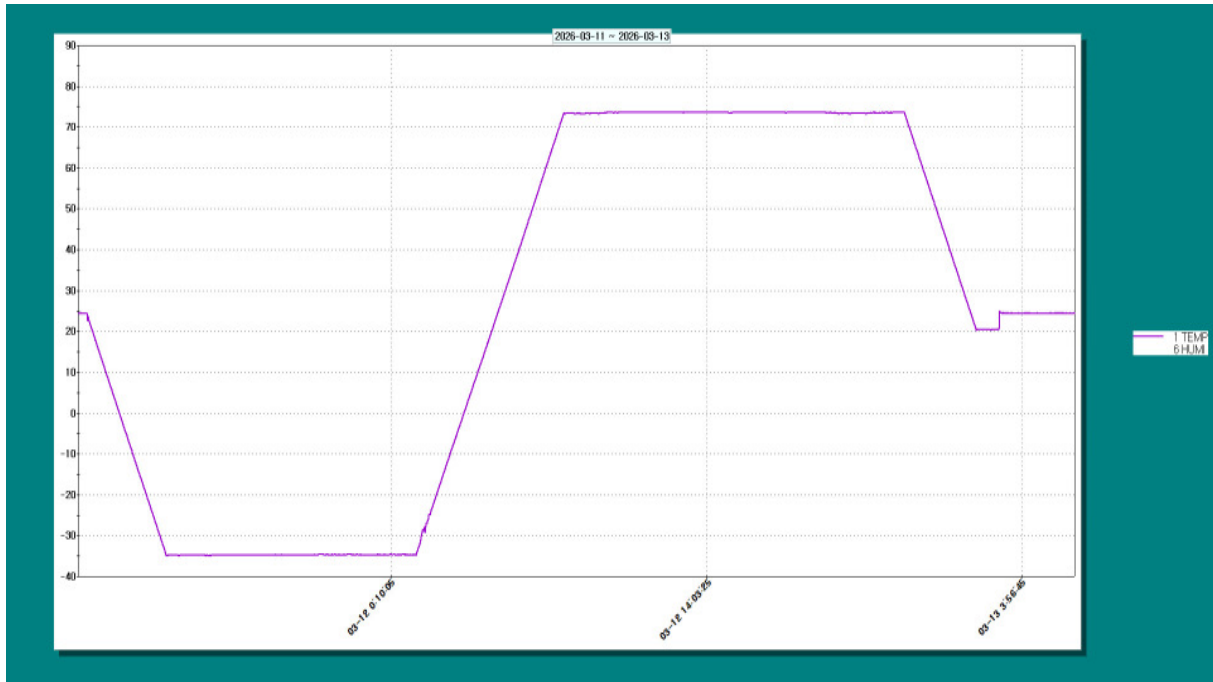
Temperature Data

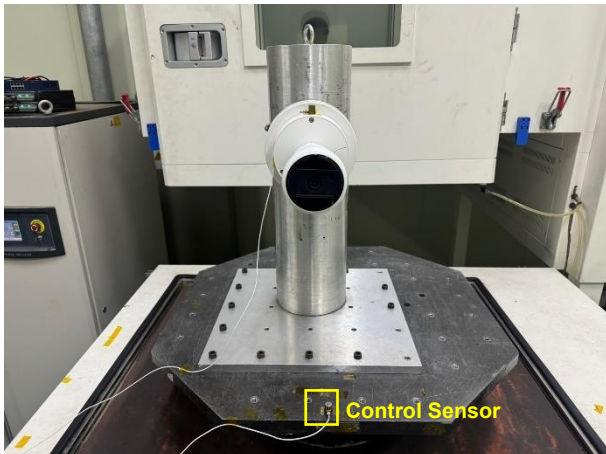
#### 5.3.1 Evidence of test setting (NEMA TS-2:2021 2.1.10)

※ The control sensors for the X and Y axes are mounted on the vibration plate.
