# TEST REPORT

REPORT No.:  
CTK-2026-00738  
Page (1) / (31) pages

NETWORK CAMERA / XNO-A9014R

NEMA TS-2:2021 2.2.7.3 Test C ~ 2.2.7.8 Test H,  
NEMA TS-2 2.2.8, NEMA TS-2 2.2.9

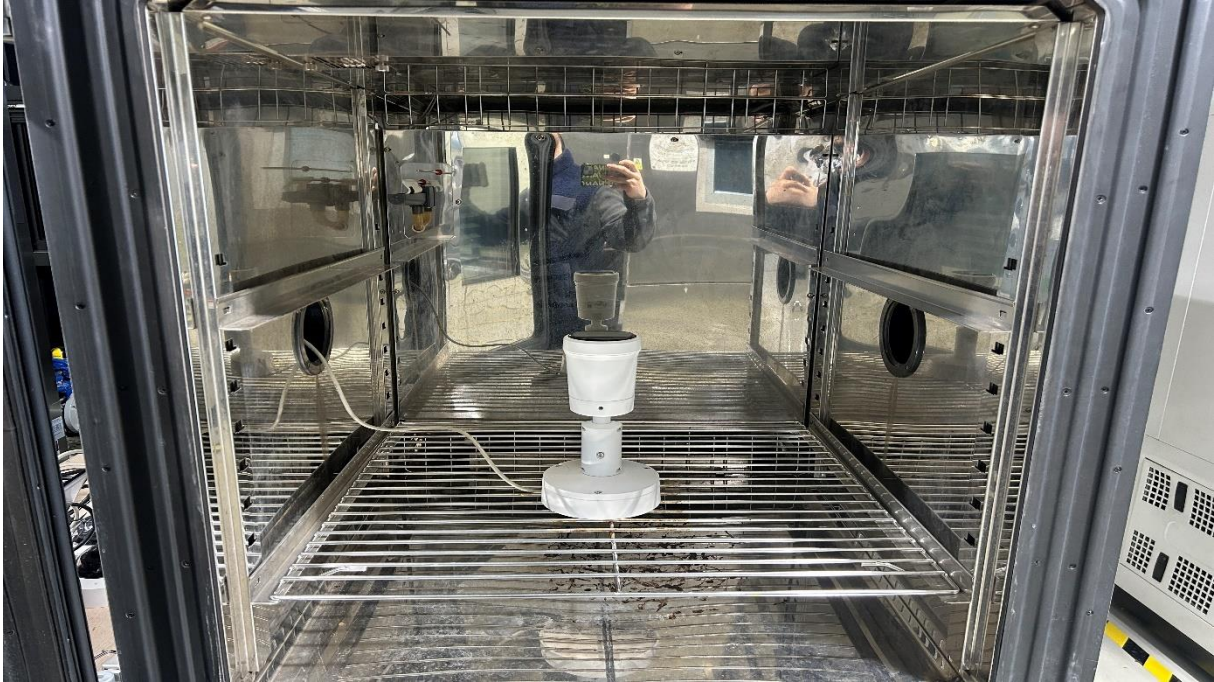
#### 3.9.1 Evidence of test setting

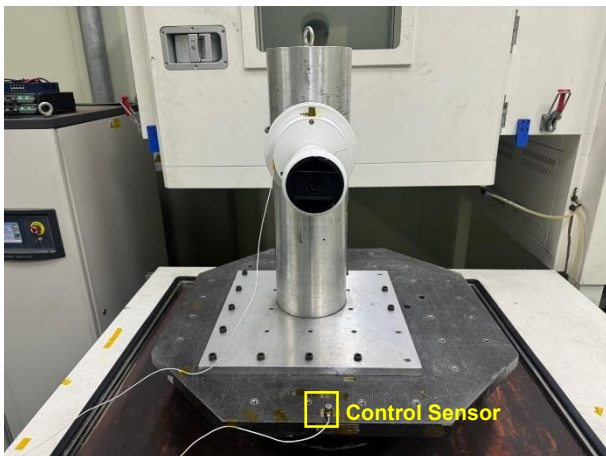
#### 5.3.1 Evidence of test setting (NEMA TS-2:2021 2.1.10)

※ The control sensors for the X and Y axes are mounted on the vibration plate.
