# TEST REPORT

CTK-2026-00386

NETWORK CAMERA / XNP-A6374RH

IEC 62262:2002+AMD1:2021

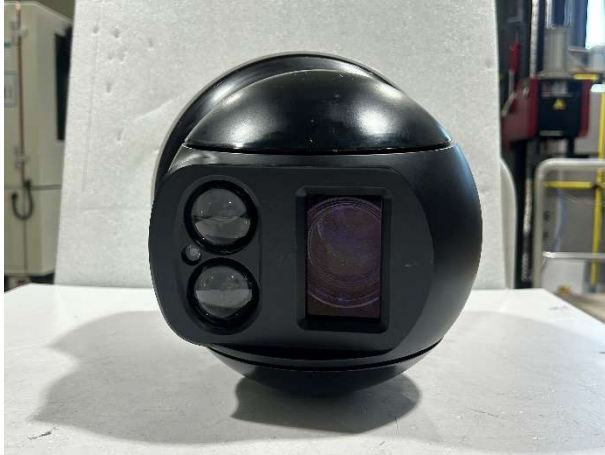
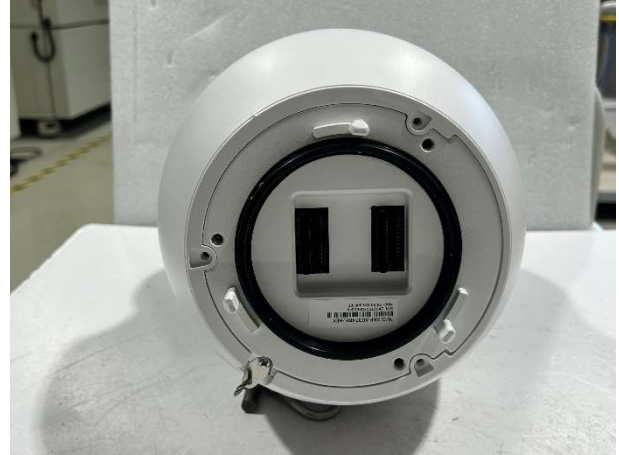
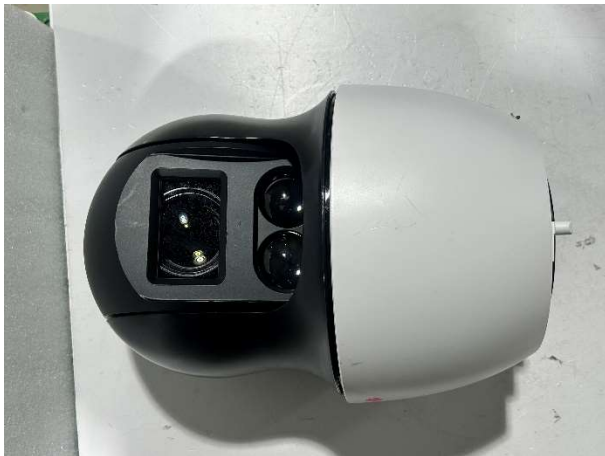
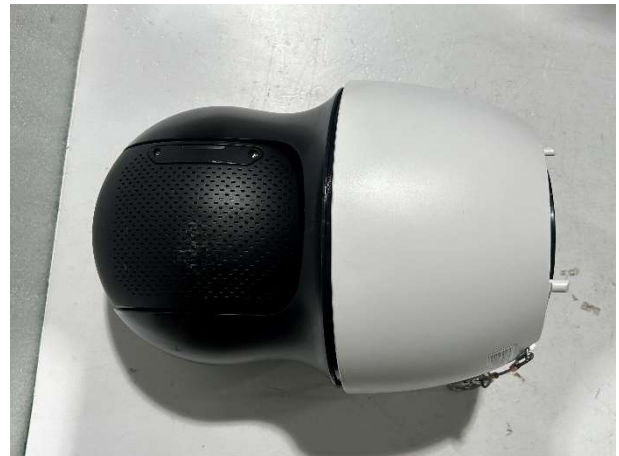
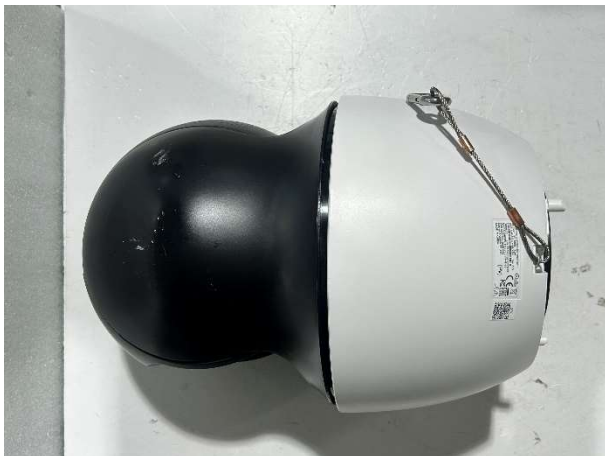
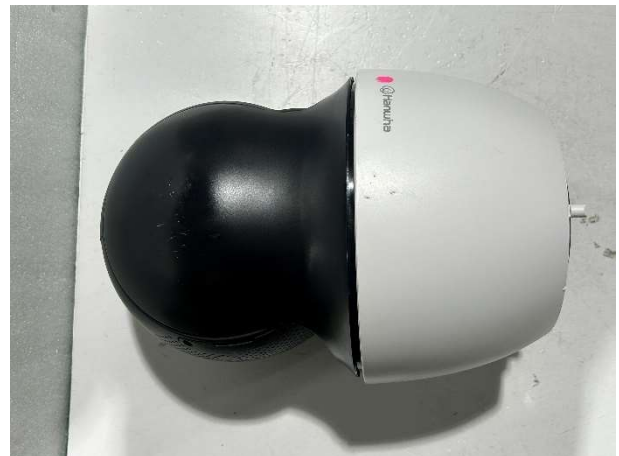
### 3.5.2 Post-test product images

| Evaluation Criteria | Test Results | Remark |
|---|---|---|
| Visual Inspection | Some scratches were generated on the outside of the product. | - |

※ Refer to the product photos after the completion of testing in section 3.5.2
