# TEST REPORT

REPORT No.:  
CTK-2026-00379  
Page (1) / (31) pages

NETWORK CAMERA / XNP-A9314R

NEMA TS 2-2021 2.2.7.3 Test C ~ 2.2.7.8 Test H,  
NEMA TS 2.2.8, NEMA TS 2.2.9

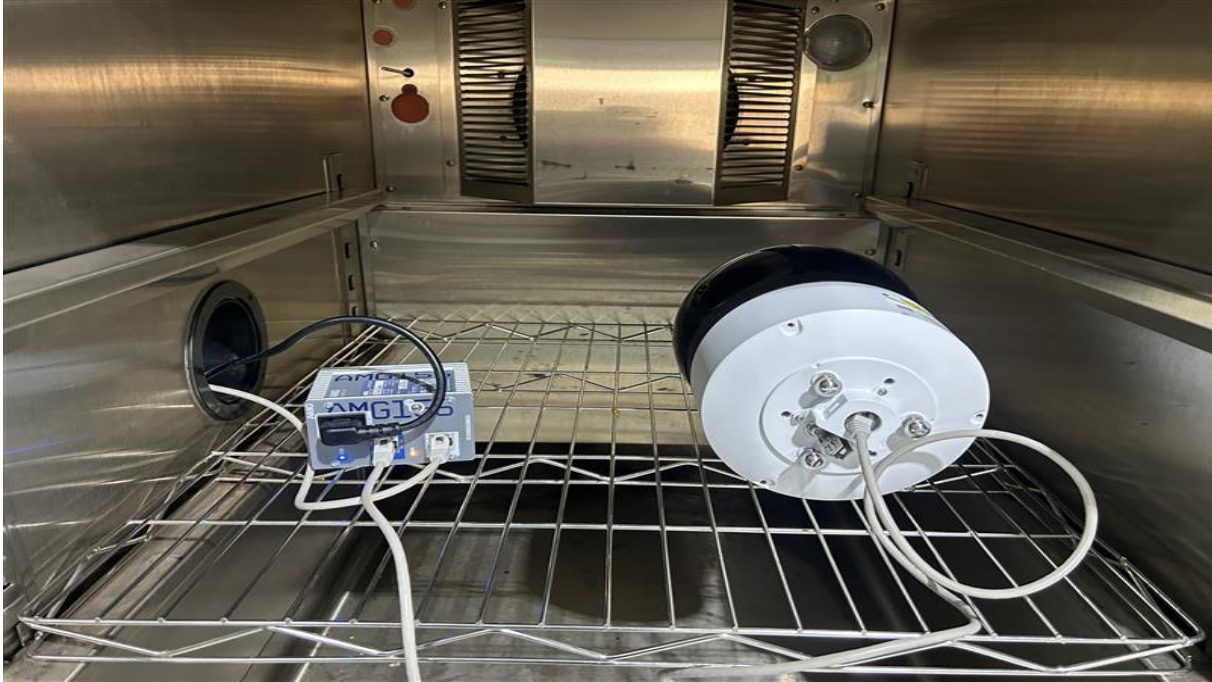
### 5.9.1 Evidence of test setting

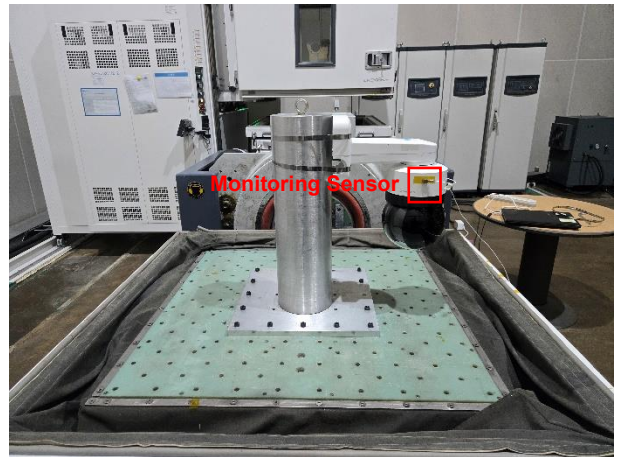
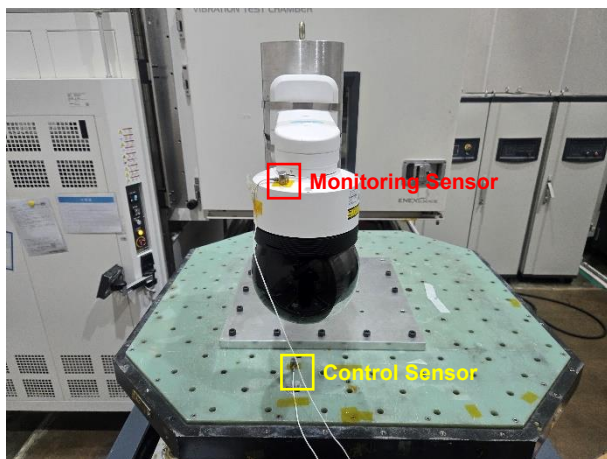
### 6.4.1 Evidence of test setting (NEMA TS-2:2021 2.2.8)

※ The control sensors for the X and Y axis are mounted on the vibration plate.
