# TEST REPORT

REPORT No.:  
CTK-2026-00730  
Page (1) / (31) pages

NETWORK CAMERA / XNV-A6014R

NEMA TS-2:2021 2.2.7.3 Test C ~ 2.2.7.8 Test H,  
NEMA TS-2 2.2.8, NEMA TS-2 2.2.9

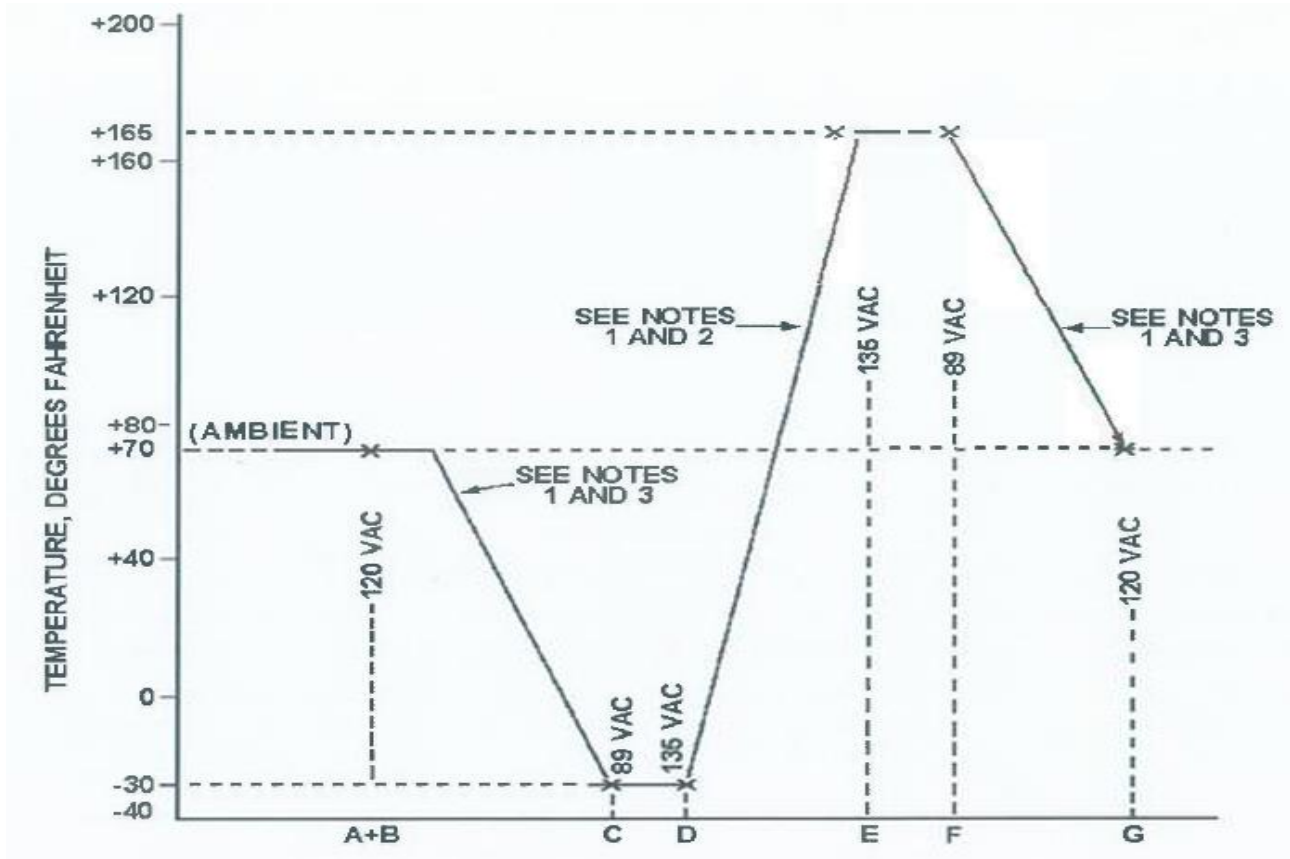
Table 2-1

### 3.8 Test Profile

3.4.3 Set the humidity controls to not exceed 95 % relative humidity over the temperature range of 4.4 °C (40 °F) to 43.3 °C (110 °F). When the temperature reaches 43 °C (109 °F), readjust the humidity control to maintain constant absolute humidity 43 °C (109 °F) wet bulb (see relative humidities shown in Table 2-1). Verify that the test sample continues to cycle satisfactorily during the period of temperature increase and at established levels of relative humidity.

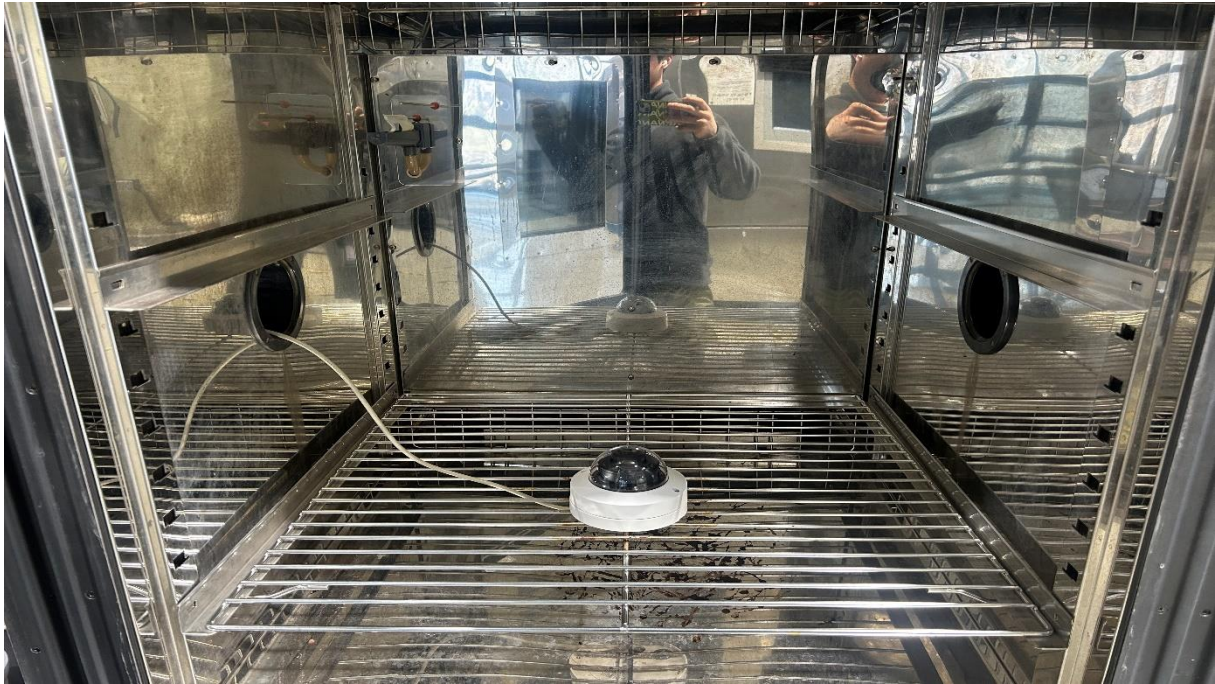
#### 3.9.1 Evidence of test setting

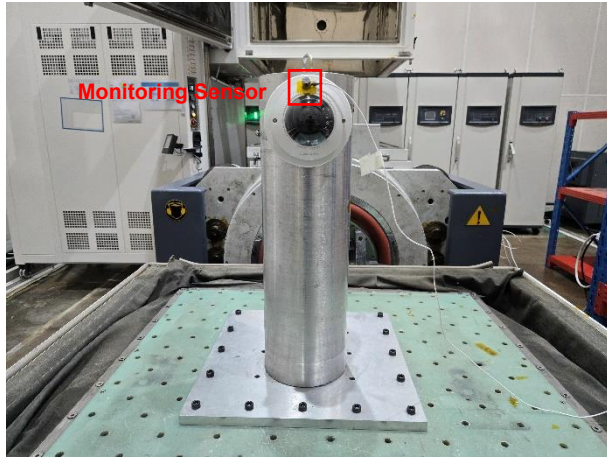
### 4.4.1 Evidence of test setting (NEMA TS-2:2021 2.2.8)

※ The control sensors for the X and Y axes are mounted on the vibration plate.

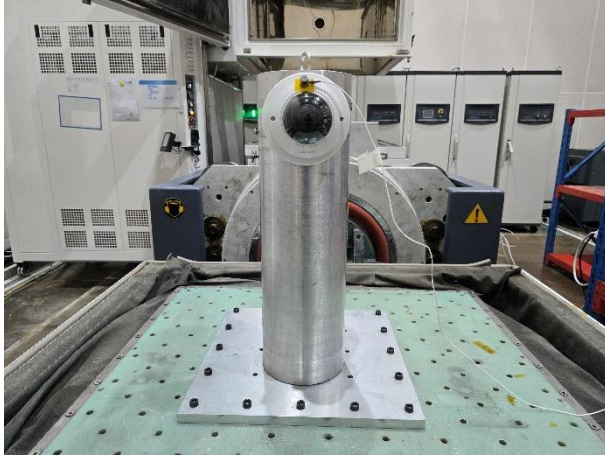
#### 5.3.1 Evidence of test setting (NEMA TS-2:2021 2.1.10)

※ The control sensors for the X and Y axes are mounted on the vibration plate.
