# TEST REPORT

CTK-2025-02257

NETWORK CAMERA / XNV-A9084R

EN 60068-2-1, EN 60068-2-2, EN 60068-2-14, EN 60068-2-6, EN  
60068-2-27, EN 60068-2-78, IEC 60068-2-1, IEC 60068-2-2, IEC  
60068-2-14, IEC 60068-2-6, IEC 60068-2-27, IEC 60068-2-78

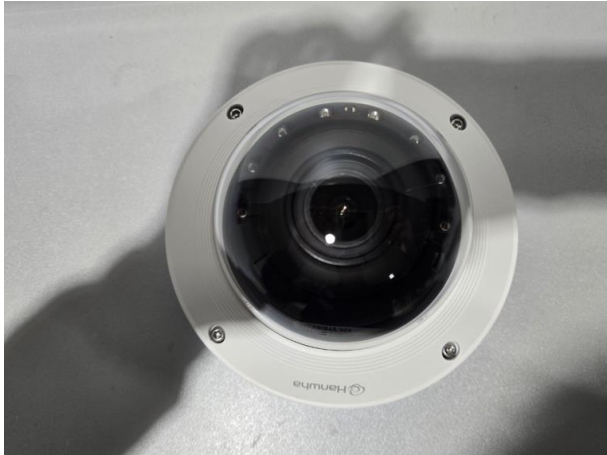
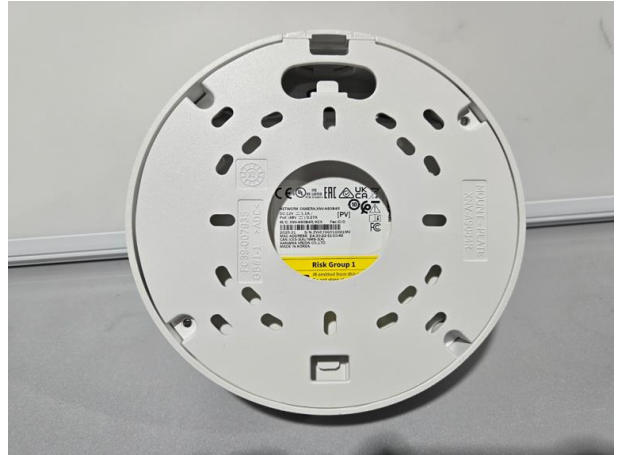
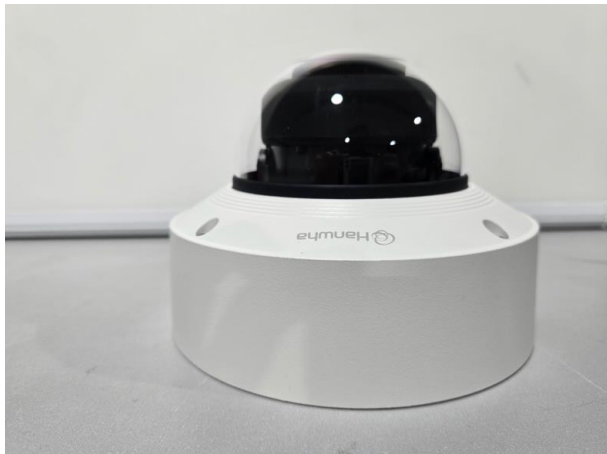
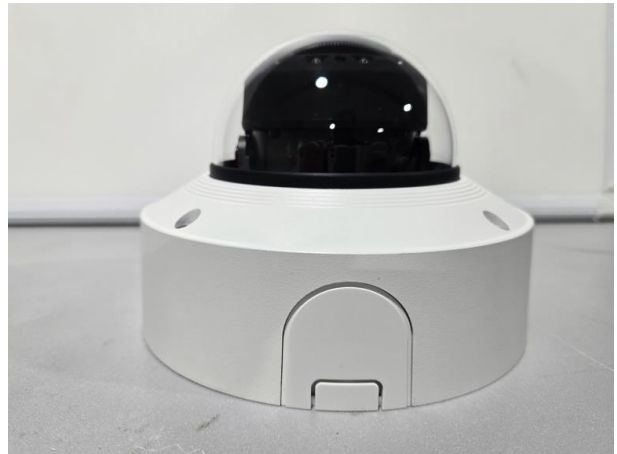
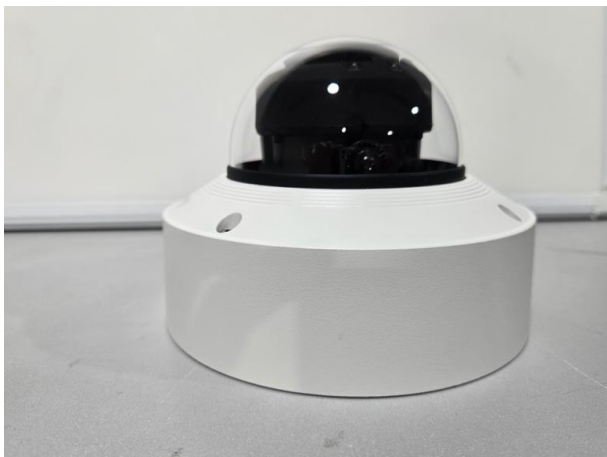
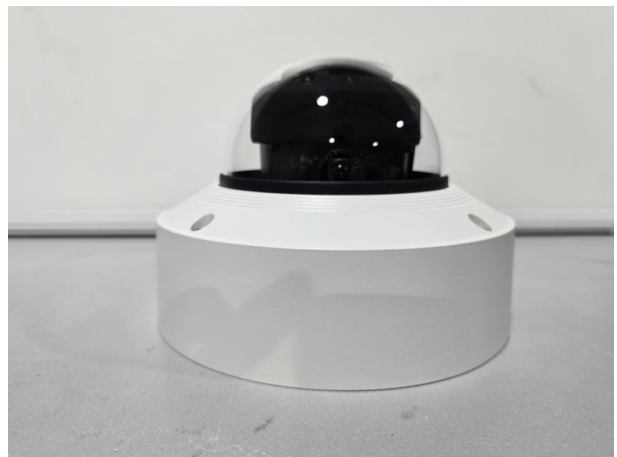
### 2.4.1 Test sample

## 2.4 Pre-test product images

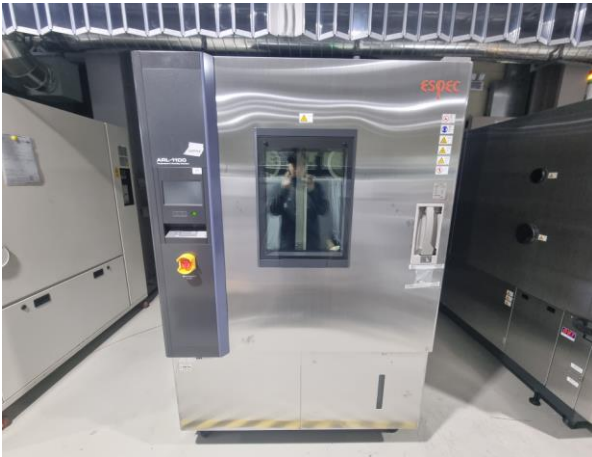
| Testing equipment | Model Name | Manufacturer | Manufacturing Number | Calibration Date |
|---|---|---|---|---|
| Temperature & Humidity Chamber | ARS-1100-AE | ESPEC | 1110024017 | Oct. 7, 2025 |

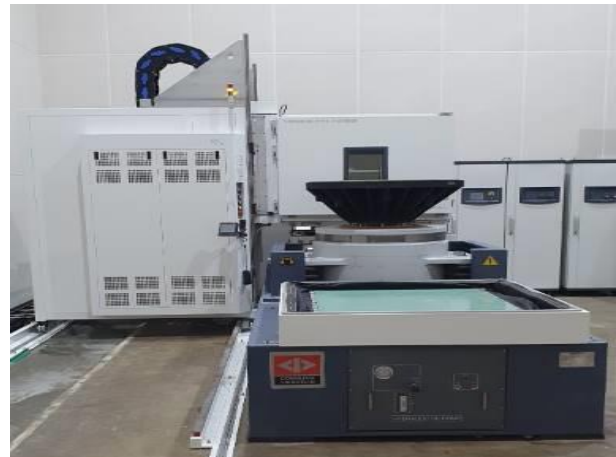
| Testing equipment | Model Name | Manufacturer | Manufacturing Number | Calibration Date |
|---|---|---|---|---|
| VIBRATION TESTING SYSTEM | LT1010 | FAMTECH | D2012335 | N/A |

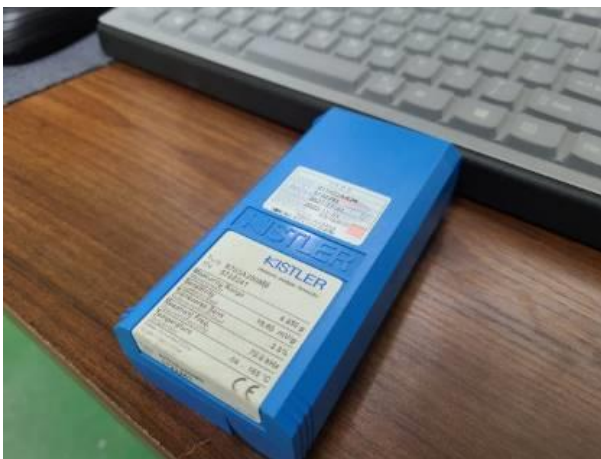
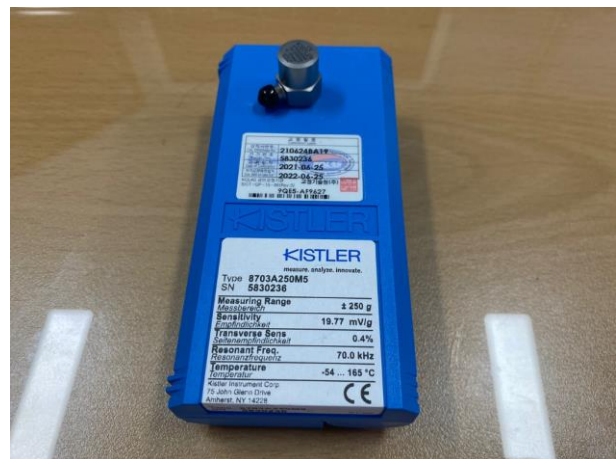
| Testing equipment | Model Name | Manufacturer | Manufacturing Number | Calibration Date |
|---|---|---|---|---|
| Acceleration sensor | 8703A250M5 | KISTLER | 5830236 | Jan. 16, 2026 |
| Acceleration sensor | 8703A250M5 | KISTLER | 5722241 | Jan. 16, 2026 |

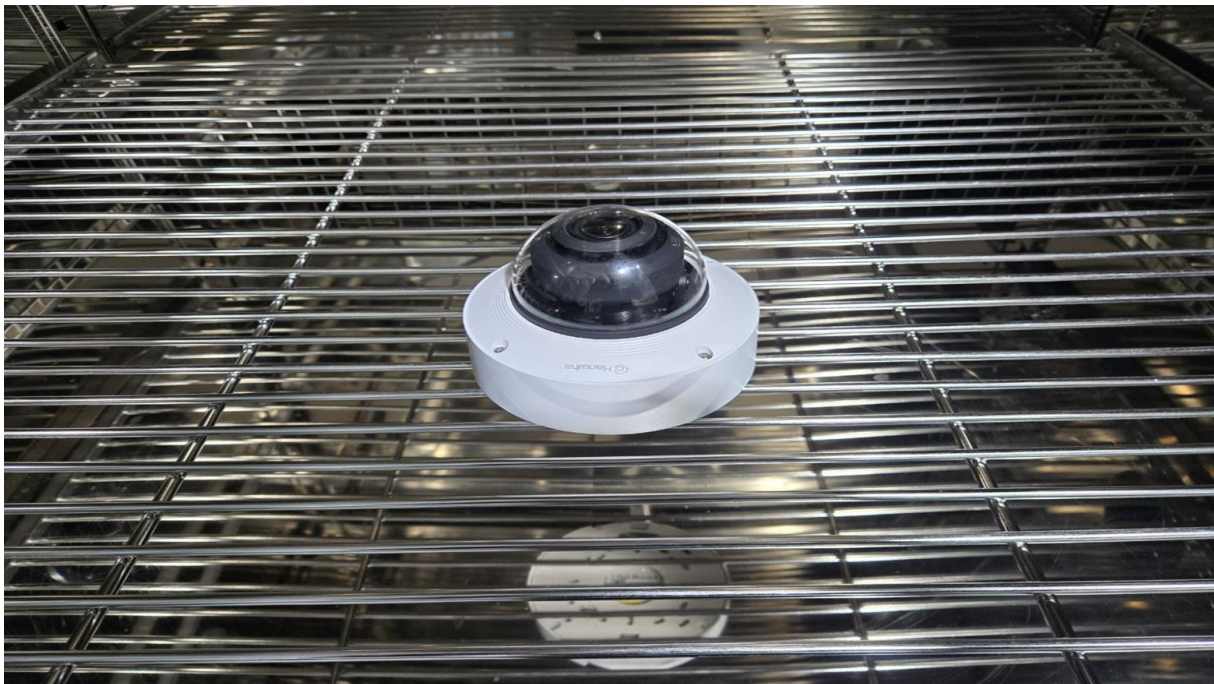
#### 3.3.1 Evidence of test setting

3.2.1 Sample status: Non-operation

3.2.2 Test temperature: -33

3.2.3 Test time: 16 h

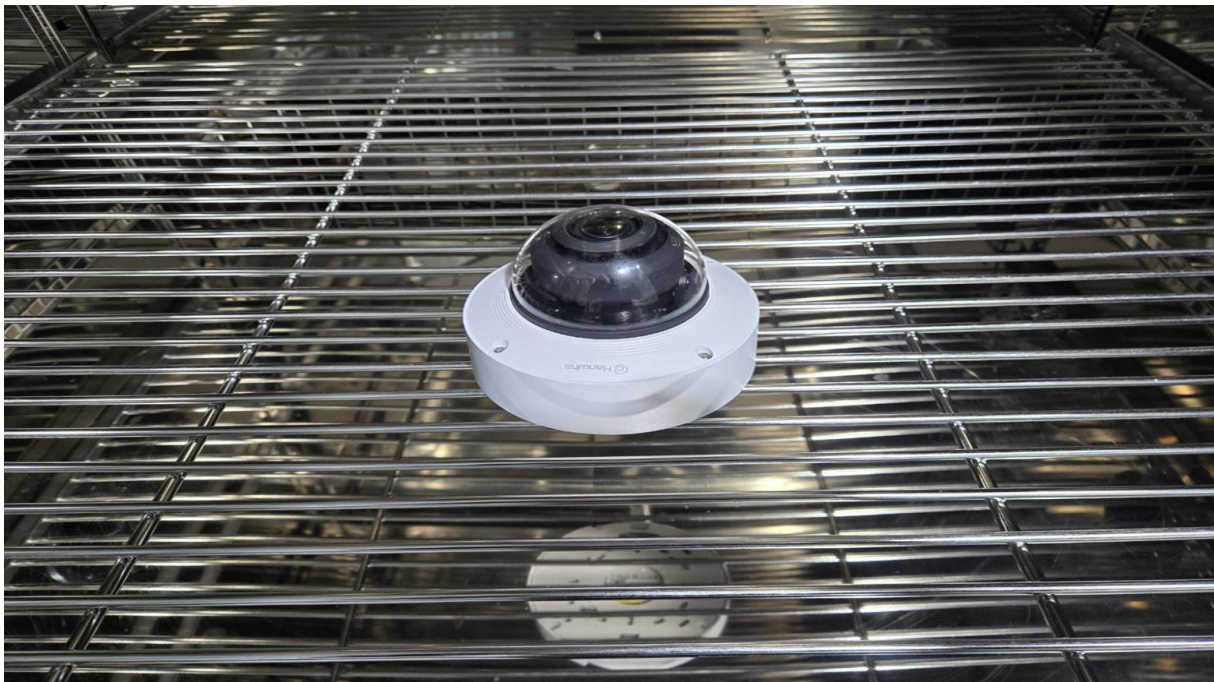
#### 4.3.1 Evidence of test setting

4.2.1 Sample status: Non-operation

4.2.2 Test temperature: 60 °C

4.2.3 Test time: 96 h

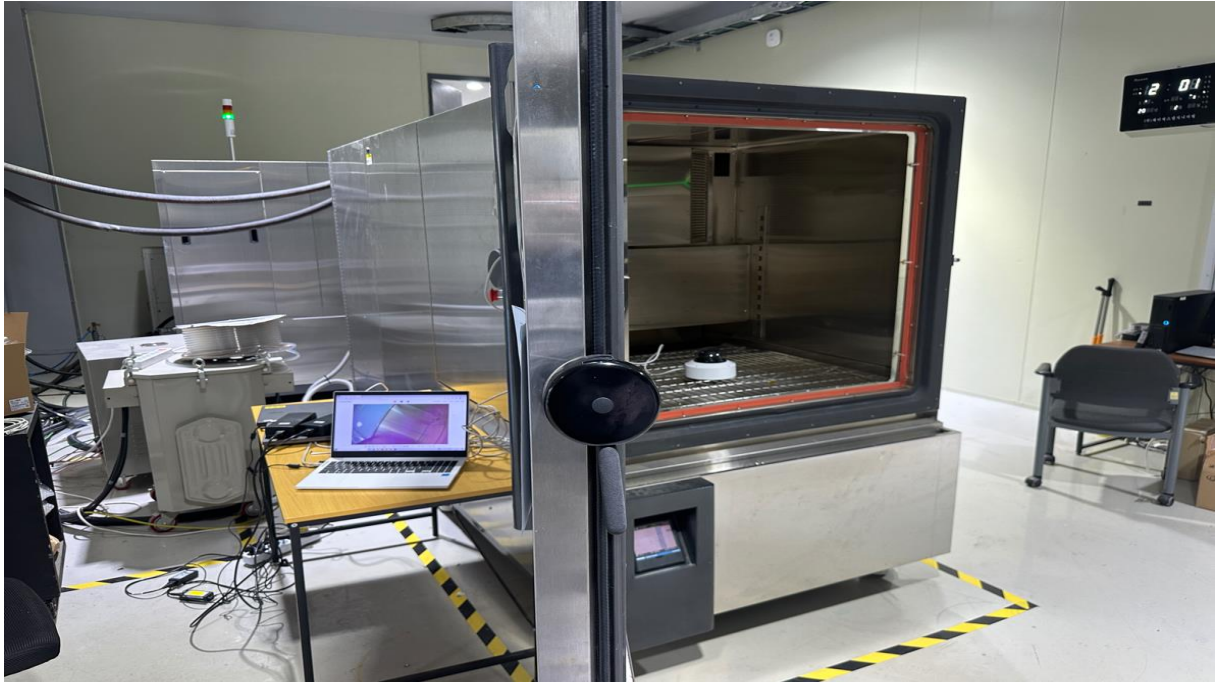
### 5.3.1 Evidence of test setting

5.2.1 Sample status: operation

5.2.2 Test temperature: -40 °C, 50 °C

5.2.3 Test time: 24 h

| T <sub>A</sub> (High)↵ | T <sub>B</sub> (Low)↵ | Temperature change rate(°C/min)↵ | t <sub>1</sub> (idle time)↵ | Cycles↵ |
| 50 °C ↵ | -↵ | 5 °C/min↵ | 3 h↵ | 3↵ |
| -↵ | -40 °C↵ | 1 °C/min↵ | 3 h↵ | 3↵ |

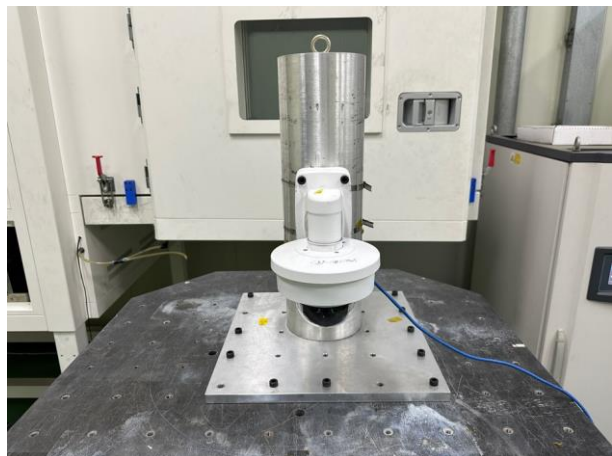
### 6.3.1 Evidence of test setting

- Sample status: operation
- Frequency(Hz): 5 Hz ~ 200 Hz
- Acceleration(G): 1 G
- Sweep rate: 1 oct/min
- Test Axis: Z, X, Y
- Test time(h): Total 30 min (10 min. per each axis)

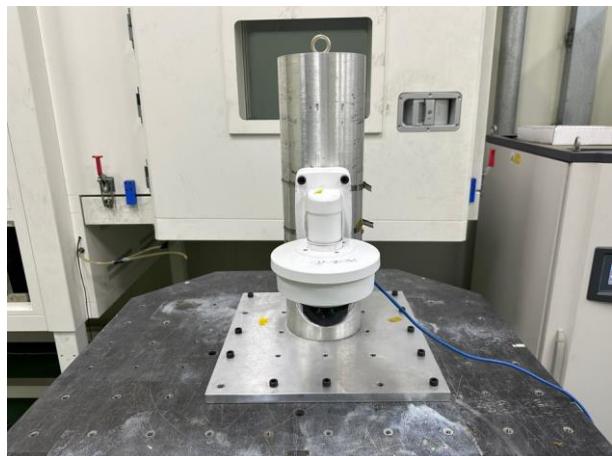
### 7.3.1 Evidence of test setting

7.2.1 Sample status: Non-operation

7.2.2 Acceleration(G): 10 G

7.2.3 Number of impacts: 10 per direction (total 60)

7.2.4 Test Axis: Z, X, Y

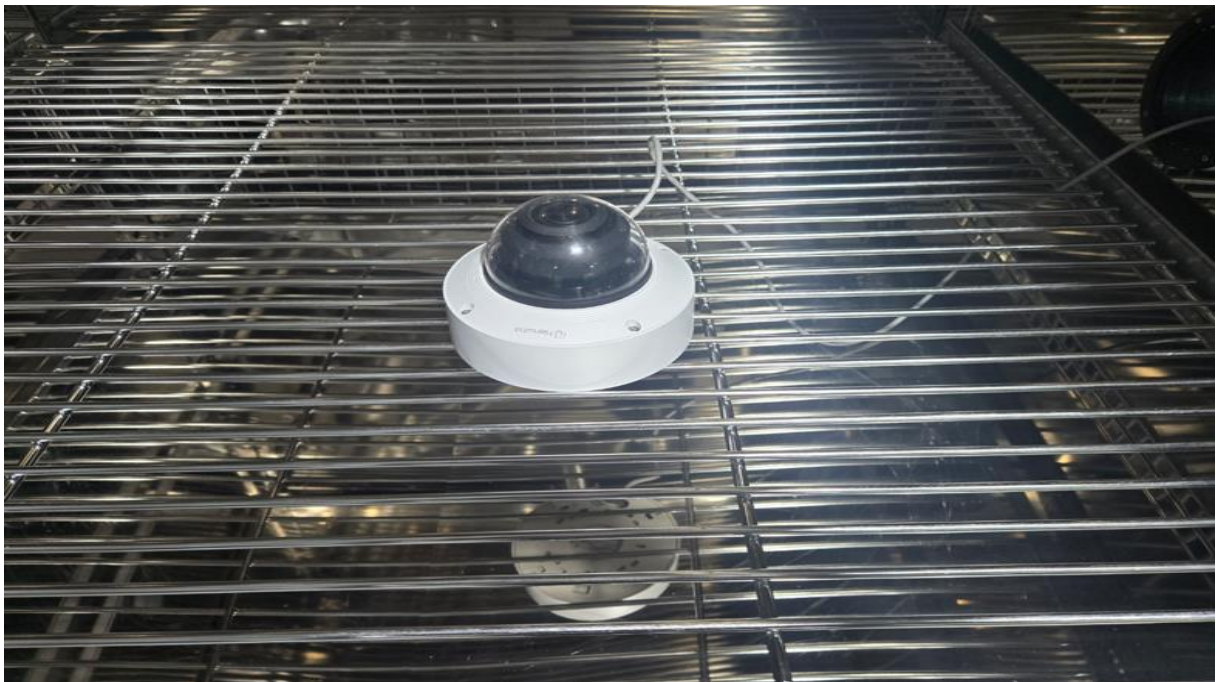
#### 8.3.1 Evidence of test setting

8.2.1 Sample status: operation

8.2.2 Test temperature:  $40 \pm 2$  °C

8.2.3 Test Humidity:  $93 \pm 3$  % R.H.

8.2.4 Test time: 240 h

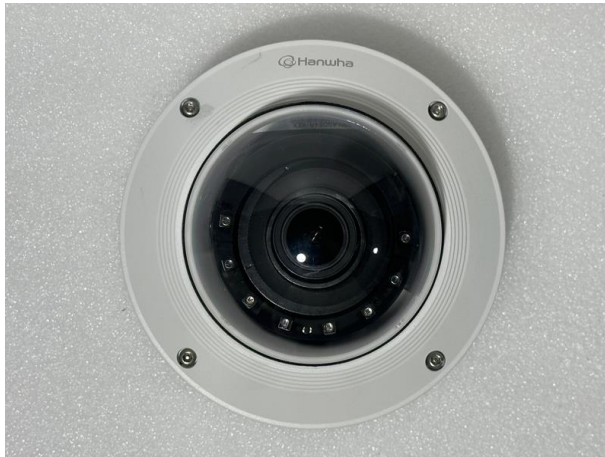
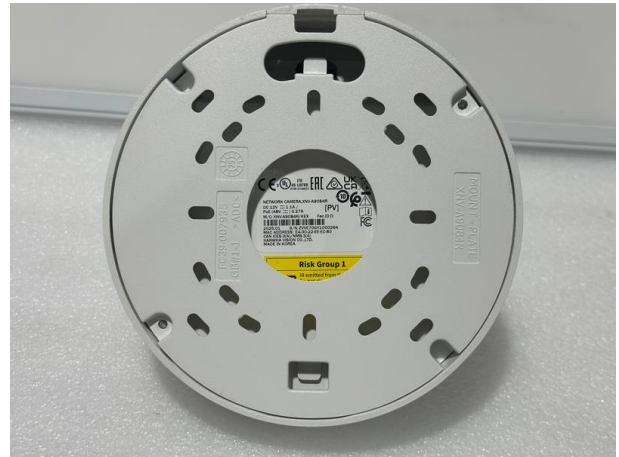
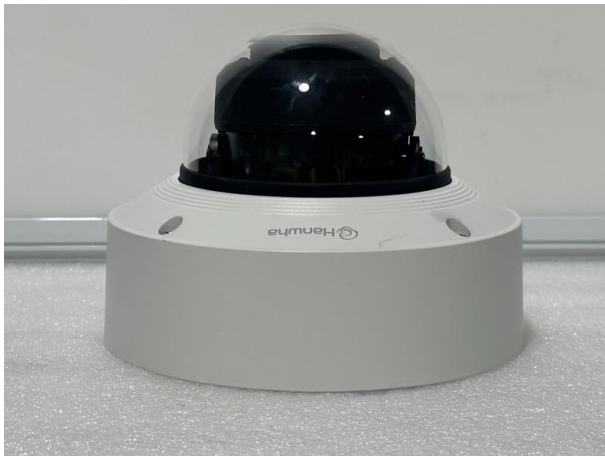
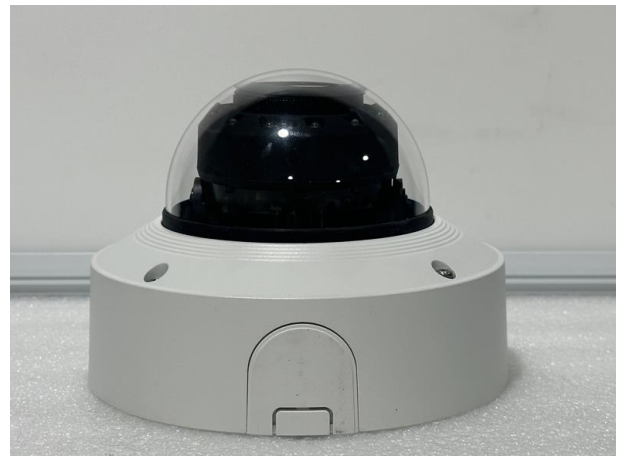
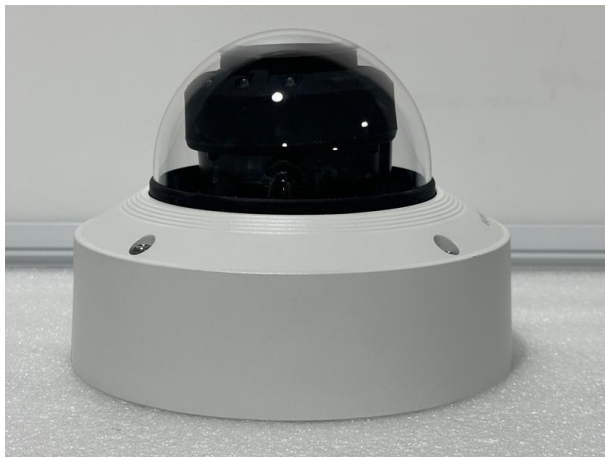
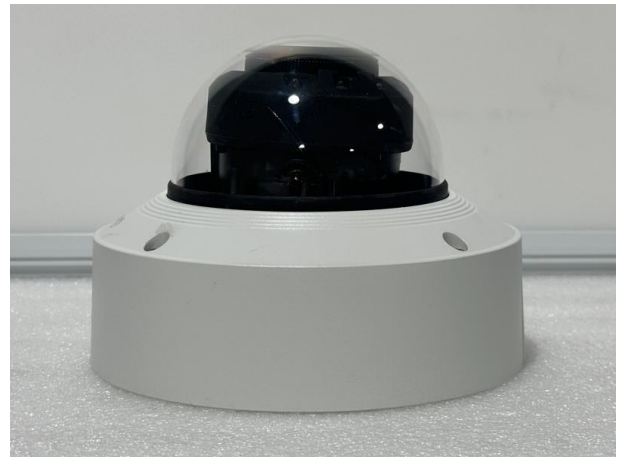
### 8.6.1 Test sample

## 8.6 Post-test product images

| Evaluations Criteria | Test result | | 비고 |
|---|---|---|---|
| | Visual Inspection | Normal | - |
