# TEST REPORT

REPORT No.:  
CTK-2025-02259  
Page (1) / (26) pages

NETWORK CAMERA / XNV-A6084R

NEMA TS 2-2013 2.2.7.3 Test C ~ 2.2.7.8 Test H,  
NEMA TS 2.2.8, NEMA TS 2.2.9

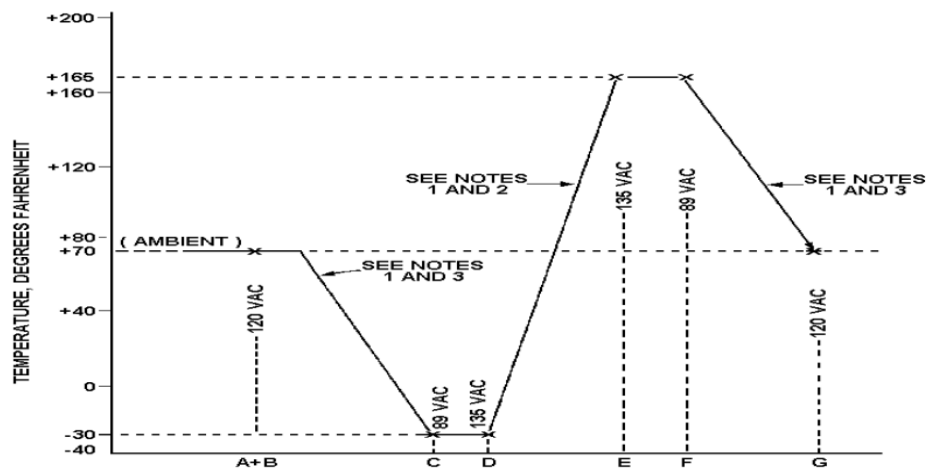
#### 3.2.7 Test Methods

- 3.2.1 2.2.7.3 Test C: - 34 °C, 89 Vac, 10 h (Check interim operation after 5 h and operation check after 10h)
- 3.2.2 2.2.7.4 Test D: - 34 °C, 135 Vac, 1 h (Operating state)
- 3.2.3 2.2.7.5 Test E: 74 °C, 18 %, 135 Vac, 15 h (Operating state)
- 3.2.4 2.2.7.6 Test F: 74 °C, 18 %, 89 Vac (Operation check after 2.2.7.5 Test E)
- 3.2.5 2.2.7.7 Test G: (21 ±6) °C, 120 Vac (Operating state)
- 3.2.6 2.2.7.8 Test H: Check for mechanical damage

- Evaluations Criteria :
  - Check for mechanical damage before and after testing
- Test methods

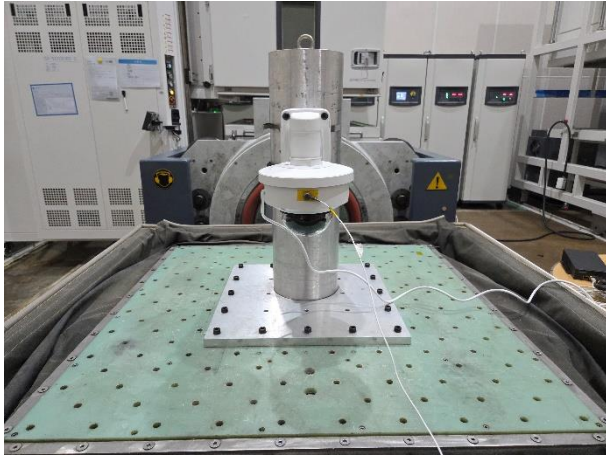
X axis

#### 4.3.1 Evidence of test setting (NEMA TS 2-2013 2.2.8)

- Sample status : unpackaged / not in operation
- Applied waveform : Sine
- Frequency(Hz) : 5 ~ 30
- Double amplitude displacement (inch) : 0.015
- Sweep rate(Sweep/min) : 12.5

- Sample status : unpackaged / not in operation
- Applied waveform : Sine
- Frequency(Hz) : 30 or 3.2.2 Test results
- Acceleration(G) : 0.5
- Applicable axis : X, Y, Z
- Test time(h) : All 3(Each axis 1)
- Evaluation items
  - Check for mechanical damage before and after testing
- Test methods
  - Vibrate the test unit in each plane at its resonant frequency for a period of 1 hour at an amplitude resulting in 0.5 g acceleration. (test profile)
  - When more than one resonant frequency has been recorded in accordance with Section 1.2 Item 4, the test period of 1 hour shall be divided equally between the resonant frequencies.
  - The total time of the endurance test shall be limited to 3 hours, 1 hour in each of three mutually perpendicular planes.

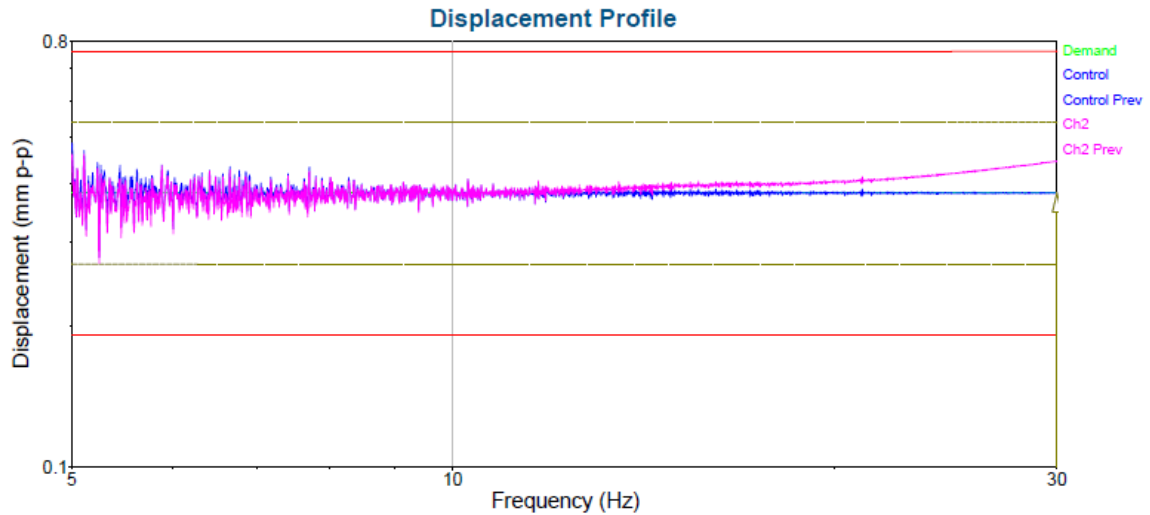
#### 4.5.1 Test Data X Axis

| 9 15, 2025 14:23:05 | Level 1) 100 % | Output: 0.0479 Volts peak | NEMA TS-2 2.2.8 |
| Demand: 0.381 mm | Level Time: 0:12:30 | Frequency: 30 Hz | |
| Control: 0.3812 mm | Total Time: 0:12:36 | End of Sweep Test | |

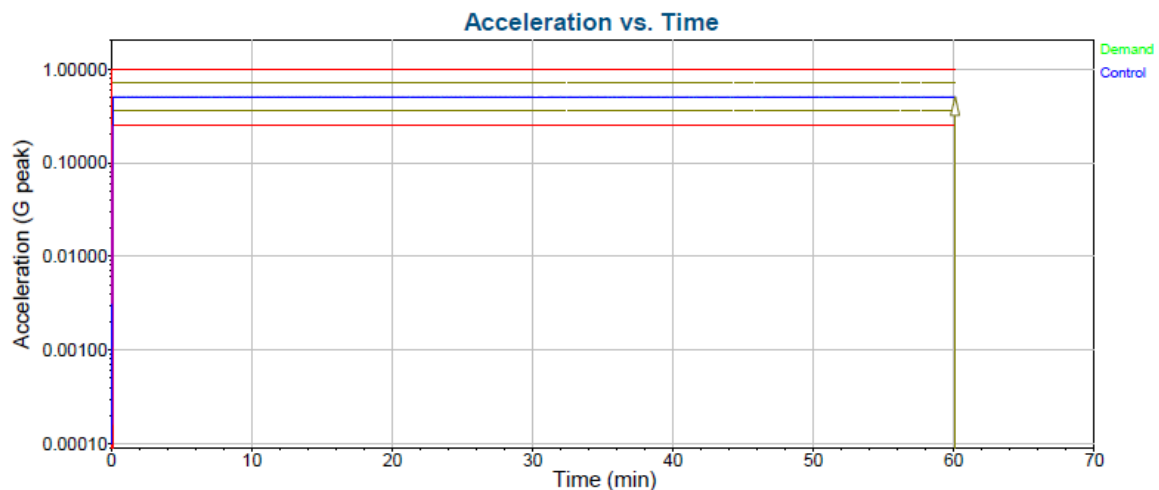
#### Endurance Test

| 9 15, 2025 15:26:36 | Level 1) 100 % | Output: 0.03526 Volts peak | NEMA TS-2 2.2.8 내구 |
| Demand: 0.5 G | Level Time: 1:00:00 | Frequency: 30 Hz | |
| Control: 0.5006 G | Total Time: 1:00:07 | End of Timed Test | |

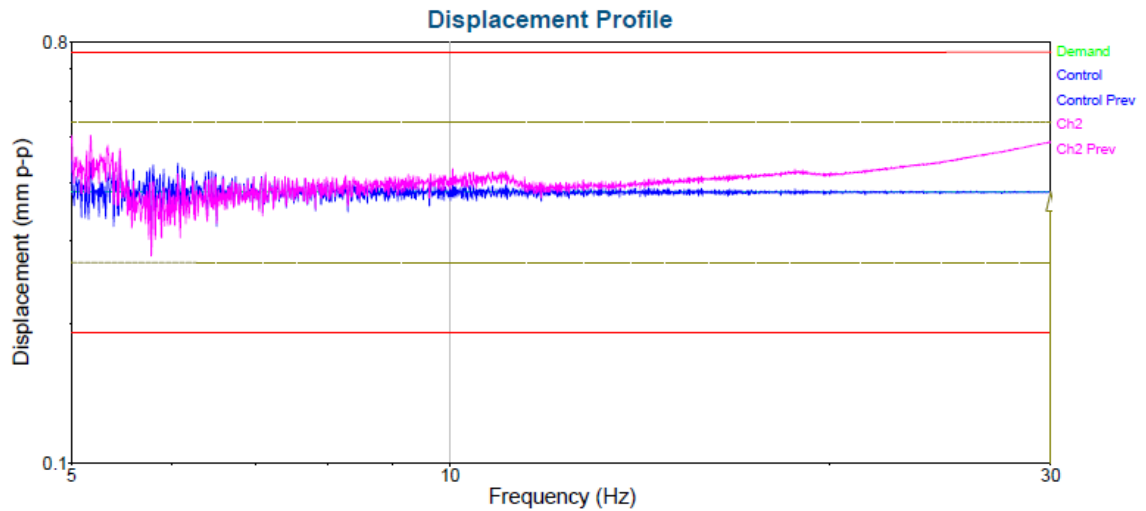
### 4.5.1 Test Data Y Axis

| 9 15, 2025 16:02:19 | Level 1) 100 % | Output: 0.04802 Volts peak | NEMA TS-2 2.2.8 |
| Demand: 0.381 mm | Level Time: 0:12:30 | Frequency: 30 Hz | |
| Control: 0.3808 mm | Total Time: 0:12:36 | End of Sweep Test | |

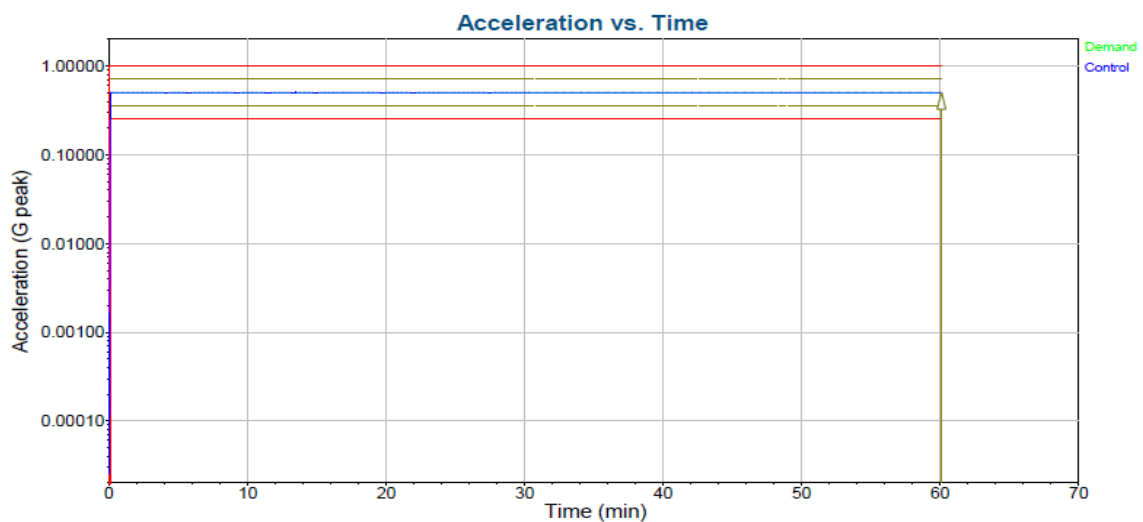
### Endurance Test

| 9 15, 2025 17:04:15 | Level 1) 100 % | Output: 0.03531 Volts peak | NEMA TS-2 2.2.8 내구 |
| Demand: 0.5 G | Level Time: 1:00:00 | Frequency: 30 Hz | |
| Control: 0.4991 G | Total Time: 1:00:07 | End of Timed Test | |

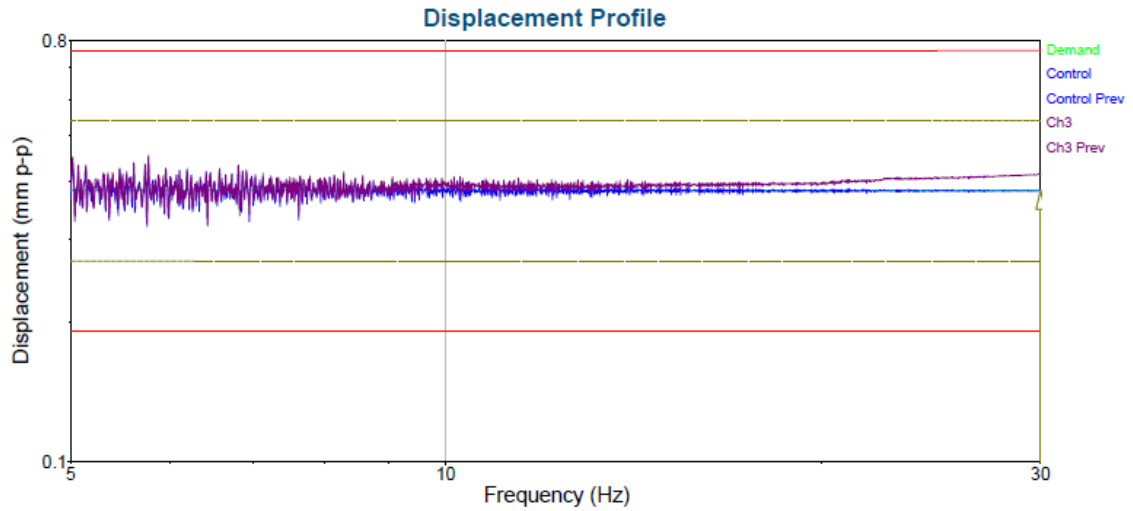
### 4.5.2 Test Data Z Axis

| 9 16, 2025 17:33:39 | Level 1) 100 % | Output: 0.04827 Volts peak | NEMA TS-2 2.2.8 |
| Demand: 0.381 mm | Level Time: 0:12:30 | Frequency: 30 Hz | |
| Control: 0.3816 mm | Total Time: 0:12:36 | End of Sweep Test | |

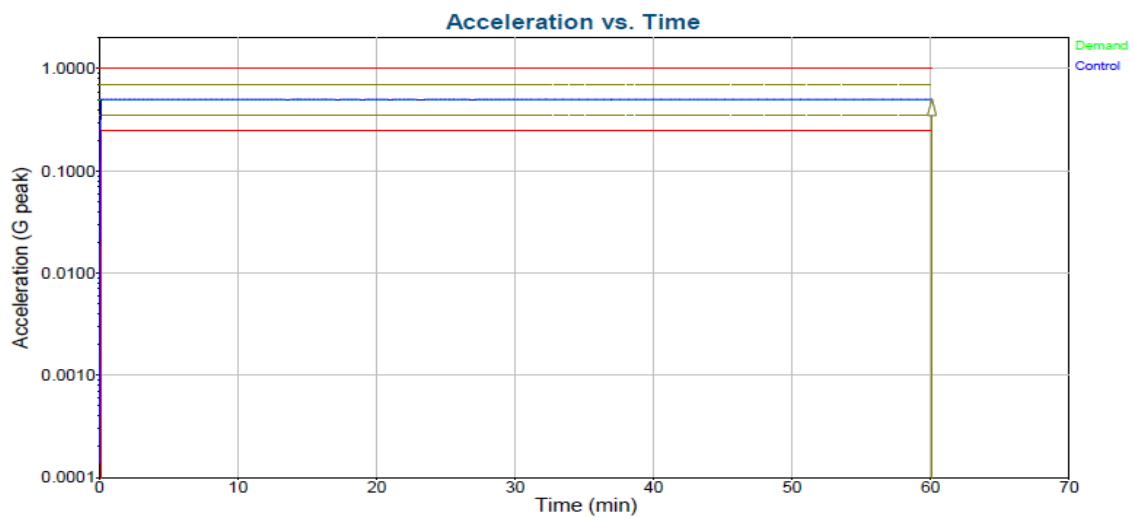
### Endurance Test

| 9 16, 2025 18:36:57 | Level 1) 100 % | Output: 0.03508 Volts peak | NEMA TS-2 2.2.8 내구 |
| Demand: 0.5 G | Level Time: 1:00:00 | Frequency: 30 Hz | |
| Control: 0.5001 G | Total Time: 1:00:06 | End of Timed Test | |

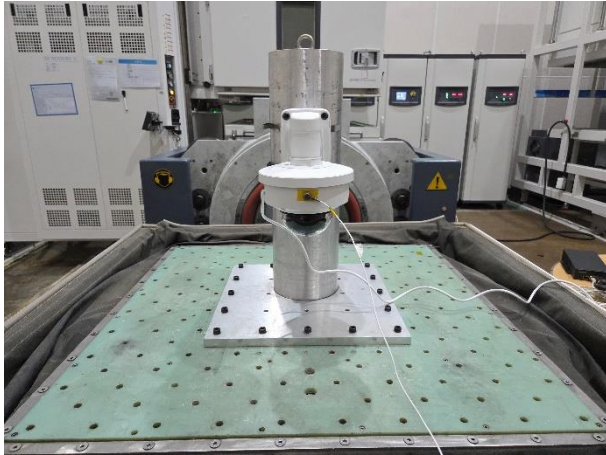
X axis

#### 5.3.1 Evidence of test setting (NEMA TS 2-2013 2.2.9)

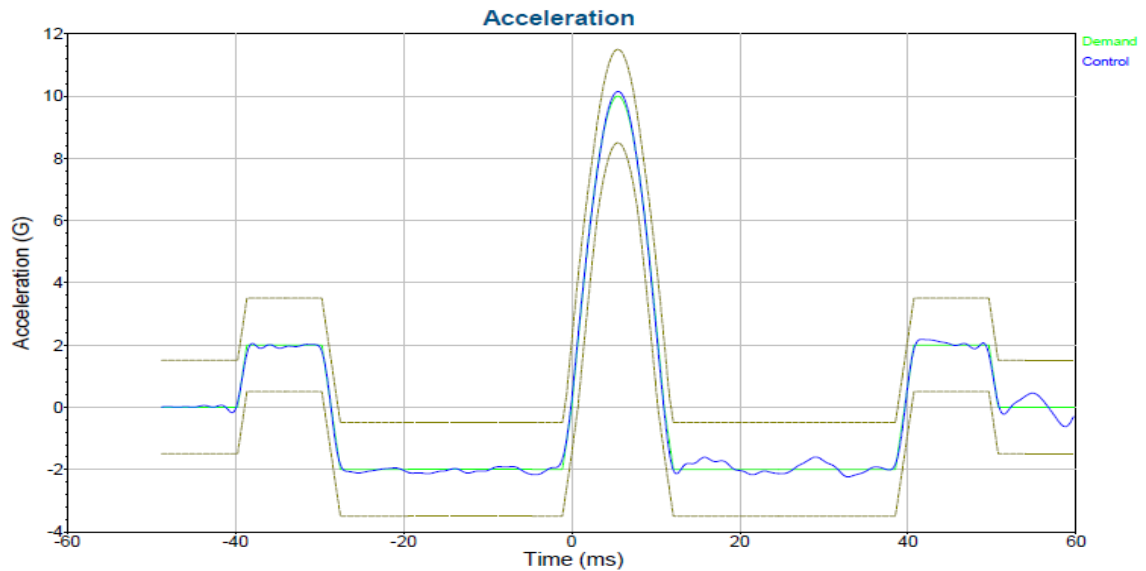
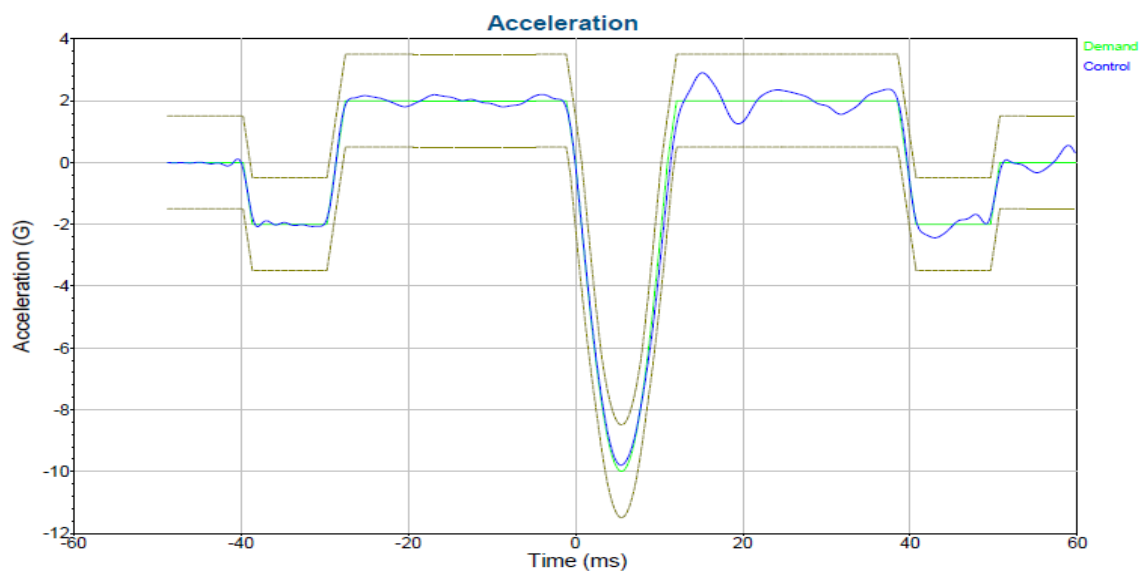
#### 5.5.1 Test Data X Axis

Demand: 10 G

Control: 10.14 G

Control: 9.803 G

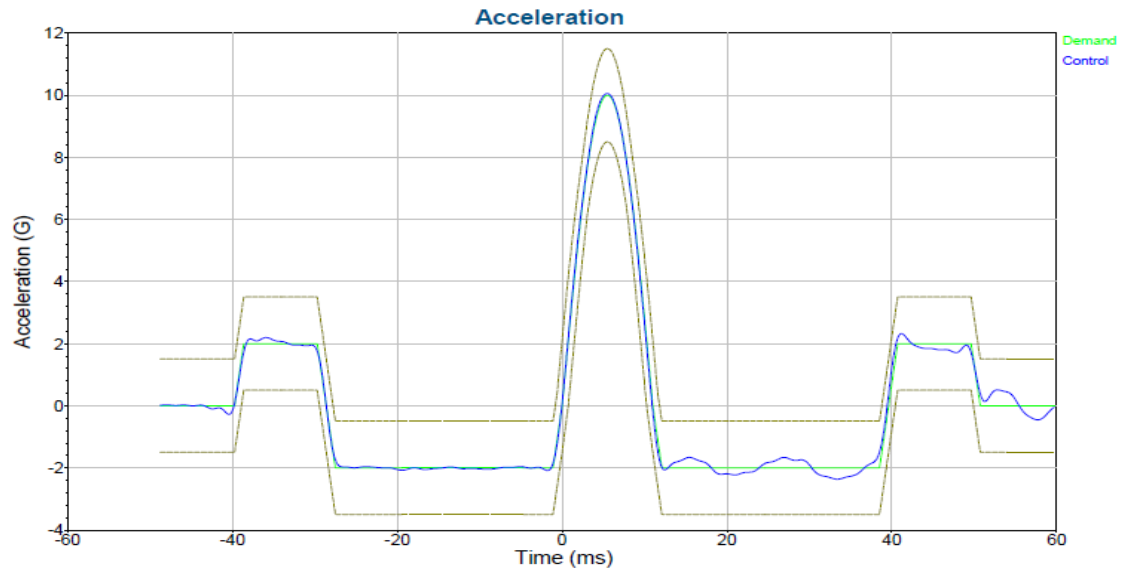
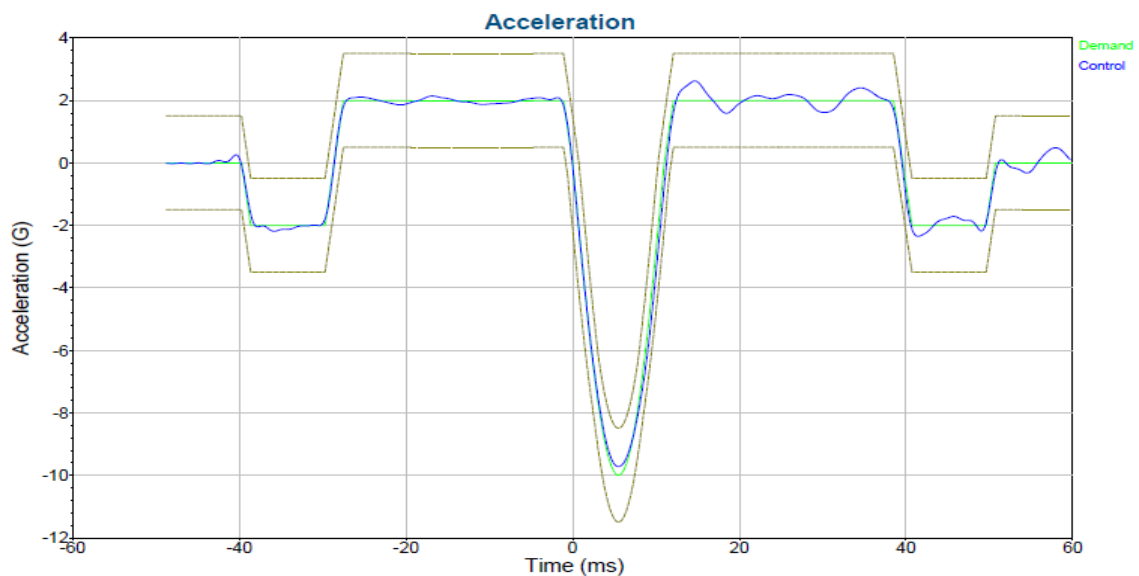
### 5.5.1 Test Data Y Axis

Demand: 10 G

Control: 10.05 G

Control: 9.727 G

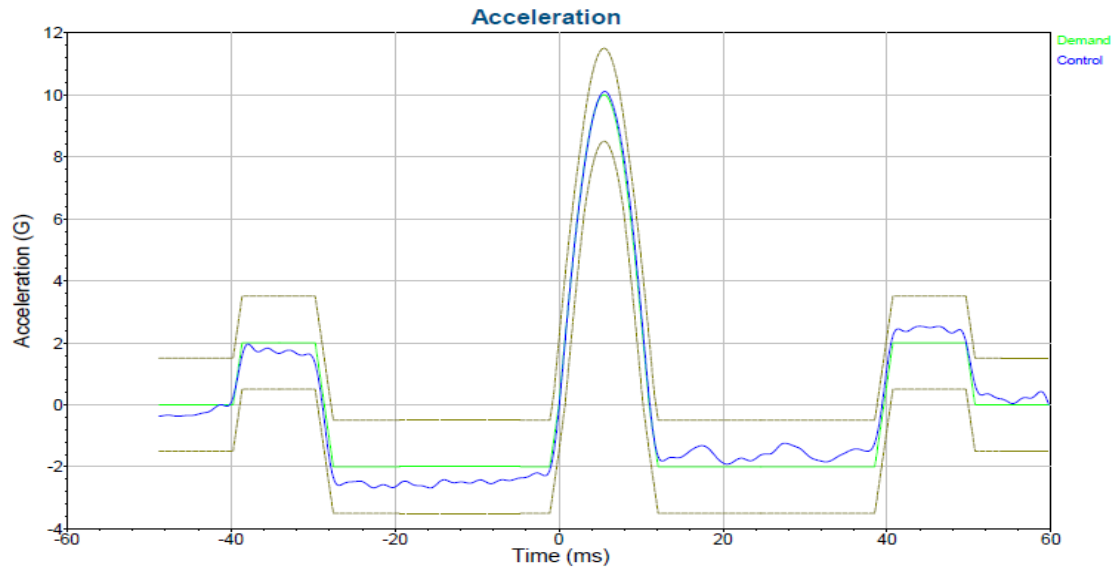
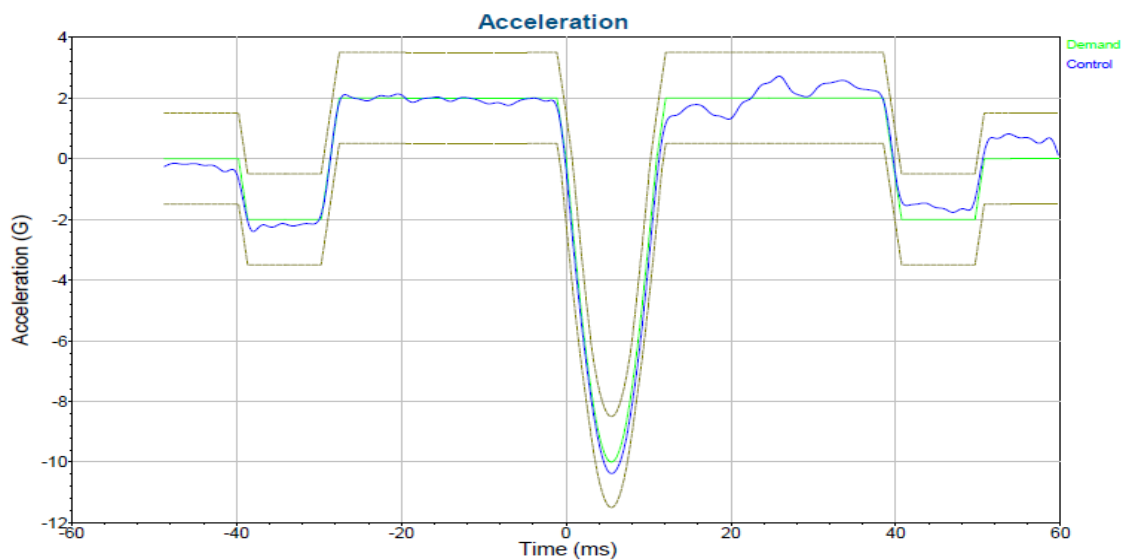
### 5.5.2 Test Data Z Axis

9 17, 2025 09:12:31    Level 1) 100 %  
Demand: 10 G  
Control: 10.11 G    Pulse: 1 of 1

9 17, 2025 09:12:34    Level 2) 100 %  
Demand: 10 G  
Control: 10.38 G    Pulse: 1 of 1
