# TEST REPORT

REPORT No.:  
CTK-2026-00011  
Page (1) / (39) pages

NETWORK CAMERA / XNV-A9016R

EN 60068-2-1, EN 60068-2-2, EN 60068-2-14, EN 60068-2-6, EN  
60068-2-27, EN 60068-2-78, IEC 60068-2-1, IEC 60068-2-2, IEC  
60068-2-14, IEC 60068-2-6, IEC 60068-2-27, IEC 60068-2-78

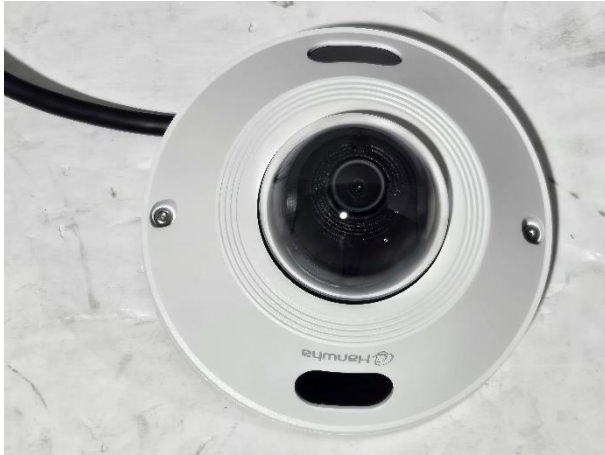
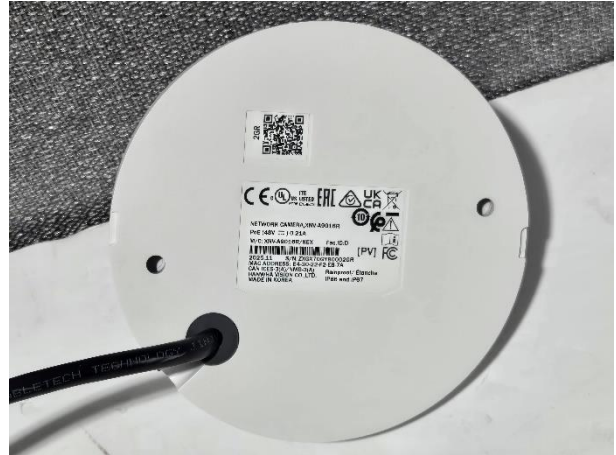
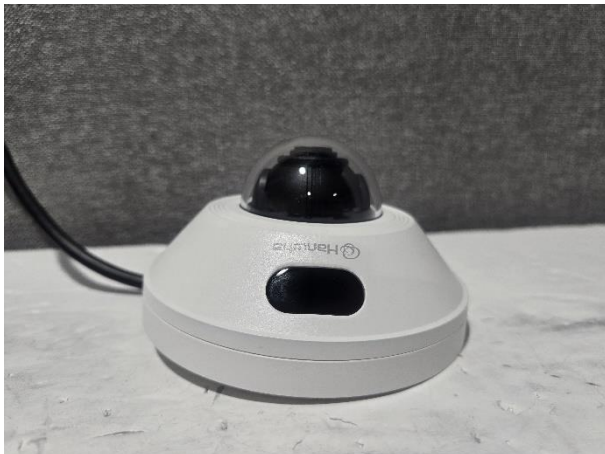
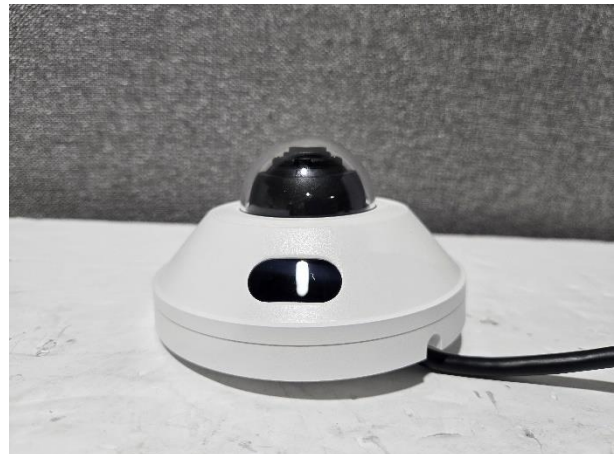
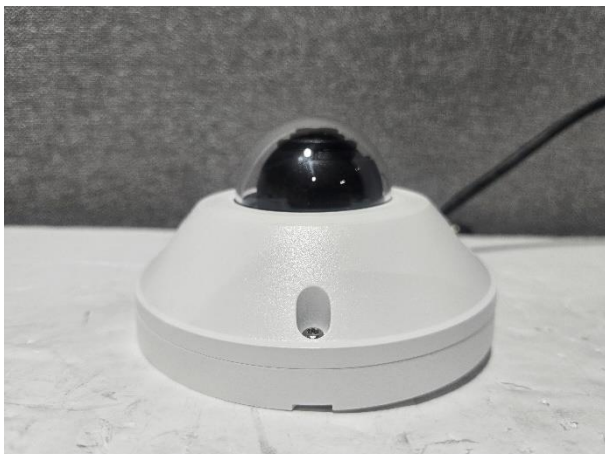
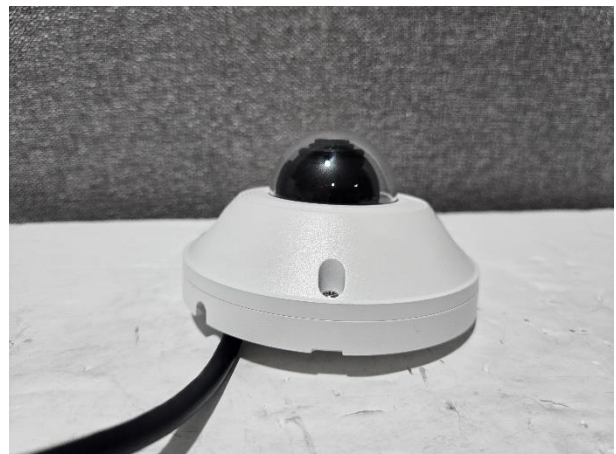
### 2.4.1 Test sample

## 2.4 Pre-test product images

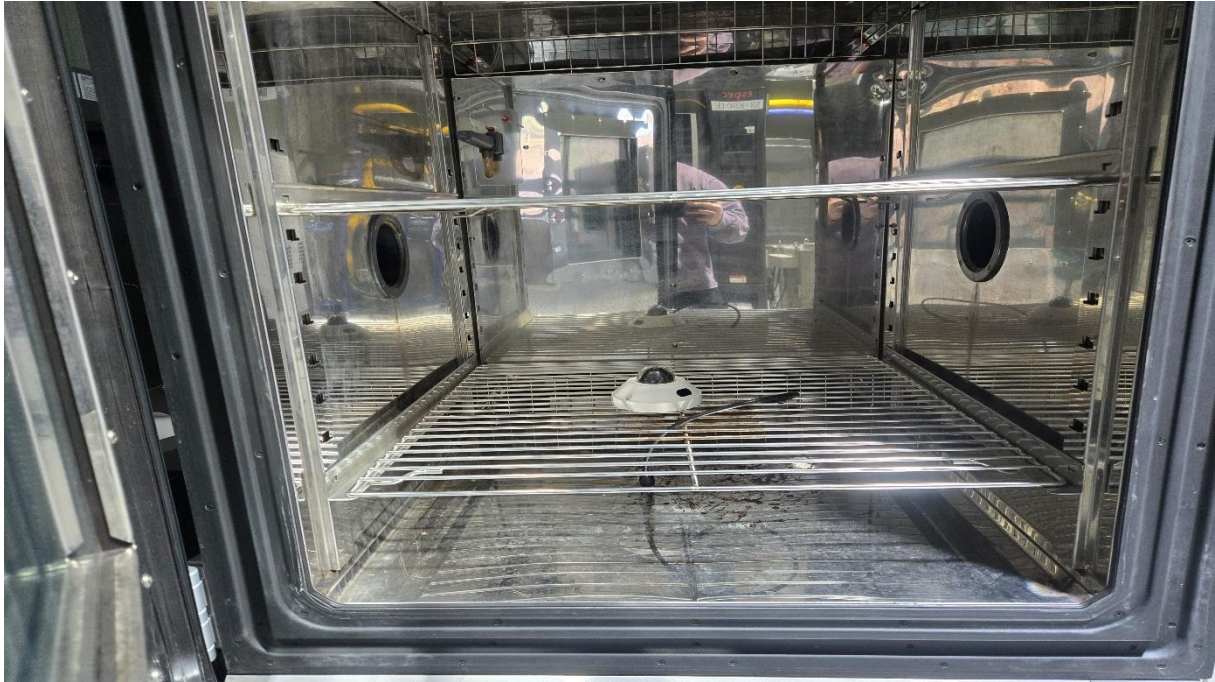
#### 3.3.1 Evidence of test setting

3.2.1 Sample status: Non-operation

3.2.2 Test temperature: -33 °C

3.2.3 Test time: 16 h

| Evaluations Criteria | Test result | | Comment |
|---|---|---|---|
| Sample | Visual Inspection | Normal | - |
| | Operation and Function | Normal | - |

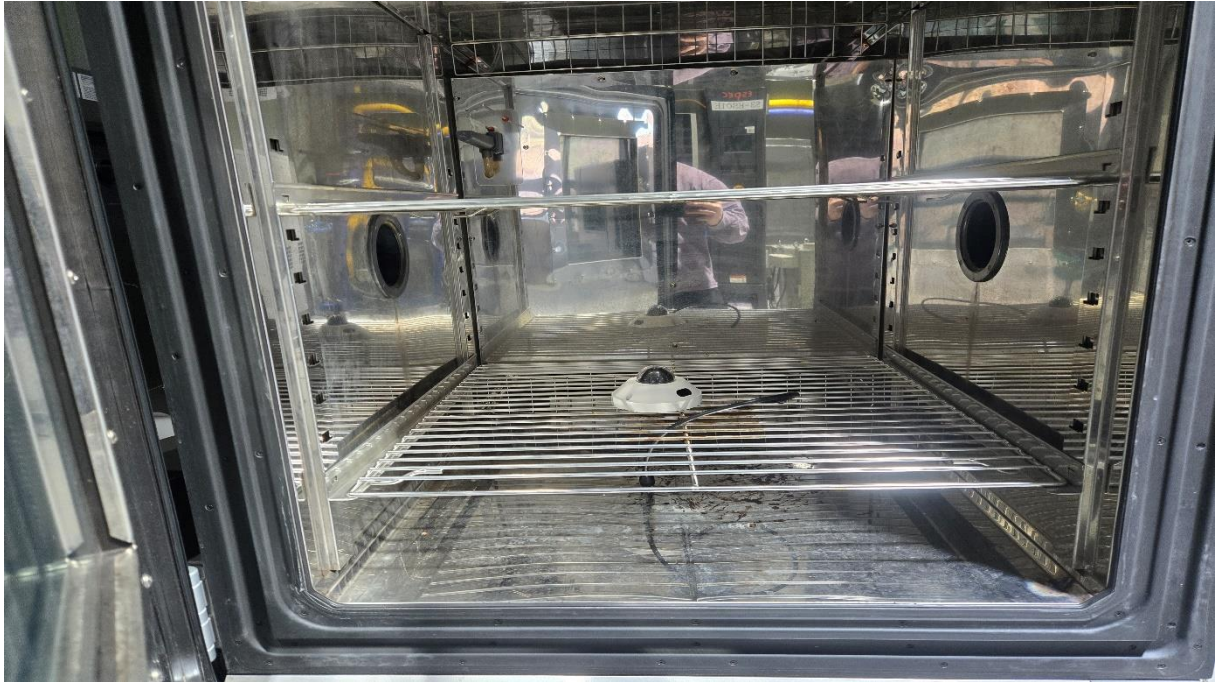
#### 4.3.1 Evidence of test setting

4.2.1 Sample status: Non-operation

4.2.2 Test temperature: 50 °C

4.2.3 Test time: 96 h

| Evaluations Criteria | Test result | | Comment |
|---|---|---|---|
| Sample | Visual Inspection | Normal | - |
| | Operation and Function | Normal | - |

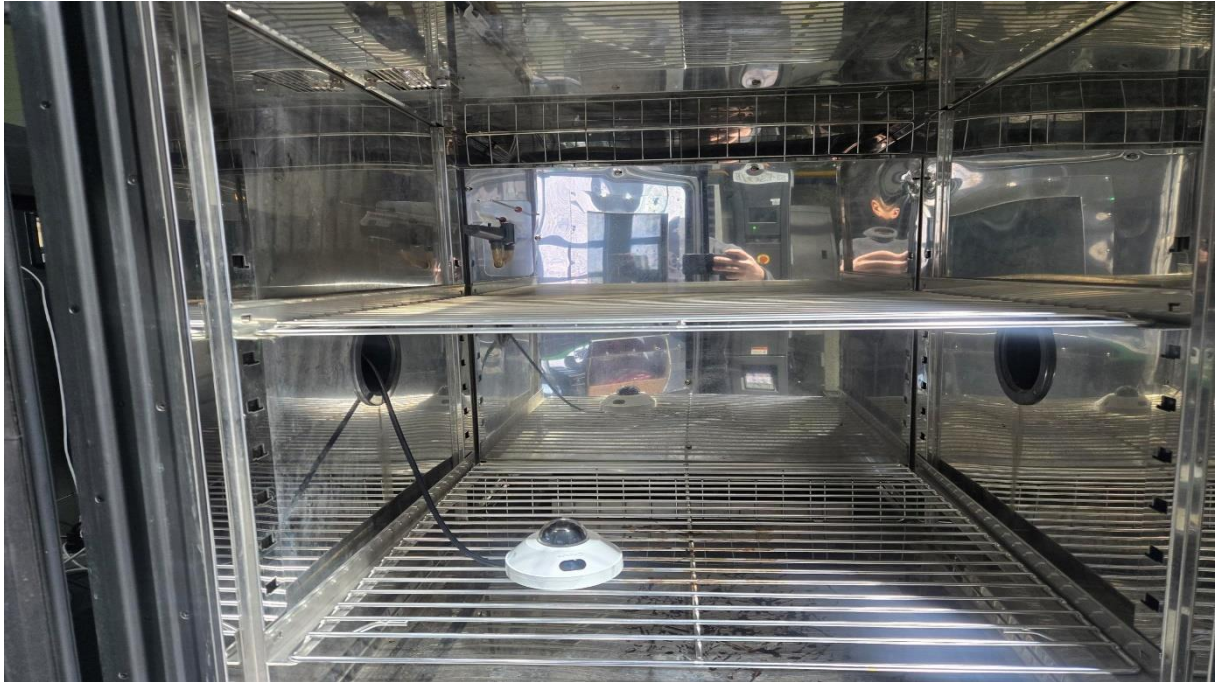
#### 5.3.1 Evidence of test setting

5.2.1 Sample status: operation

5.2.2 Test temperature: -33 °C, 50 °C

| Temp↵ | Temperature change rate(°C/min)↵ | t <sub>1</sub> (idle time)↵ | Cycles↵ |
| High↵ | 5 °C/min↵ | 3 h↵ | 3↵ |
| Low↵ | 1 °C/min↵ | 3 h↵ | 3↵ |

| Evaluations Criteria | Test result | | Comment |
|---|---|---|---|
| Sample | Visual Inspection | Normal | - |
| | Operation and Function | Normal | - |

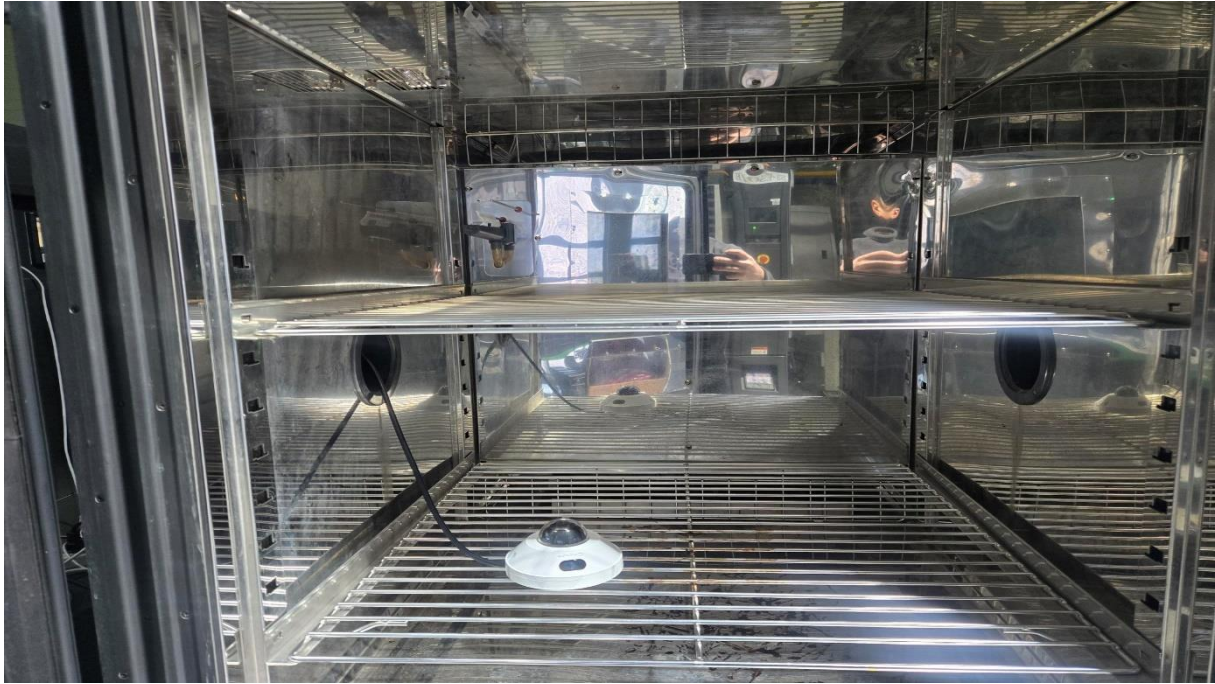
#### 8.3.1 Evidence of test setting

8.2.1 Sample status: operation

8.2.2 Test temperature:  $40 \pm 2$  °C

8.2.3 Test Humidity:  $93 \pm 3$  % R.H.

8.2.4 Test time: 240 h

| Evaluations Criteria | Test result | | 비고 |
|---|---|---|---|
| Sample | Visual Inspection | Normal | - |
| | Operation and Function | Normal | - |

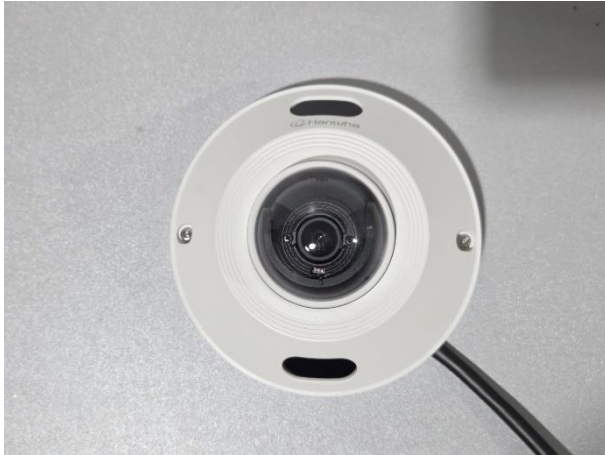
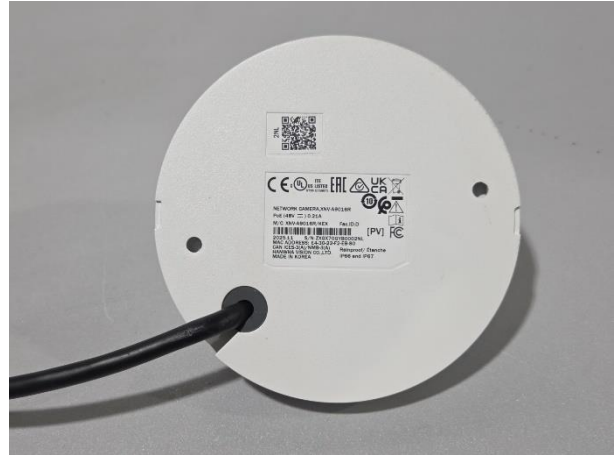
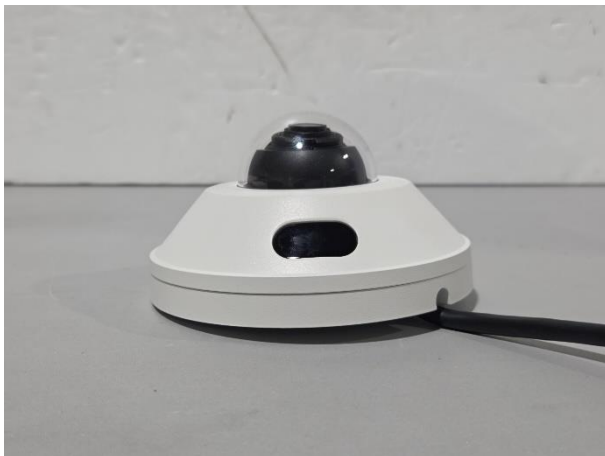
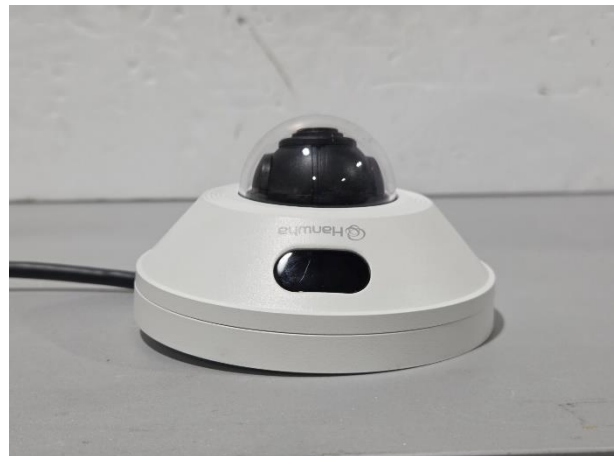
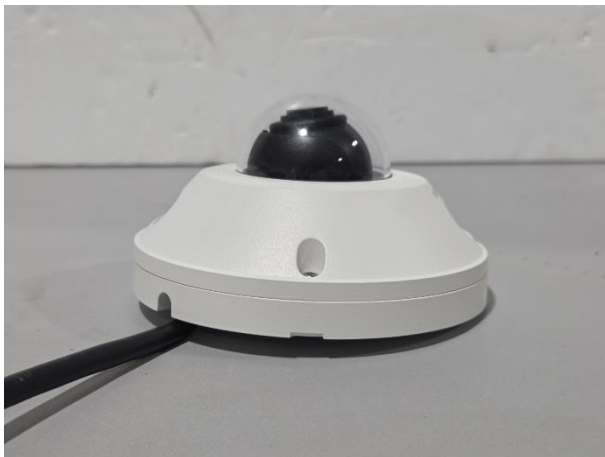
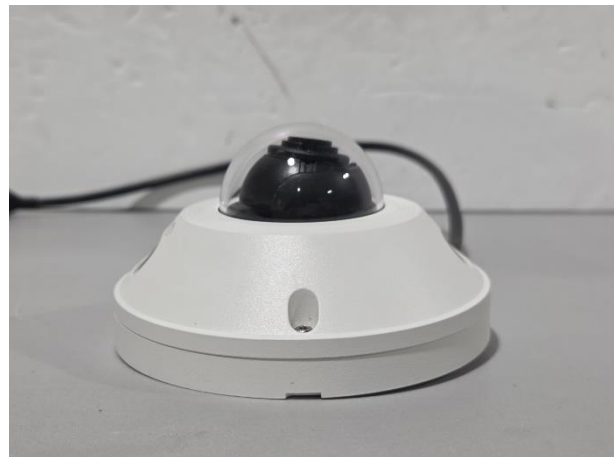
### 8.6.1 Test sample

## 8.6 Post-test product images
