# TEST REPORT

REPORT No.:  
CTK-2026-00013  
Page (1) / (25) pages

NETWORK CAMERA / XNV-A9016R

NEMA TS 2-2013 2.2.7.3 Test C ~ 2.2.7.8 Test H,  
NEMA TS 2.2.8, NEMA TS 2.2.9

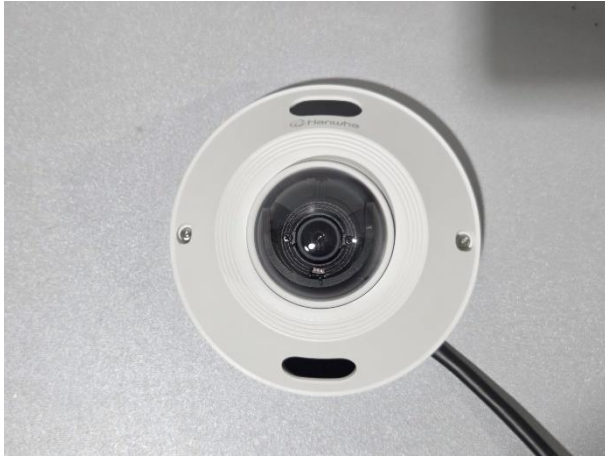
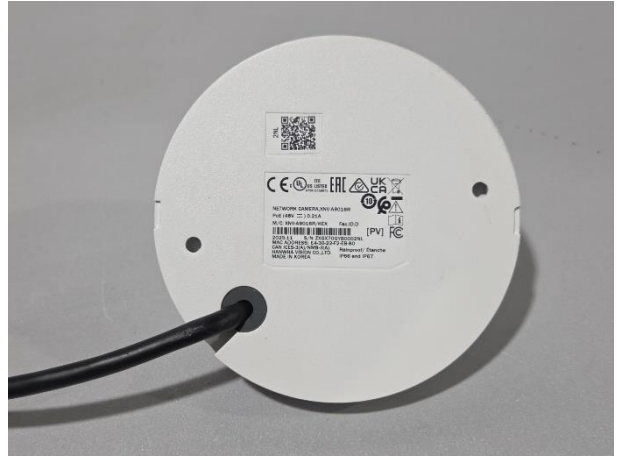
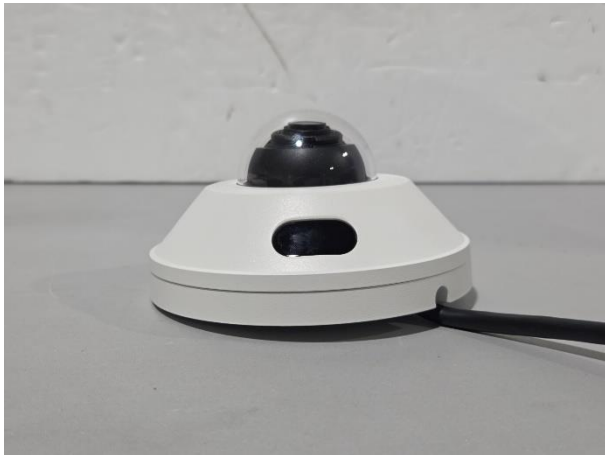
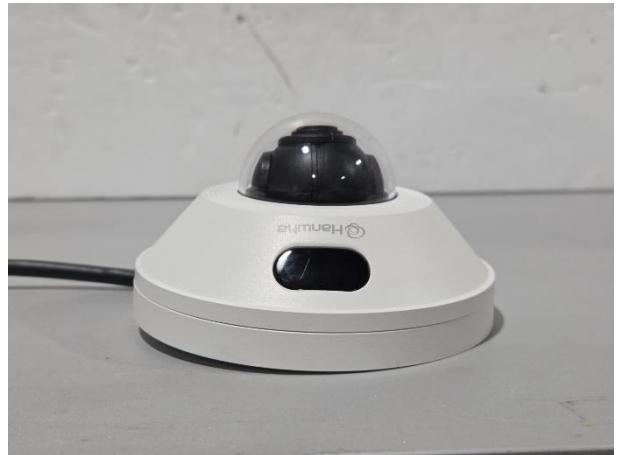
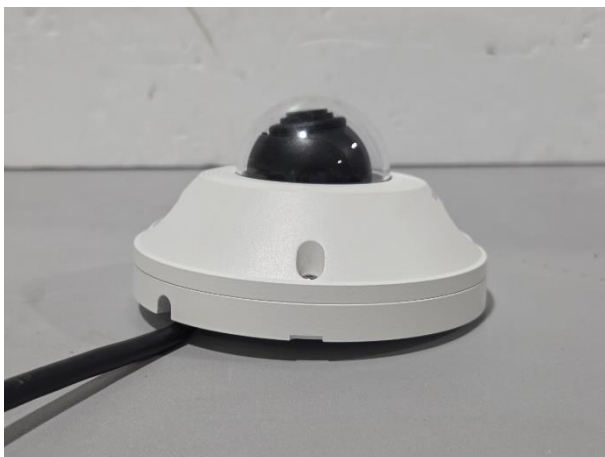
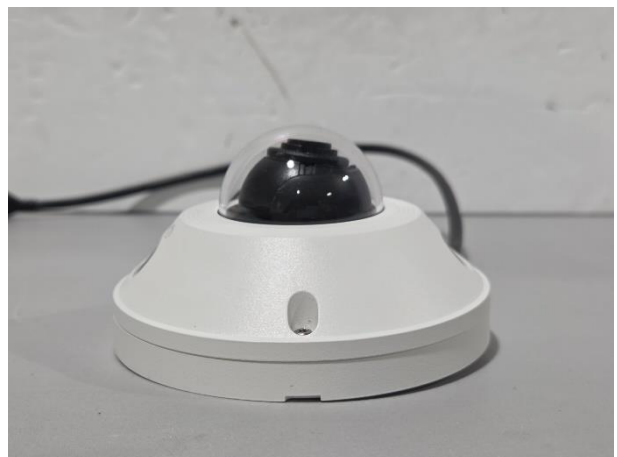
### 5.6.1 Test sample

| Evaluation Criteria | | Test Results | Comment |
|---|---|---|---|
| | After | Normal | |
