# TEST REPORT

REPORT No.:  
CTK-2025-00627  
Page (1) / (24) pages

NETWORK CAMERA / XNV-A9084R

NEMA TS 2-2013 2.2.7.2 Test B ~ 2.2.7.8, NEMA TS 2.2.8,  
NEMA TS 2.2.9

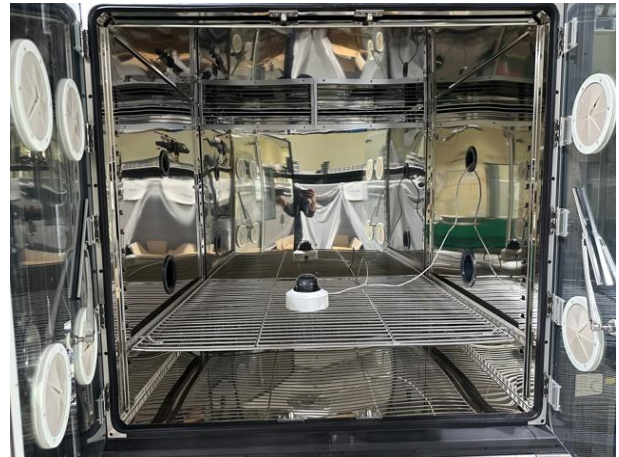
Transient Tests

#### 3.3.1 Evidence of test setting (2.2.7.2 Test B ~ 2.2.7.8 Transient Test)
