# TEST REPORT

REPORT No.:  
CTK-2025-03247  
Page (1) / (13) pages

NETWORK CAMERA / XNV-A9084RS

IEC 60529:1989 +A1:1999+A2:2013

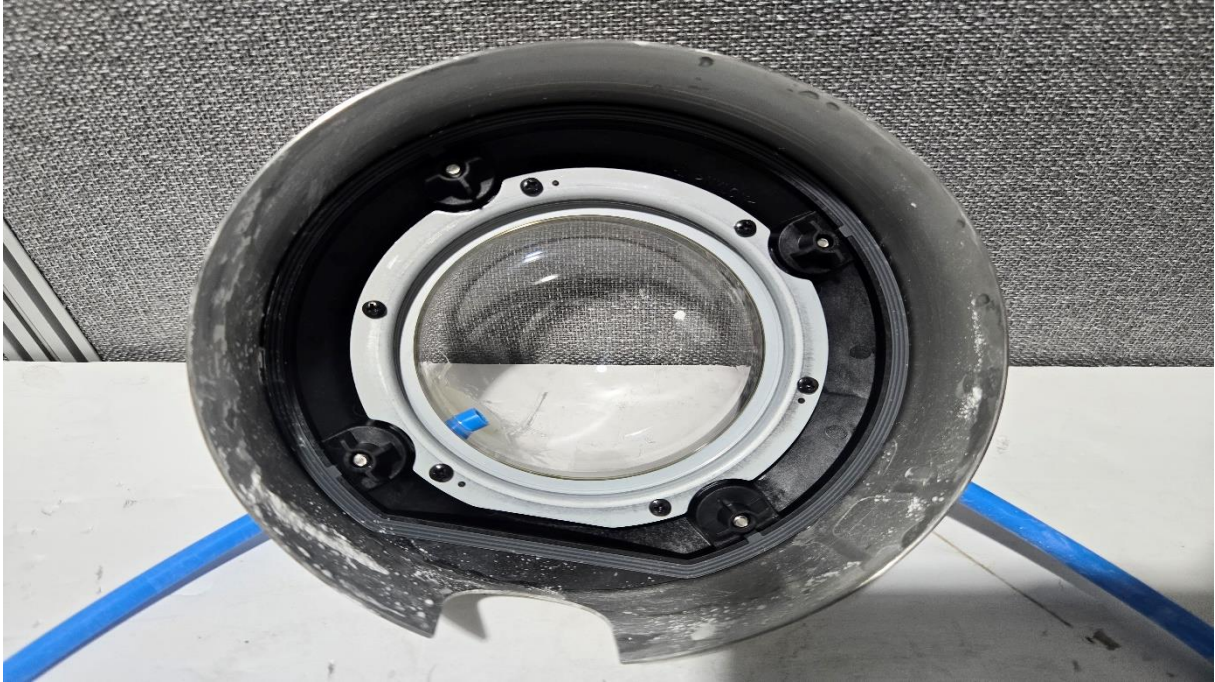
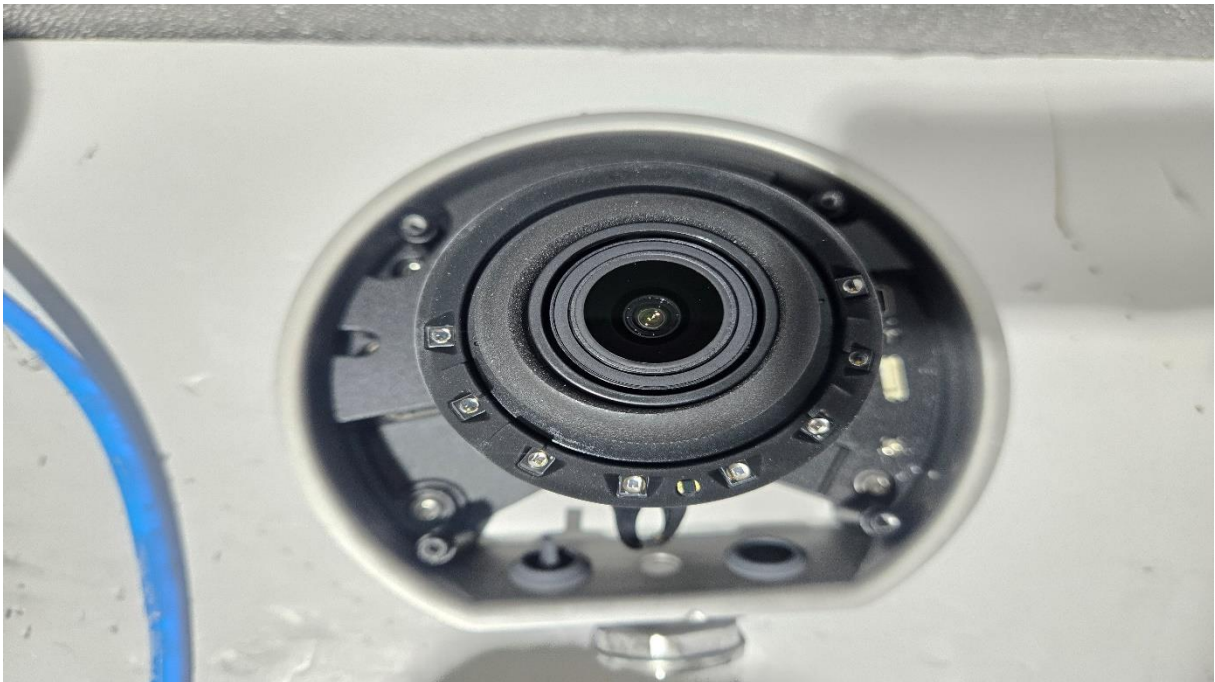
#### 3.5.1 Product internal images after test [The first characteristic numeral test]

※ Refer to the product photos after the completion of testing in section 3.5.

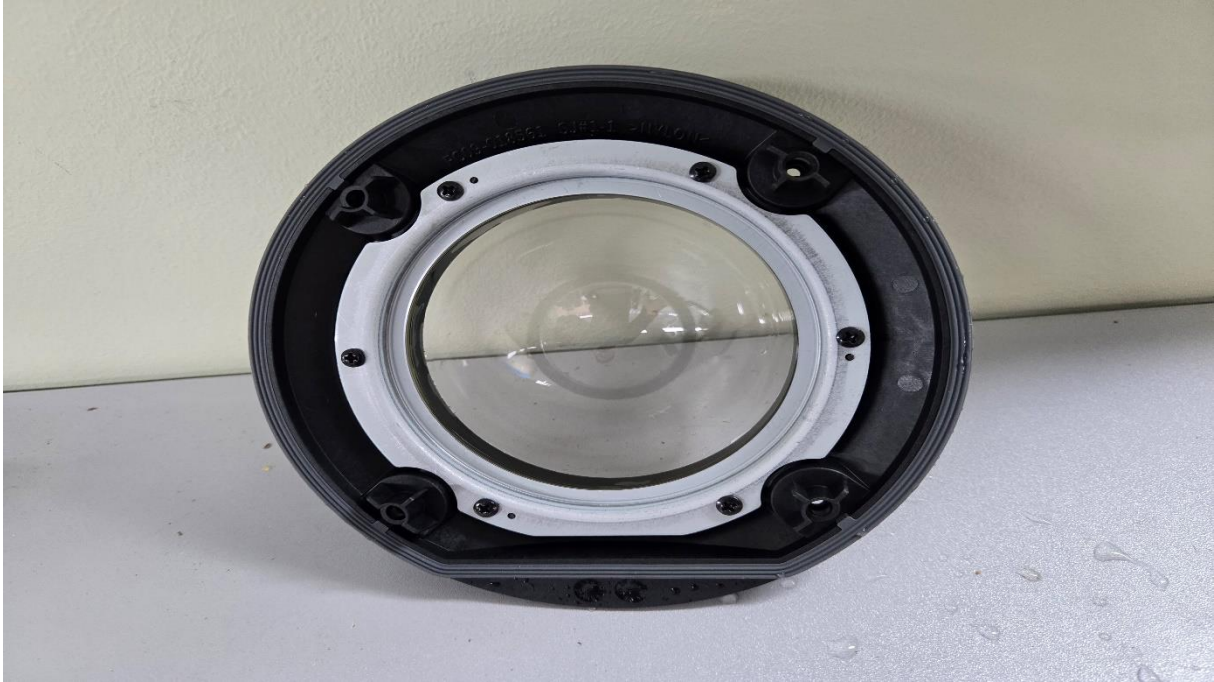
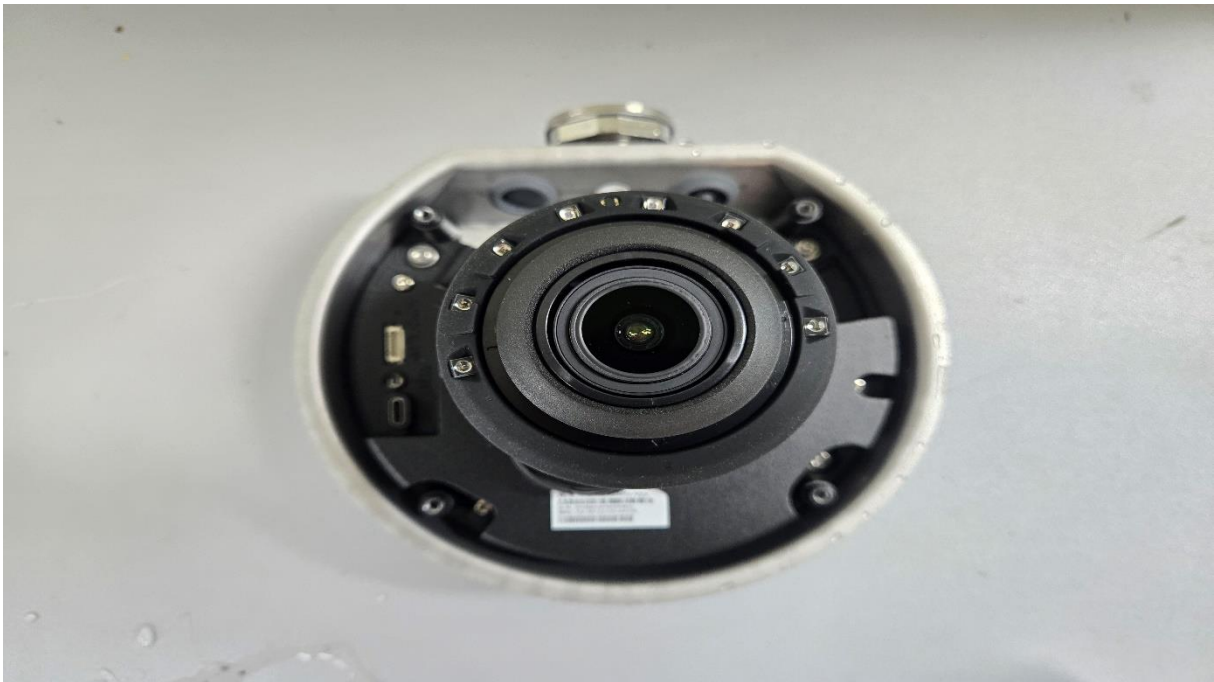
### 3.5.2 Product internal images after test [The second characteristic numeral test]
