# TEST REPORT

REPORT No.:  
CTK-2025-03249  
Page (1) / (13) pages

NETWORK CAMERA / XNV-A9084RS

IEC 60529:1989 +A1:1999+A2:2013

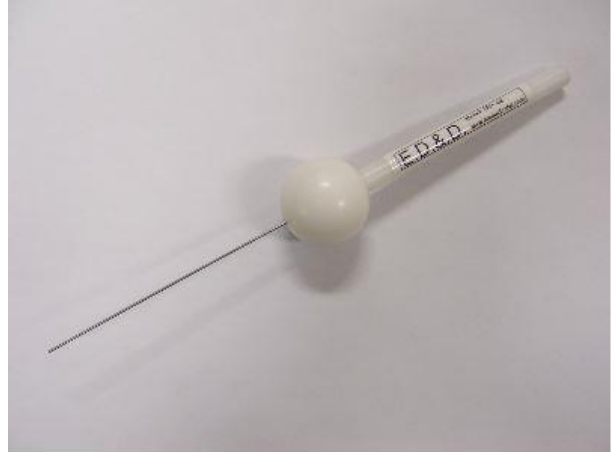
Test Rod Probe Ø1.0

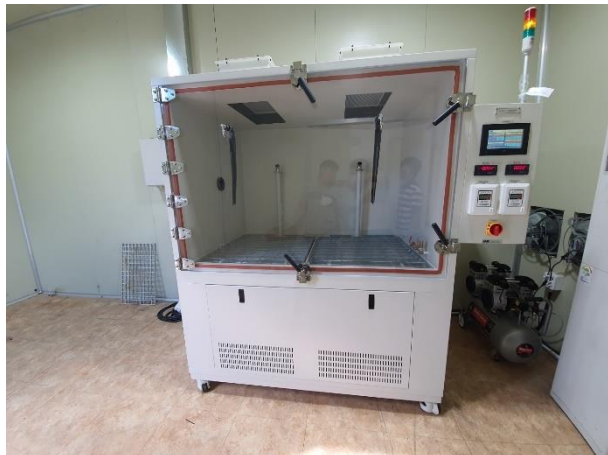
Dust Chamber

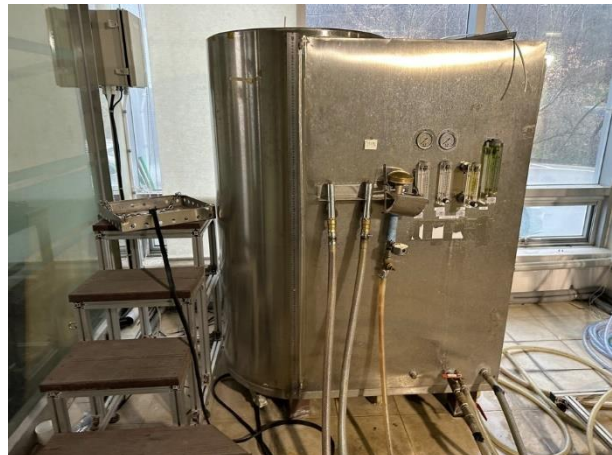
Immersion tank

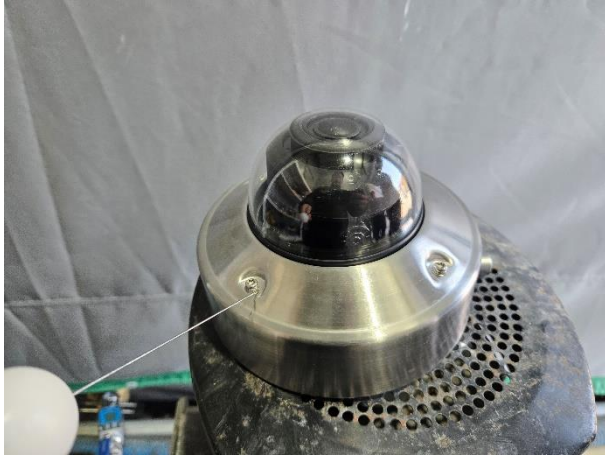
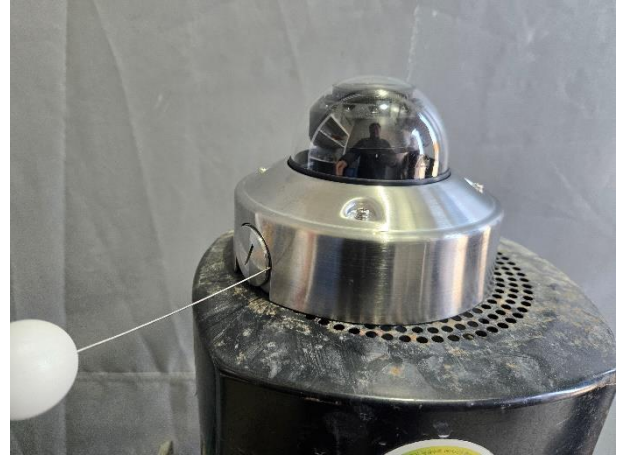
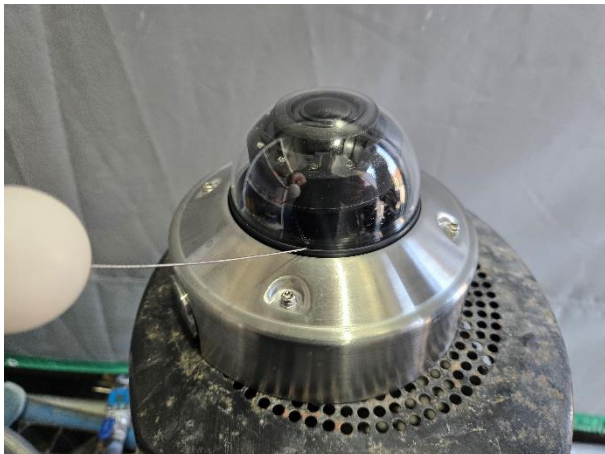
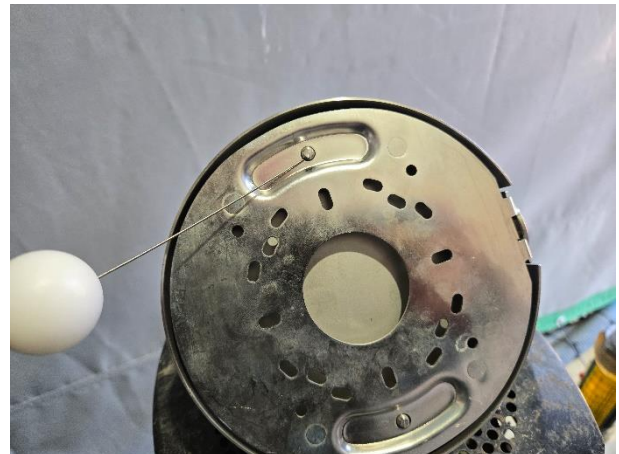
Probe test

| IP code | Evaluation Criteria | Test Results | Remark |
|---|---|---|---|
| IP 6X | No ingress of Probe | Normal | - |

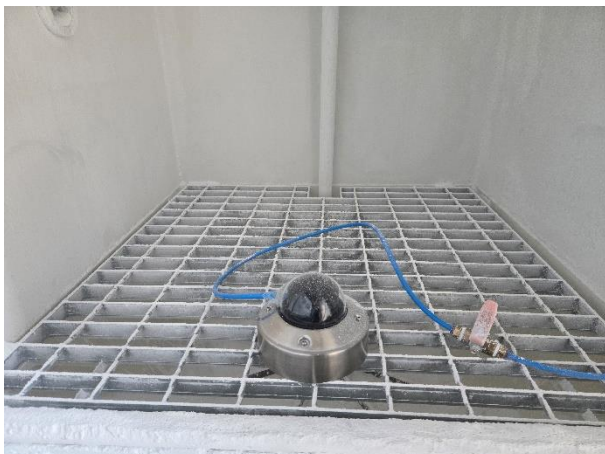
Dust test

| IP code | Evaluation Criteria | Test Results | Remark |
|---|---|---|---|
| | No ingress of dust | Normal | |

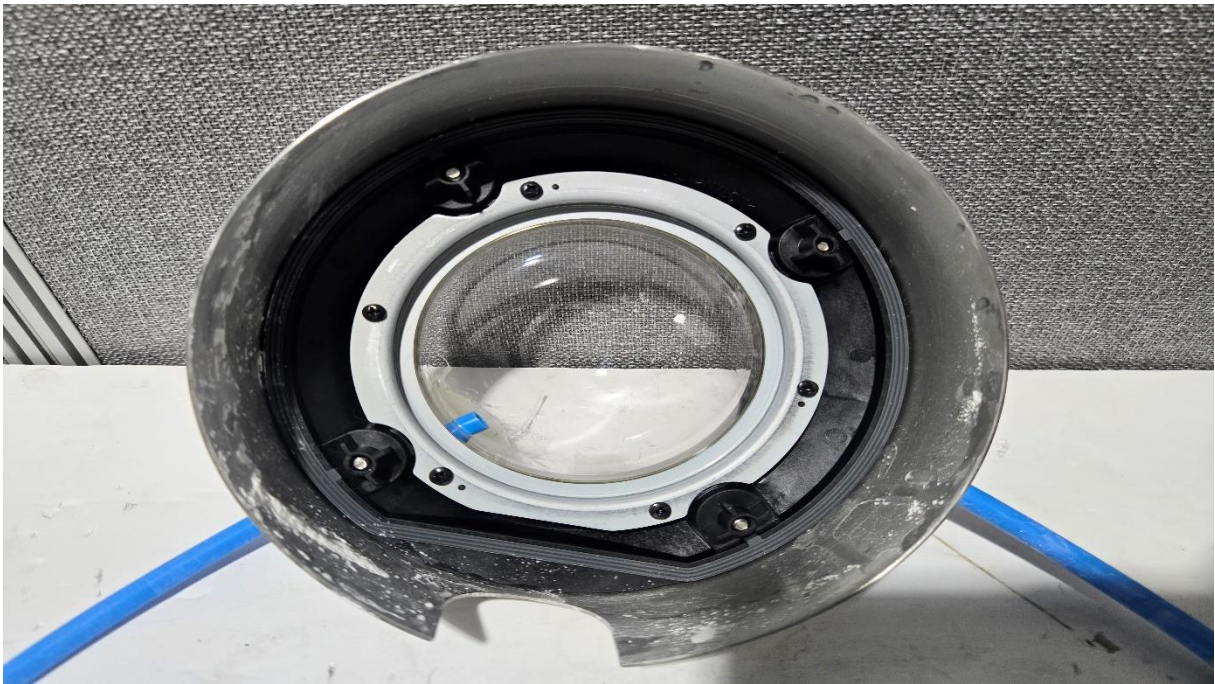
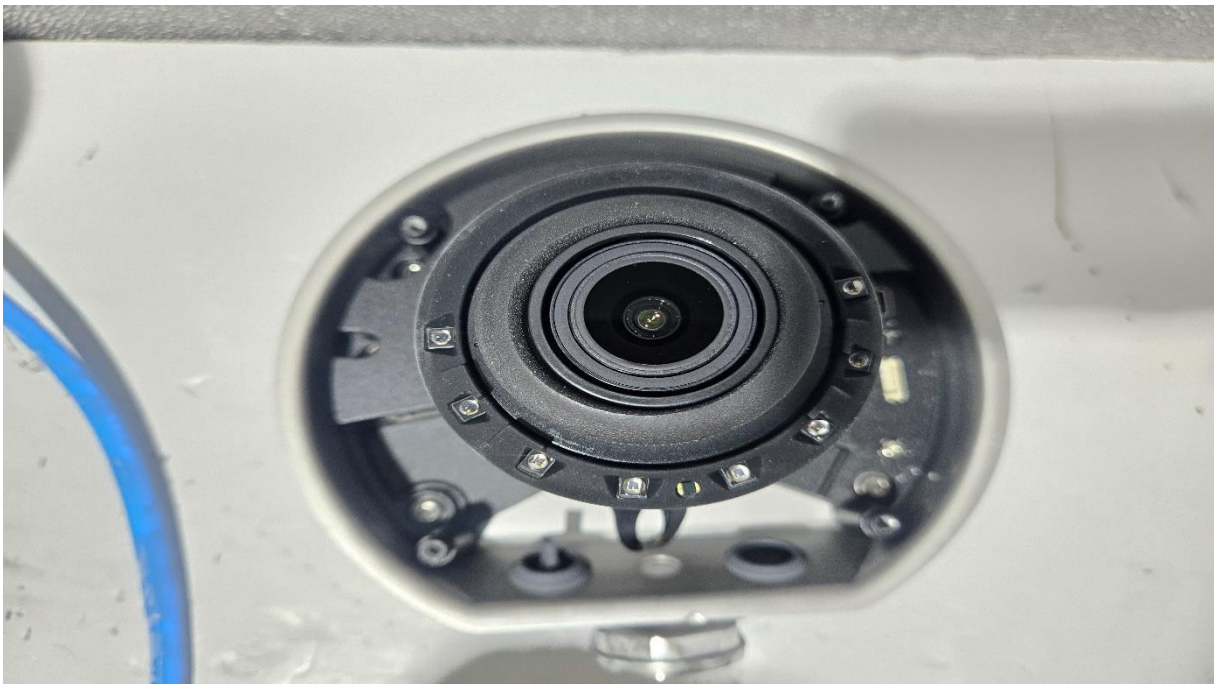
#### 3.5.1 Product internal images after test [The first characteristic numeral test]

※ Refer to the product photos after the completion of testing in section 3.5.

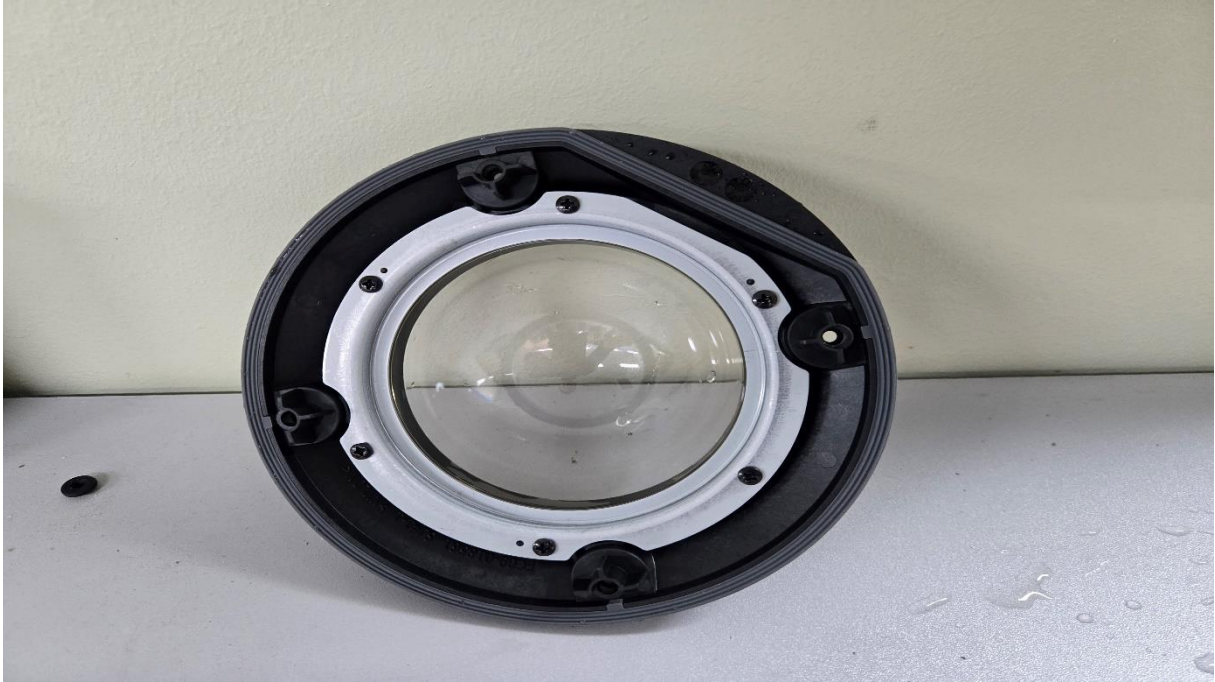
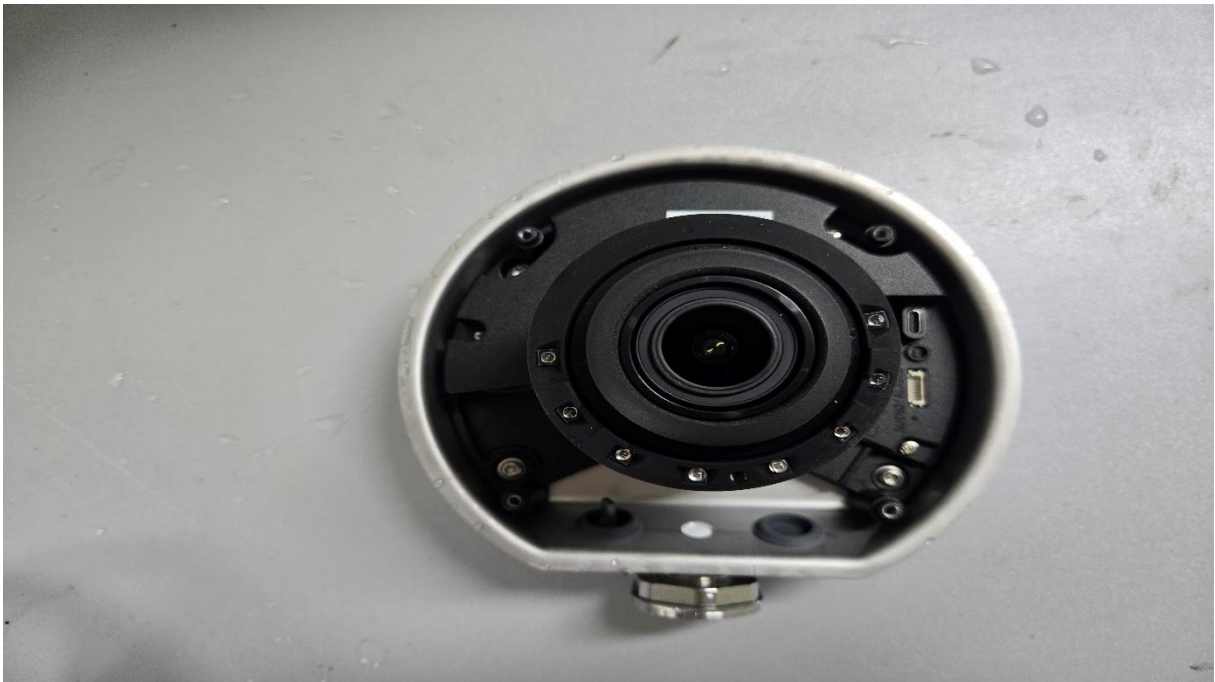
### 3.5.2 Product internal images after test [The second characteristic numeral test]

| IP code | Evaluation Criteria | Test Results | Remark |
|---|---|---|---|
| IP X7 | No ingress of water | Normal | |
