TEST REPORT

REPORT No.:
CTK-2019-05140

4. Test sample / Model ..... : Network Camera / XNO-L6080R

1. Degrees of protection provided by enclosures for electrical equipment against external mechanical impacts (IK code)

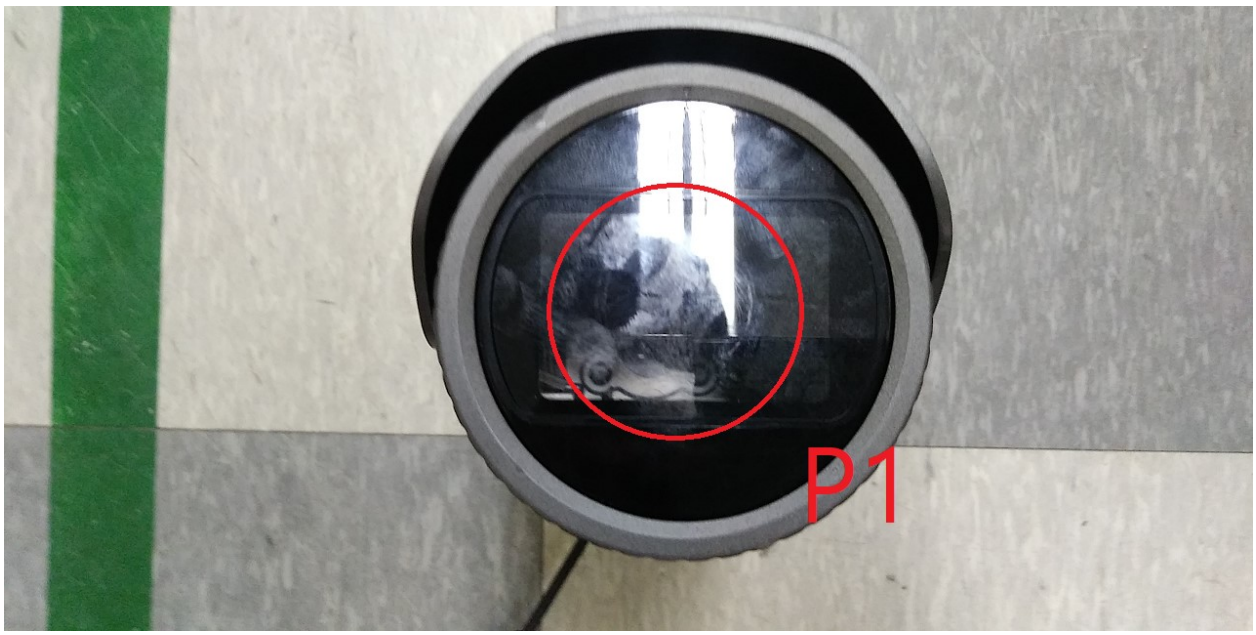
2.3 Photos after test

Item	Contents	Result
Operation after the test	Only the enclosure was obtained.	-
External protection Enclosure	No damage	Pass
Comment Related Product certification: IEC 60950-1 Only the enclosure was obtained and the electrical performance could not be verified. Some scratches were generated on the outside of the product.
