TEST REPORT

REPORT No.: CTK-2026-02415

Sample Name	Model Name	S/N	Date of Manufacture	Quantity	Comment
NETWORK CAMERA	PNM-A32084RQZ	ZXLQ6V4L70000RH	Jul. 2026	1 EA	-

3.2.1 Test standard: IEC 62262:2002+AMD1:2021

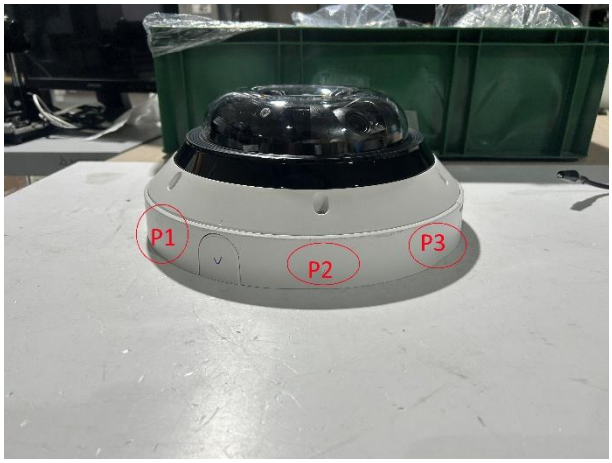
Evaluation Criteria	Test Results	Remark
Visual Inspection	Some scratches were generated on the outside of the Sample.	-
