TEST REPORT

REPORT No.:
CTK-2026-01352

4. Test sample / Model : NETWORK INTERCOM / TID-A800

6. Test Standard (Method) used : IEC 62262:2002+AMD1:2021

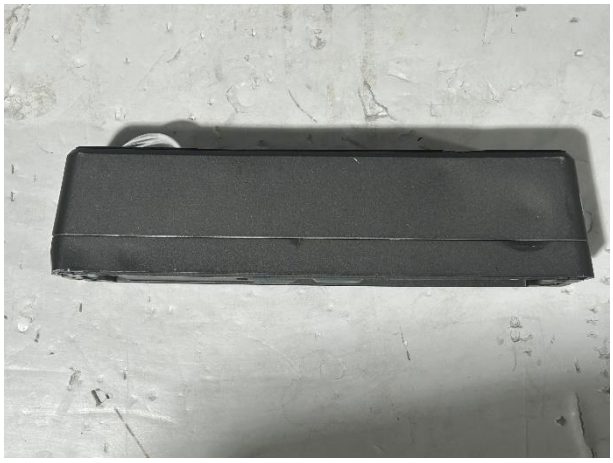
3.6.1 Test sample

Evaluation Criteria	Test Results	Remark
Visual Inspection	Some scratches were generated on the outside of the Sample.	-
