TEST REPORT

REPORT No.:
CTK-K-2026-00419
Page (1) / (14) pages

4. Test sample / Model : NETWORK INTERCOM / TID-A800

6. Test Standard (Method) used : IEC 60529:1989 +A1:1999+A2:2013

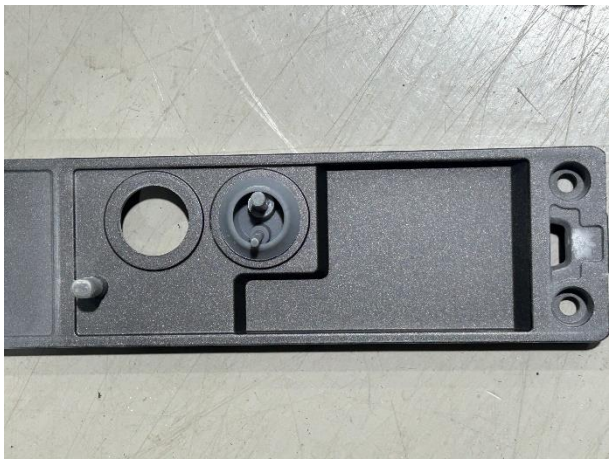
post dust test image(1)

IP code	Evaluation Criteria	Test Results	Remark
IP 6X	No ingress of Probe	Normal	-
	No ingress of dust	Normal	
IP X5	No ingress of water	Normal
