TEST REPORT

REPORT No.:
CTK-2026-01786

Product Name	Model Name	Quantity	Comment
NETWORK CAMERA	XND-A9085RV	1 EA	-

3.2.1 Test standard: IEC 62262:2002+AMD1:2021

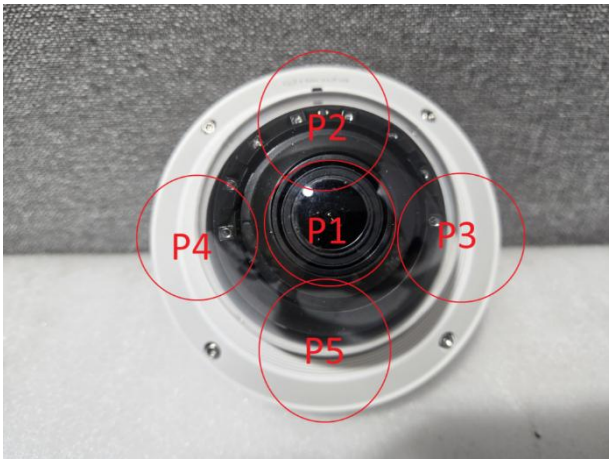
Check the hit area the test_1

Evaluation Criteria	Test Results	Remark
Visual Inspection	Some scratches were generated on the outside of the Sample.	-
