TEST REPORT

REPORT No.: CTK-2026-00736

Sample Name	Model Name	S/N	Date of Manufacture	Quantity	Comment
Network Camera	XNO-A9014R	ZX4C70GL10000GX	2026.01	1 EA	-

3.2.1 Test standard: IEC 62262:2002+AMD1:2021

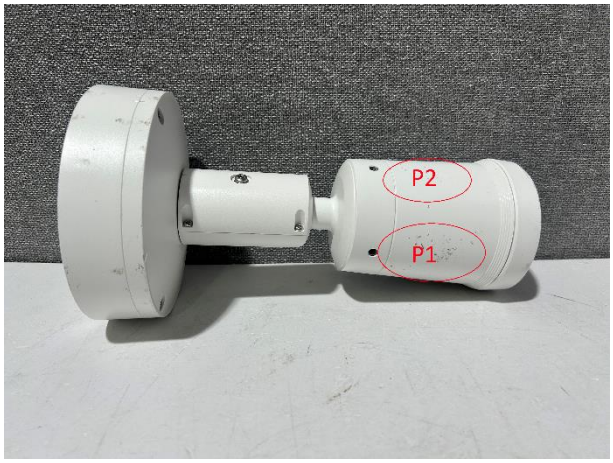
Evaluation Criteria	Test Results	Remark
Visual Inspection	Some scratches were generated on the outside of the product.	-
