TEST REPORT

REPORT No.:
CTK-2026-00734

Sample Name	Model Name	S/N	Date of Manufacture	Quantity	Comment
Network Camera	XNO-A9014R	ZX4C70GL10000DP	2026.01	1 EA	-

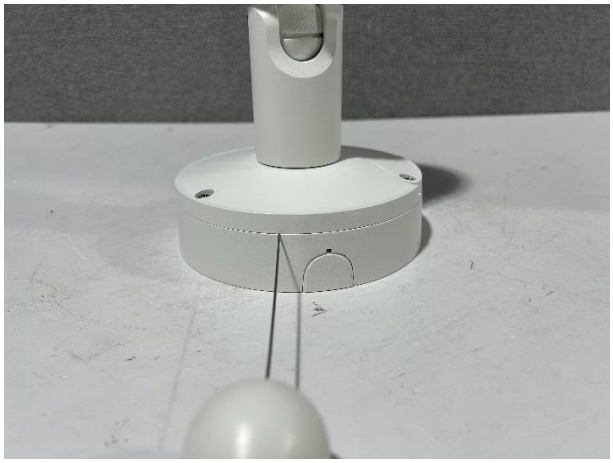
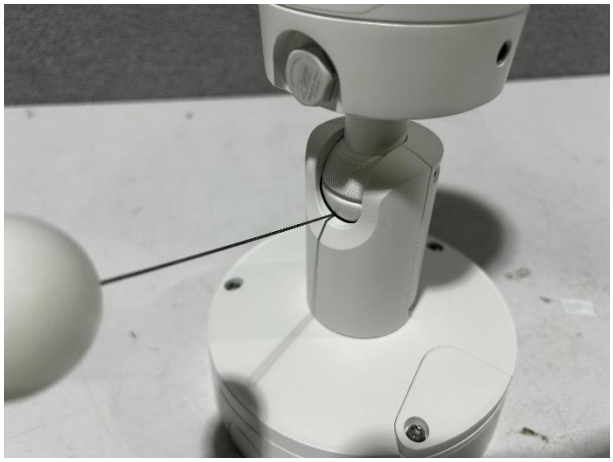
3.3.1 Evidence of test setting

Prove test

Dust test

Waterproof test

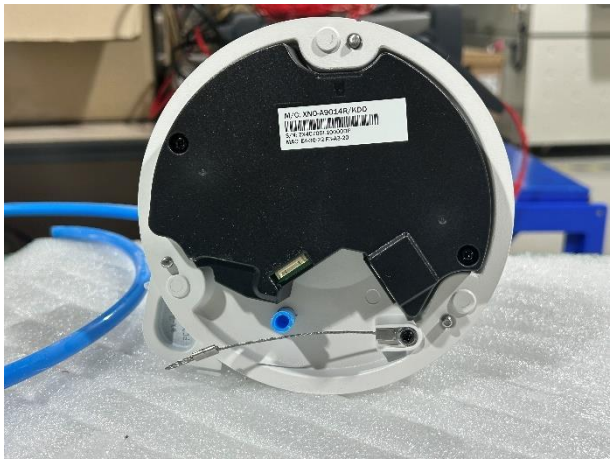
3.5.1 Sample internal images after test [The first characteristic numeral test]

IP code	Evaluation Criteria	Test Results	Remark
IP 6X	No ingress of Probe	Normal	-
	No ingress of dust	Normal	
IP X7	No ingress of water	Normal

※ Refer to the sample images after the completion of testing in section 3.5.
