TEST REPORT

REPORT No.:
CTK-2026-01983

Product Name	Model Name	Quantity	Comment
NETWORK CAMERA	XNV-A9085R	1 EA	-

3. Degrees of protection provided by enclosures for electrical equipment against external mechanical impacts (IK code)

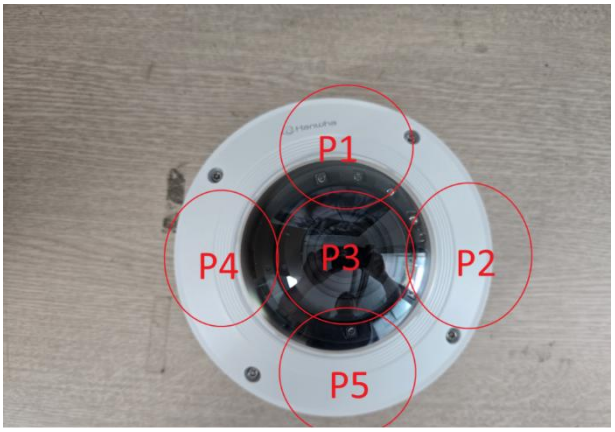
Check the hit area the test_1

Evaluation Criteria	Test Results	Remark
Visual Inspection	Some scratches were generated on the outside of the Sample.	-
