TEST REPORT

REPORT No.:
CTK-K-2026-00616

1.	**Applicant**	
	◦ Name :	Hanwha Vision Co., Ltd.
	◦ Address :	6, Pangyo-ro 319Beon-gil, Bundang-gu, Seongnam-si, Gyeonggi-do, 13488 KOREA
	◦ Date of Receipt :	Jun. 11, 2026
2.	**Manufacturer**	
	◦ Name :	Hanwha Vision Co., Ltd.
3.	**Use of Report :**	For submission to customer
4.	**Test sample / Model :**	NETWORK CAMERA / XNV-A9095RZ
5.	**Date(s) of test :**	Jun. 15, 2026 ~ Jun. 17, 2026
6.	**Test Standard (Method) used :**	IEC 60529:1989 +A1:1999+A2:2013
7.	**Testing Environment :**	Temperature: (25 ± 10) ℃, Humidity: (50 ± 25) % R.H. Pressure: (96 ± 10) kPa
8.	**Test Results :**	Refer to the test results
9.	**Location of Test :**	☒ Permanent Testing Lab ☐ On Site Testing (113, Yejik-ro, Cheoin-gu, Yongin-si, Gyeonggi-do, Republic of Korea)

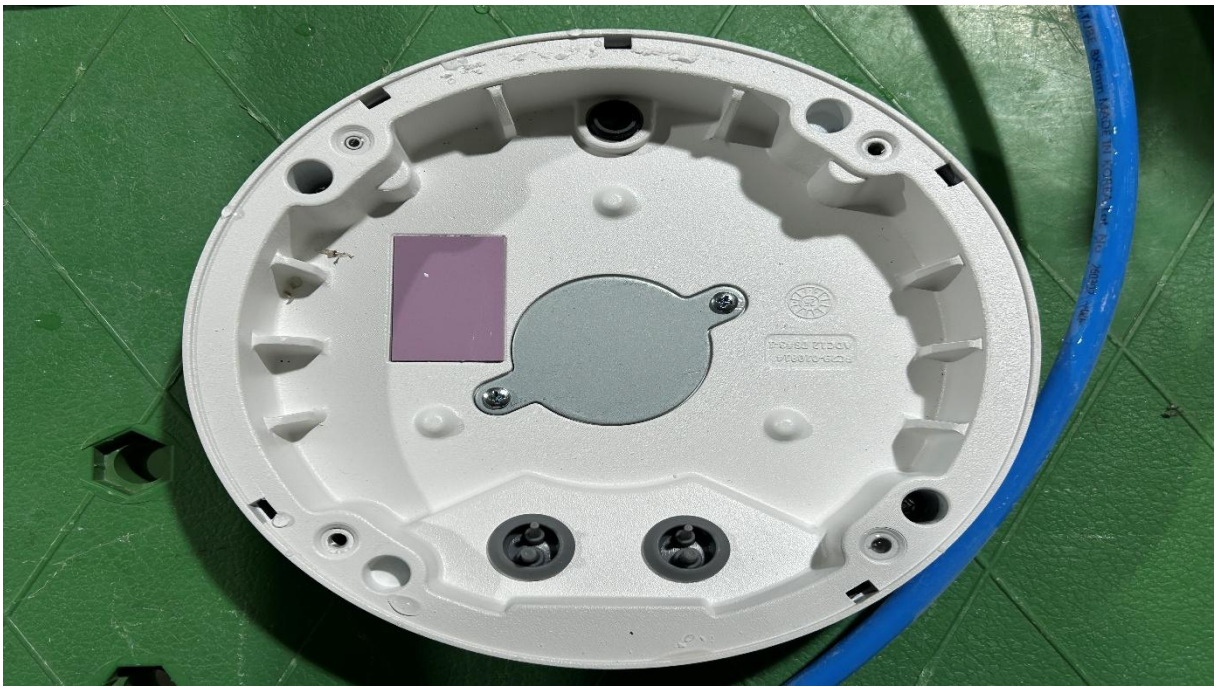
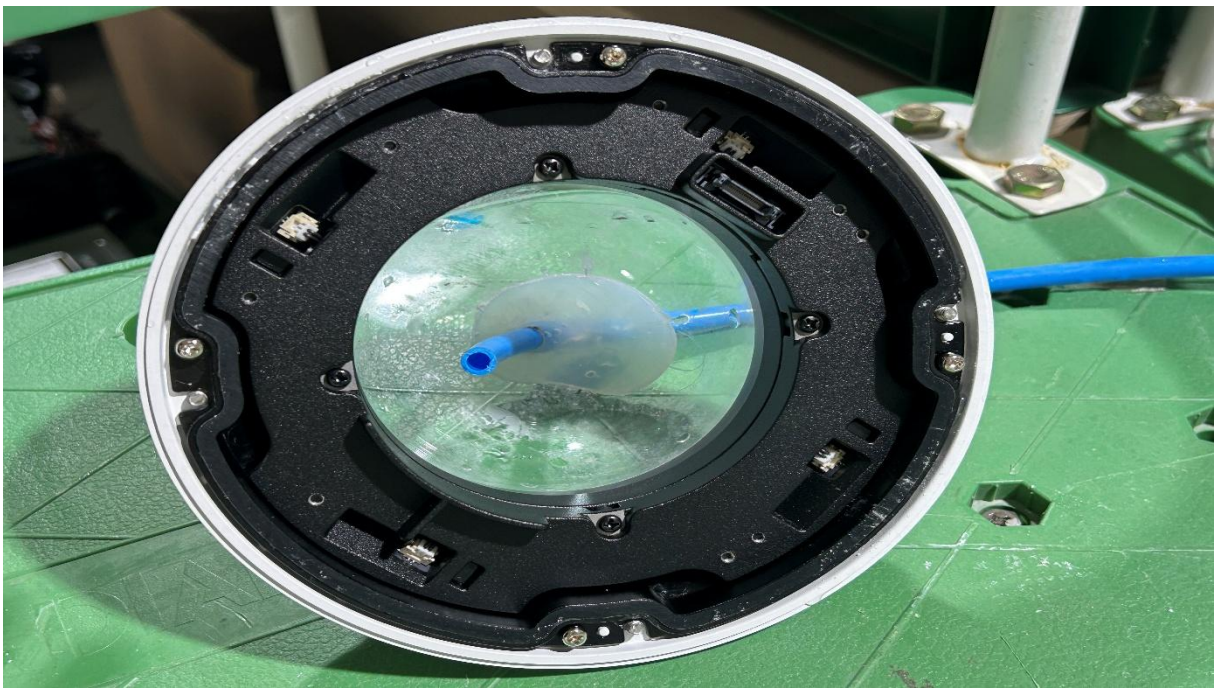
3.5.1 Sample internal images after test [The first characteristic numeral test]

IP code	Evaluation Criteria	Test Results	Remark
IP 6X	No ingress of Probe	Normal	-
	No ingress of dust	Normal	-
IP X7	No ingress of water	Normal	-

※ Refer to the sample photos after the completion of testing in section 3.5.
